PART III
COASTAL STRUCTURES AND RELATED PROBLEMS,

CHAPTER 97

DAMAGES TO COASTAL STRUCTURES

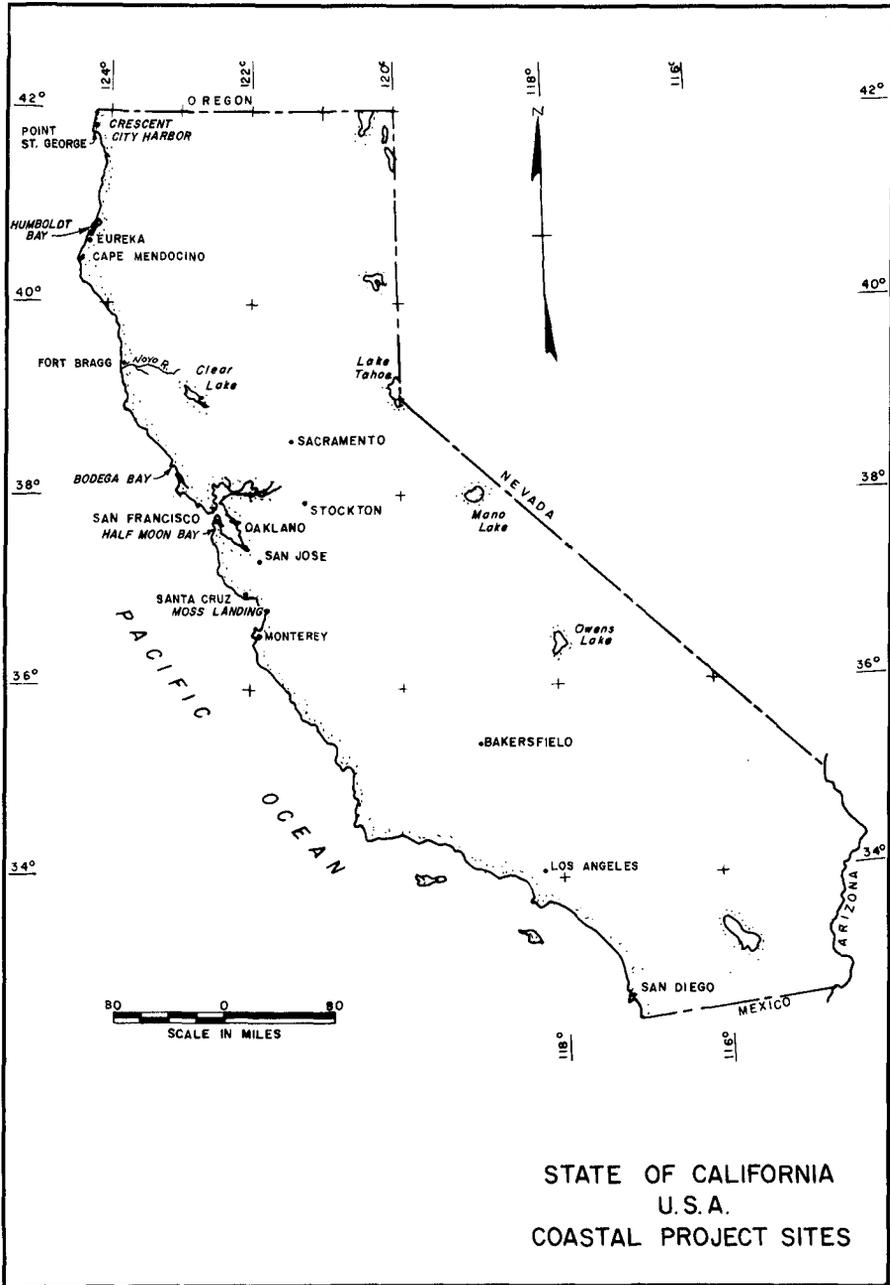
FIGURE 2

The reach of coast under consideration and the location of the structures discussed in this paper is shown on Figure 2. The exposed portion of the California Coastline is over 1,300 miles in length and includes a great variety of coastal shoreline types. It is interesting to note that a vast portion of California's coastal shoreline is retrograding and is therefore being lost by natural geologic processes of erosion. In some areas, such as the entrance to Humboldt Bay, jetties are used to stabilize the entrance through a barrier beach. Other areas are rocky coasts, and breakwaters are needed to provide harbors and safe mooring areas. In still other areas, seawalls are used to provide protection of eroding coastlines. The wave climate in the northerly portion of the California Coast is severe. It is exposed to the full force of north Pacific winter storms, usually occurring during the period from November to March. Generally, the severe storms at this location are produced by extra tropical cyclones, which originate near Japan and move generally eastward toward Alaska. When the "Pacific high pressure area" moves southward, the stronger and rapidly moving low pressure of frontal systems produce severe storms which produce high waves along the coast.
