PROTOTYPE TESTS ON RIPRAP UNDER RANDOM WAVE ATTACK  
J.D. Pitt and P. Ackers (Member ASCE)\*

This paper describes the performance of test panels of riprap on an offshore island in the Wash estuary, UK, for the first 2½ years after their construction, by which time all but one had failed. It outlines the methods used in obtaining and analysing data on stone size, wind, tides and waves. The techniques used in surveying the test panels for damage and the reduction of the survey data to yield quantitative estimates of damage are described.

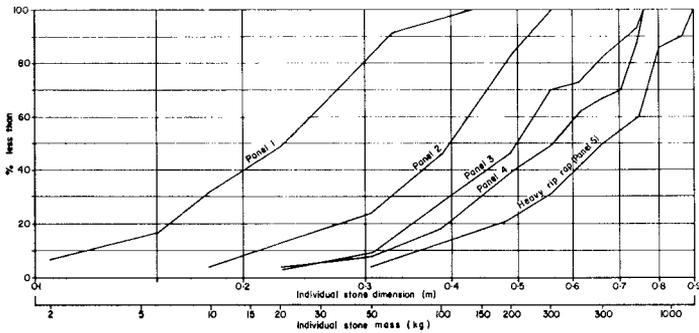
FIG. 3. GRADING CURVES FOR RIP RAP.

The mass grading curves obtained were converted to dimensional grading curves (figure 3) using the relationship suggested in Reference 3:

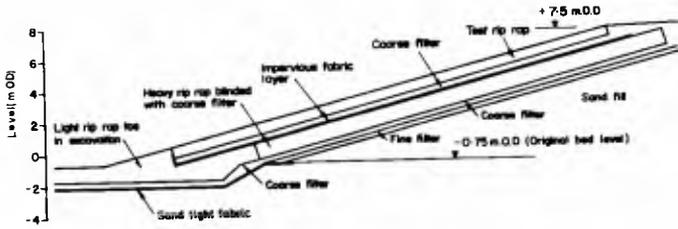
FIG. 4. SECTION THROUGH TEST PANEL.

The first stage of constructing the four test panels was to blind the selected area of main riprap protection with a layer of filter material to ensure that no settlement of the test panels would occur through the filling of voids beneath them. A fabric sandwich, consisting of two layers of a non-woven sand-tight fabric separated by a sheet of PVC, was placed on the blinded surface to make the test panel foundation impervious, in an attempt to match the previous laboratory arrangement. A layer of filter was placed over the fabric on which the stone forming the test panels was laid, with the panel containing the smallest stone (Panel 1) at the eastern edge of the test area, each panel being flanked on its western edge by the panel containing the next larger size of stone. The location and arrangement of the panels on the embankment is shown in Figure 2, and a longitudinal section through one of the panels is shown in Figure 4.

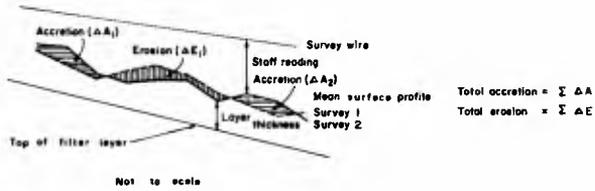
FIG. 5. ILLUSTRATION OF DAMAGE ANALYSIS.

The definition of damage was that used in the HRS laboratory studies reported by CIRIA<sup>(3)</sup>: the volume removed, expressed as an equivalent number of D<sub>50</sub> - size spherical stones for a 9D<sub>50</sub> width of panel, considering only downward movements of the surveyed profiles (reductions in thickness). In the laboratory tests, these movements occurred in a fairly well-defined area about the still-water level. Positive movements (accretion of displaced stone) generally occurring in the region below the eroded area were ignored, since these are not of interest when considering the ability of the riprap layer to withstand damage (Figure 5).

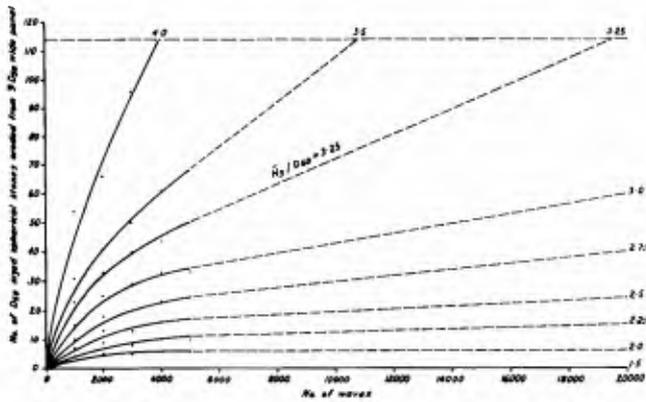
FIG. 8. DAMAGE FROM WAVE ATTACK, BASED ON HRS RESULTS (REF. 3)

Results of the laboratory study<sup>(3)</sup> were used with the recorded wave data to hindcast the damage sustained by the test panels. The method used is a variation of that set out as Method 2 in CIRIA report 61(3), making the appropriate allowance for the different water densities in the laboratory and fieldwork. The data contained in that Report were used to prepare Figure 8, in which damage is related to number of waves incident on the panel and the ratio  $H_S/D_{50}$ . The total damage expected was obtained by summing the damage arising from waves of each height, i.e. as if they were attacking an undamaged surface.

5. The very large number of waves involved.
6. A different ratio of filter-size to riprap size.
7. The thickness of the panels (2D50 in the laboratory work: but considerably less than that in Panels 2, 3 and 4 in the field trials).
8. Different methods of placing the riprap, involving some degree of segregation and differing bulk density of the finished layer.
9. Problems of measuring stone size and differences in the grading and shape of the riprap.
10. The very different sizes of the stone in the laboratory and site situation and the consequential scale effects.
