Rehabilitation Methods for Damaged Breakwaters

R.L. Croeneveld *
A. Mol *
E.H. Nieuwenhuys *

Abstract

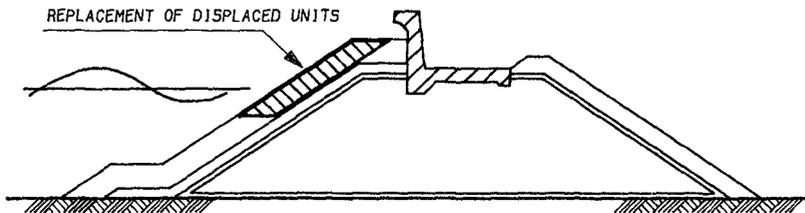
METHOD 1
FIGURE 3

The feasibility of replacing the individual units should be considered case by case. Usually, if the units are of the interlocking type, the undamaged original units on the slope above the gap caused by the displaced damaged units, will need to be removed and replaced to provide adequate interlocking between individual elements.

Because the displaced units have most likely been removed from above or just below the water-line, the method of repair can in most cases be carried out with lifting equipment placed on the breakwater, provided that space is available. (Ref. Figure 3)

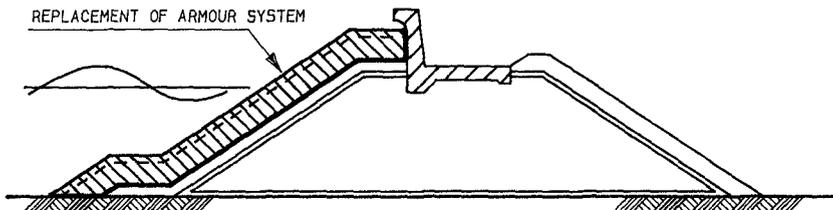
FIGURE 4

This method requires the replacement of the armour units by others of a different type and requires the removal of all original units. The method may be feasible if excessive maintenance to the original system is anticipated over the life of the structure, and capitalized costs of this maintenance exceed the cost of replacement. The underlying material should suit the new armour units and must be checked for layer thickness and compaction. It may be necessary also to place a new layer of secondary armour, in which case an adjustment of the slope may be considered. (Ref. Figure 4)

This method has been applied in cases in which the original choice of armour units proved to be inadequate. In particular this may occur, regarding the structural strength of units with a sophisticated interlocking form. The original units were possibly selected because similar but smaller units proved to be successful for breakwaters in shallower water with less wave action. However, the extrapolation to deepwater breakwaters often yields unsatisfactory results because the larger units have insufficient strength.

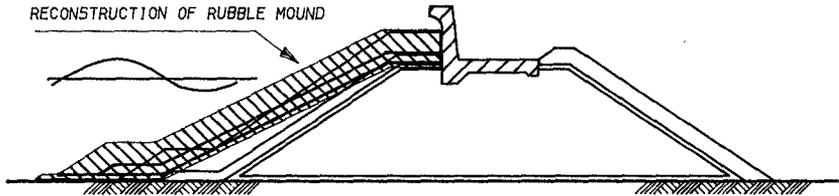
FIGURE 5

This method involves removal of the original armour and underlayers and placement of new layers after preparation of well-compacted core material and the placement of a suitable filter between core and armour material. (Ref. Figure 5)

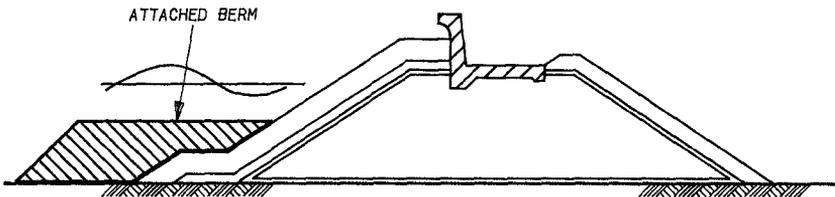
FIGURE 6

- a) Provision of an Underwater Berm attached to the Breakwater:

This underwater berm should be designed to reduce the energy of the waves, which may be critical to the stability of the slope. (Ref. Figure 6)
