CHAPTER ONE HUNDRED SEVENTY SEVEN

Surveys of Coastal Structures Using Geophysical Techniques

John R. Dingler and Roberto J. Anima*

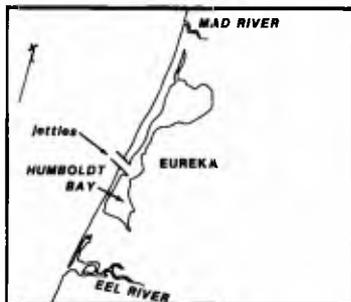
Because of strong storm waves in the area, both jetties have experienced repeated damage and repair. Because traditional designs were unable to protect the jetty heads, in 1971 both were widened and

armored with 38- and 39-t (42- and 43-ton) dolosse. This was the first use of these units in the United States (Hagwood, 1981, p. 348). At present, the heads of both jetties have settled, and in one place the inside flank of the south jetty has separated from the cap.

Figure 2: Entrance to Humboldt Bay at Eureka, California.
