REEF RUNWAY WAVE PROTECTIVE STRUCTURE, HONOLULU INTERNATIONAL AIRPORT, OAHU, HAWAII, STABILITY PERFORMANCE EVALUATION

Robert S. Chun*, Edward K. Noda**, Elaine E. Tamaye***

Abstract

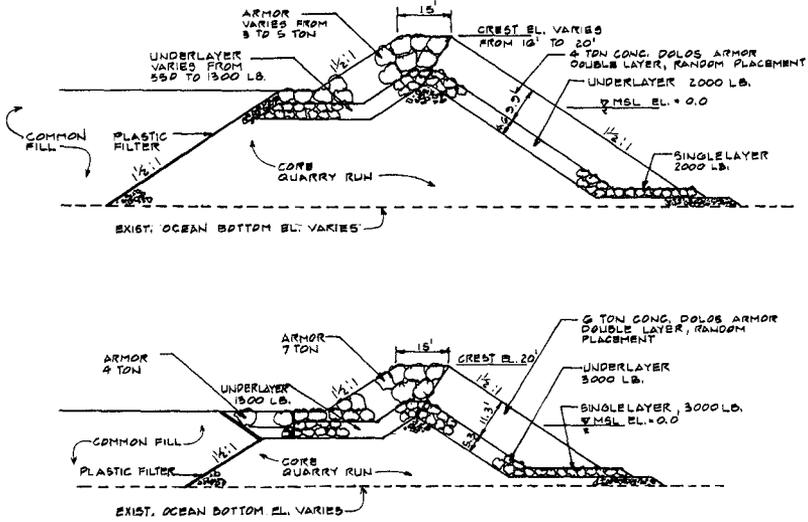
FIG.2 TYPICAL DOLOS ARMOR PROTECTIVE STRUCTURE SECTIONS
(Not To Scale)

Station 116+00. Figure 2 depicts typical cross sections for the protective structure. Figure 3 depicts the relative dolos dimensions and Table 2 lists the design dimensions for the 4 and 6 ton units, based on a unit weight of 147 lb/ft³ for concrete.

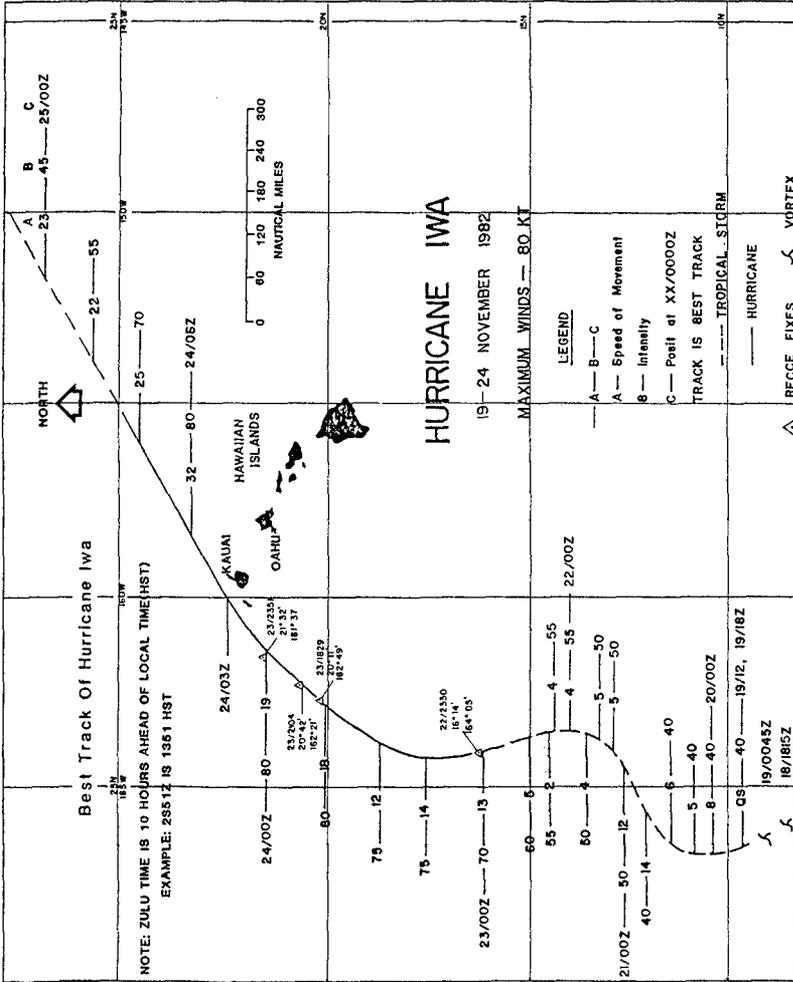
FIG. 8 TRACK OF HURRICANE IWA, NOVEMBER 1982

Figure 8 shows the track of Hurricane Iwa, where the storm center passed within 110 to 120 nautical miles of the Reef Runway at its closest point of approach. The hindcast indicated maximum significant wave heights of 39.8 feet with wave period of 13.3 seconds, and expected significant wave heights offshore the Reef Runway of about 31 feet associated with sustained winds of 35 knots. Bretschneider (1984) suggests that the radius of maximum wind was probably as large as 50 nautical miles, with hindcast maximum significant wave heights of 41 to 43 feet and periods of 14.2 to 14.7 seconds. Based on his hindcast analysis, expected significant wave heights offshore the site were on the order of 35 feet.
