FIELD INVESTIGATIONS ON WAVE-DISSIPATING CONCRETE BLOCKS COVERING VERTICAL WALL BREAKWATER

Michio Gomyoh¹, Kazuhiko Sakai², Tomotuka Takayama³,
Kojiro Suzuki⁴, Shigeo Takahashi⁵

The failures experienced in Japan by wave-dissipating concrete blocks (WDCB) covering vertical wall breakwaters are investigated, and the deformation characteristics such as failure features and factors are examined.

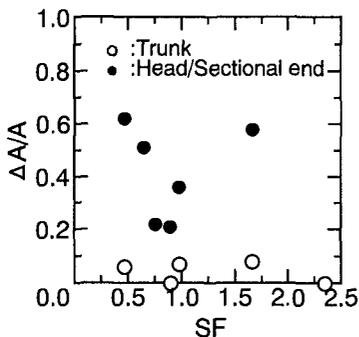
Figure 4. Relationship between degree of scattering and safety factor

Judging from the above, the degree of scattering of WDCB seems to depend on its location and cross-sectional shape. Figure 4 shows the relationship between the degree of scattering of WDCB and the safety factor, where $\Delta A/A$ is the ratio of the cross-sectional damaged area to design area, and SF shows the ratio of the actual weight to the calculated weight when failure occurred. It is clear that WDCB at the trunk section remains stable at a safety factor as low as 0.5, and in contrast, the scattering of WDCB at the breakwater head/sectional end occurs severely even though the safety factor is as high as 1.7. Consequently, it is indicated that the applicability of the Hudson formula is adequate at the breakwater trunk section and marginal at the head/sectional end.

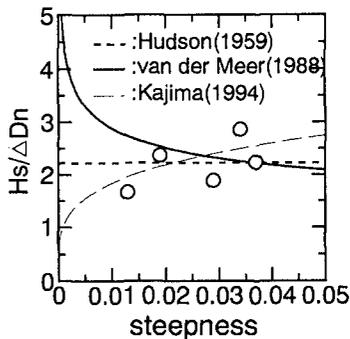
Figure 5. Effect of steepness on stability number as determined by three formulas and observed failure cases

Corresponding analyses are also performed using the design formulas by van der Meer(1988) and Kajima(1994) as well as the Hudson formula. Figure 5 shows the effect of steepness on the stability number by comparing the no

damaged cases at trunk section to the results calculated by three formulas in such conditions that relative damage level in van der Meer(1988), $N_o=0.2$; deformation level in Kajima(1994); $S=1.2$, and wave number; $N=1000$. It is found that they show similar applicability when considering limited amount of field data though the effects of steepness varies among them. In other words, there is almost no difference among them in a practical wave steepness ranging from 0.01 to 0.05.

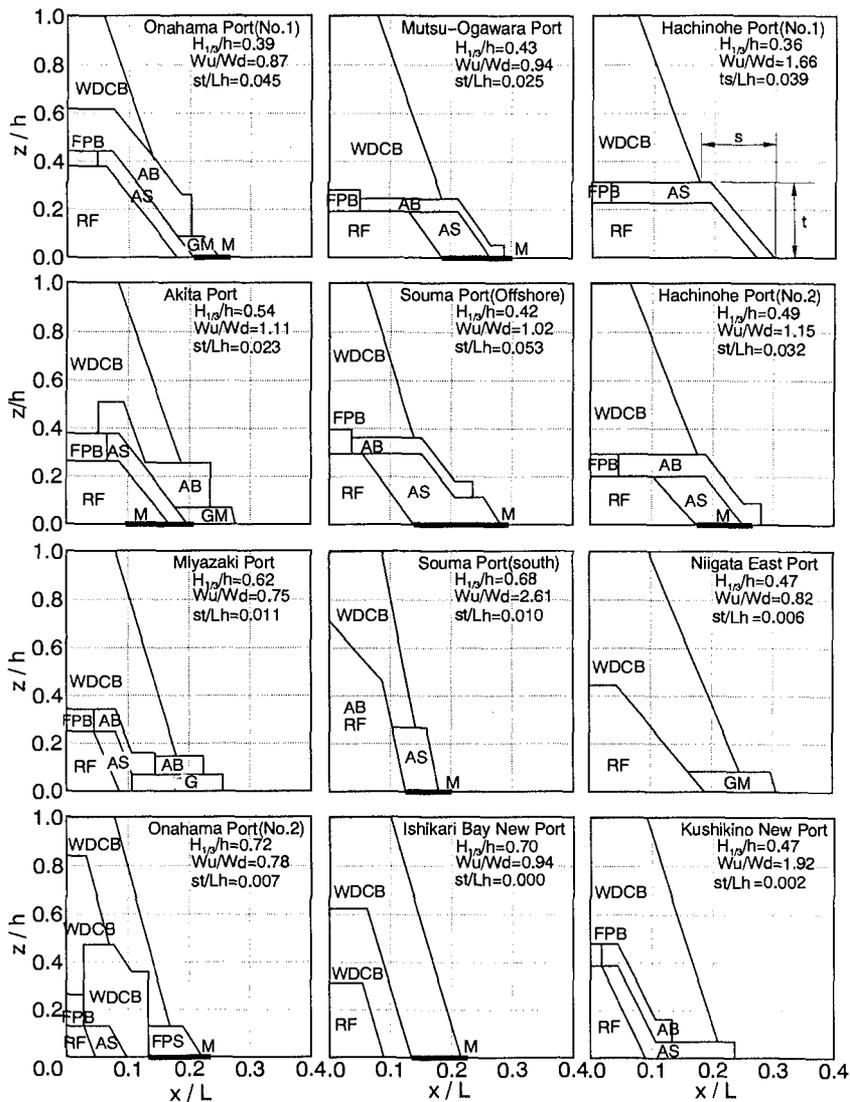
Figure 9. Structure parameterization

Considering the settlement feature and its process, it seems reasonable to suppose that both material and dimension of the toe area are important factors to prevent settlement deformation of blocks. Therefore, the structures including WDCB in front of a vertical wall are represented with dimensionless parameters as shown in Figure 9. In this figure, x and z indicate the distance measured from the vertical wall and sea bottom, and h and L show the water depth and wave length in design, respectively. Furthermore, the following abbreviations are used: AB (armor block), AS (armor stone), FPB (foot protection block), FPS (foot protection stone), G (gabion), GM (gravel mat), M

As illustrated in this figure, the structures for toe area have a certain range from the thick and wide to the thin and narrow. Consequently, we parameterized the structure for toe area by its thickness; t and width; s as shown in the top right, where st shows an index of cross-sectional area of toe structure.

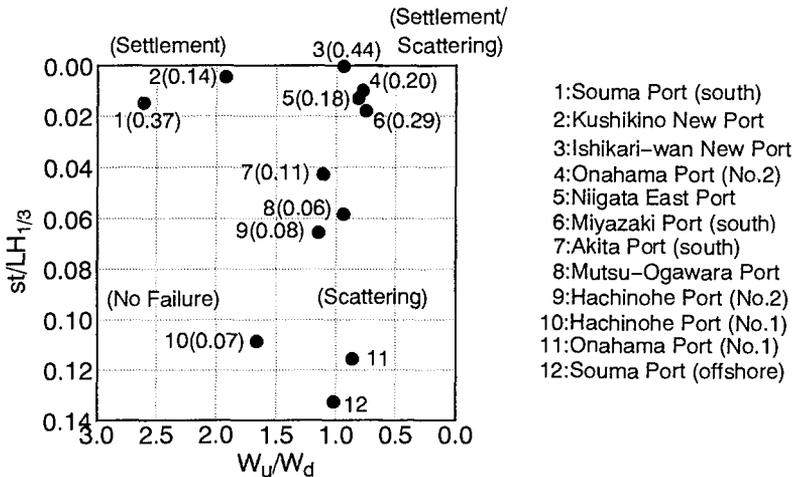
Figure 10. Influence of stability of toe area and WDCB on scattering and settlement behavior (values in parentheses indicate $\Delta A/A$)

To discuss both effect of stability of WDCB and toe area on scattering and settlement behavior, two parameters are suggested: $st/LH_{1/3}$ which indicates the stability of toe area being non-dimensional parameter with st , design significant wave height; $H_{1/3}$ and wave length; L , and W_u/W_d which indicates the stability of WDCB by using actual weight; W_u and design weight; W_d . Figure 10 shows the relationship between two parameters and the degree of deformation at trunk section. As shown in this figure, deformation becomes larger when $st/LH_{1/3}$ is smaller than 0.04 and the failures can be divided into four regions in this figure: no failure, settlement, settlement and scattering, and scattering.

2) The failure case observed at Souma Port (south) shows the severe deformation against the wave attack slightly exceeding the design wave condition although the weight of WDCB is enough to keep itself stable under such a wave condition. This case can be explained as typical one caused by settlement deformation.

3) The case at Onahama Port (No.2), where the blocks less than design weight were used, the value of $st/LH_{1/3}$ is 0.01, and the exceedance of wave design condition was experienced, seems to indicate a complex failure feature which both settlement and scattering occurred at the same time.

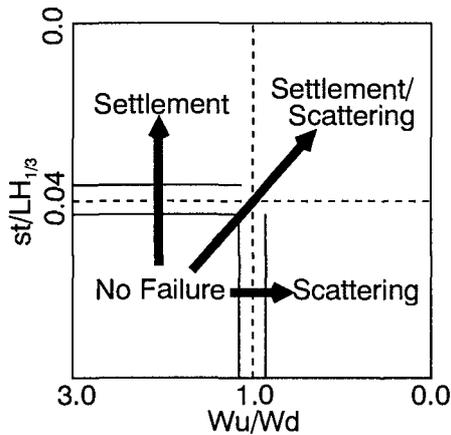
Figure 11. A diagrammatic representation of Figure 10

Based on the above discussion and Figure 10, the failure behavior can be conceptualized as shown in Figure 11. This diagram shows a summary representation of the effects of stability of toe area and WDCB on failure behavior of WDCB.
