BREAKWATER REPAIR: MONITORING, MODELLING, AND CONSTRUCTION

Abstract

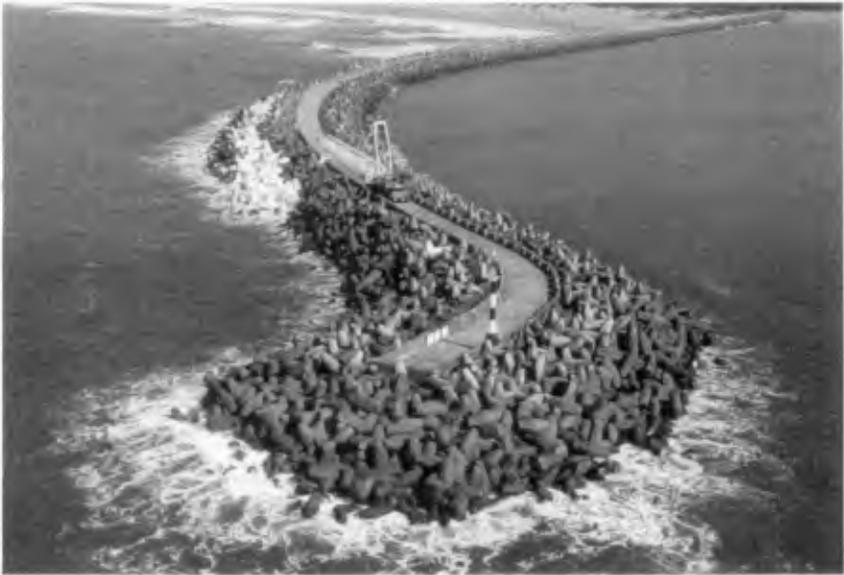
Figure 1: Aerial View of South Breakwater

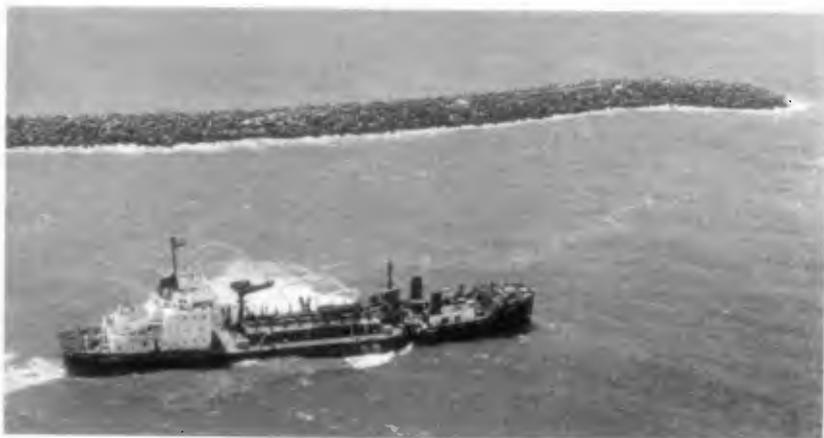
much closer to the breakwater than originally anticipated (up to 60m closer). The depth of the sand-trap has reached -24m and the side slope as steep as 1:4,7. Figure 4 shows the dredger and Figure 5 the average position and sections through the sand-trap.

Figure 4 : Portnet Dredger Trail Dredging in the Sand-trap

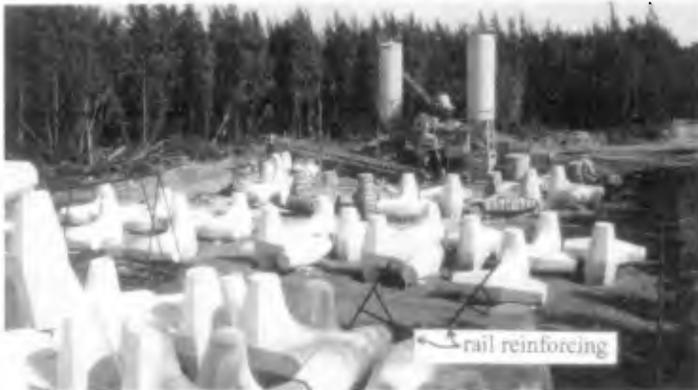
Figure 7: Casting Yard for New Dolosse

After acceptance of the above repair design, a total of 1000 new 30t dolosse were cast near the root of the south breakwater (Figure 7). The start of construction of the repairs was however delayed for more than a year because the Portnet crane that was to be used for the repair at Richards Bay was unavailable. In this time there was substantial accretion, (of up to 3m) especially along the trunk of the breakwater (Figure 8). The breakwater repair section was again tested in the 2 D flume with the reduced depth. The depth at the toe at some sections was as shallow as -5m CD. During the re-testing of the

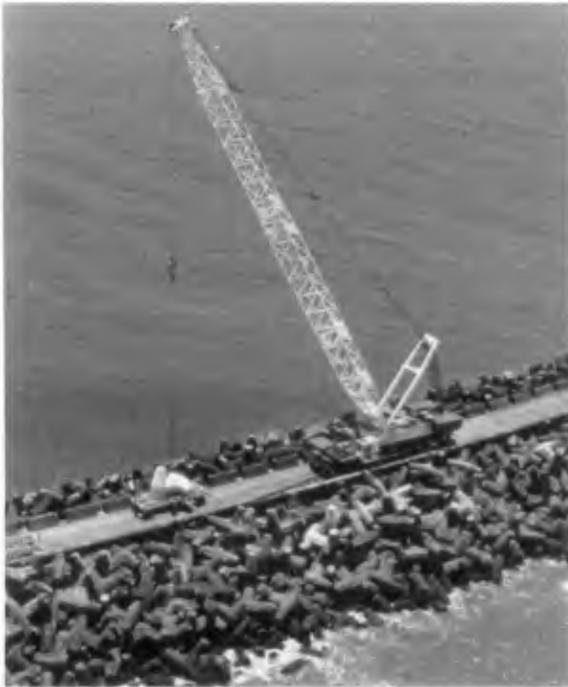
Figure 11: Portnet Crane Offloading Dolosse from Trailor

Based on the results of the model tests, only 30t dolosse were to be used for the repair. These dolosse were brought from the casting yard (1001 new 30t units) and old stockpile (37 old 20t and 88 old 30t units left over from the original breakwater construction) on the south side of the entrance channel directly onto the breakwater. Three double direction trailers were then used to transport the dolosse, but as these trailers could only pass when unloaded, it meant that only one 30t dolos could be brought onto the breakwater at any one time (Figure 11). A portal crane was used to handle the dolosse from the casting yard onto the stockpile and from there onto the trailers.
