BREACHING AND TSUNAMI WATER DRAINAGE AT OLD RIVER MOUTH LOCATIONS DURING THE 2011 TSUNAMI

Hitoshi Tanaka¹, Mohammad Bagus Adityawan¹, Keiko Udo² and Akira Mano²

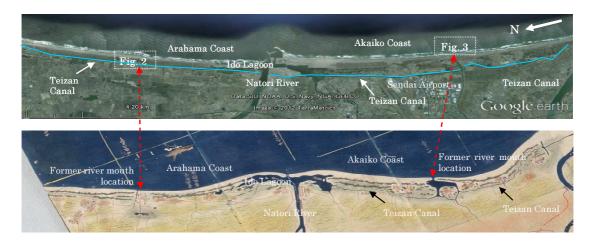
Figure 5. Map comparison (Top: in 2012, Bottom: in 1853)

Figure 5 shows the comparison of the study area based on Google Earth image (2012) to the historical map (1853). It is noted that the old map was slightly less accurate. The Natori River Mouth in the old map was located further on the seaside. Nevertheless, the existence of the Teizan Canal on the right side of the Natori River was also confirmed in both maps. The location of the Ido Lagoon at the left side of the river mouth was also confirmed in both maps. However, the Teizan Canal on the left side of the Natori River was not yet constructed in 1853. Hence, it was not drawn in the old map. The river mouth at the Arahama Coast was also confirmed from an older map, drawn in 1701 (Fig. 6). Both river mouths were closed around the Meiji Era until present, as shown in Fig. 7 and Fig. 8.

Based on the comparison, the sandy coast breaching in both locations (Fig. 2 and Fig. 3) occurred at the former location of river mouths (Fig. 5). These river mouths were part of the old drainage system, which have been closed for many years. Back then, the water from the Sendai Plain flowed to the sea from these river mouths. After the closure, the Teizan Canal serves to collect and to flow the water from the plain to the sea through the Natori River. However, in the tsunami of 2011, it was suggested that the return flow was very strong and caused the sandy coast breaching at these locations, e.g., as captured and shown in Fig. 4.
