CHAPTER 92

CHANGES OF SEA BED DUE TO DETACHED BREAKWATERS

Osamu Toyoshima

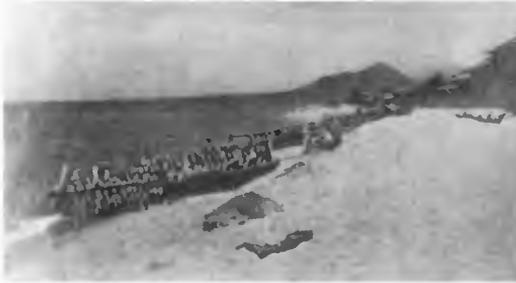
Fig.3 In 1942, people in the seabord tried to weaken the longshore current by means of primitive crib works using pine logs, but these works were destroyed soon.

In the face of acute construction material shortage during the World War II, an attempt was made to weaken the rate of beach recession by means of primitive crib works using pine logs which had commonly

Unfortunately almost of the works were destroyed soon after their completion by very strong actions of stormy waves.

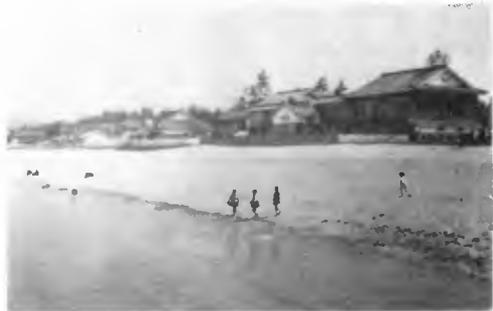
Fig.9 In December 1960, most of the sandy beach were vanished. The arrow mark on the center of the picture shows the fountainhead No.3 shown in Figure 4.

Even when the Kaike coast was seemed to be stable, a large amount of beach sediment carried offshoreward with every attack of severe wind waves in winter. As the result of wave attacks groins and seawalls on the Kaike coast were damaged locally in January 1961.

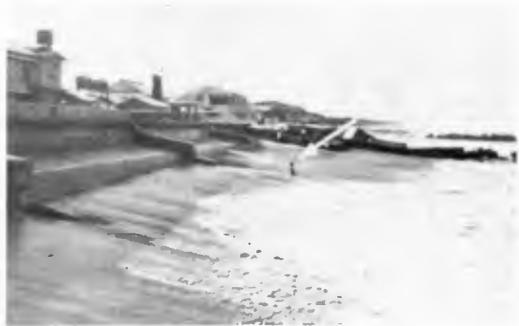
Fig.10 In January 1961, the stepped face seawall had been partly destroyed by the winter strong wave force. Waves had scoured beach at the foot of the seawall, and the body of the seawall had been scattered. The seawall had been reconstructed at once.

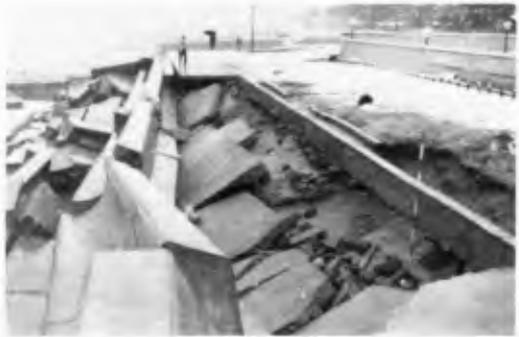
Fig.11 Reinforced inclined-face type seawall was adopted as the restored seawall.

The profile of seawall restored by the local government was an inclined-face type seawall with sandtight cutoff wall by steel sheet pile as shown in Figure 11.

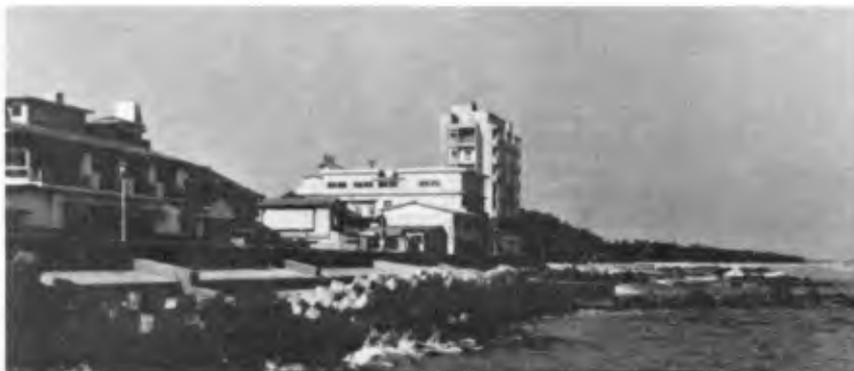
Fig.12 As the wave defence works, armour concrete blocks, named Hexa-leg block, were piled up in front of the seawall. But a number of these blocks have sank under the sea bed (photo in 1970).

After a lull in beach retrogression Kaike coast begun to retreat again in the early 1960's. Incident waves directly struck seawalls and overtopped. In order to reduce wave overtopping, wave defence works composed of artificial concrete blocks were constructed in front of the seawalls.

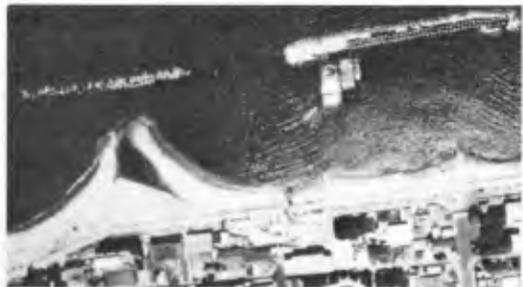
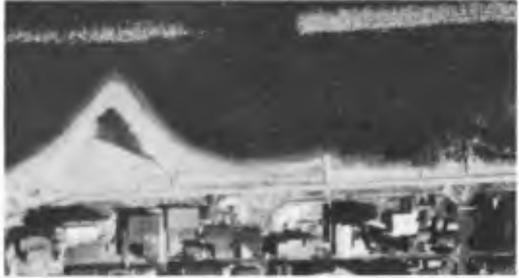
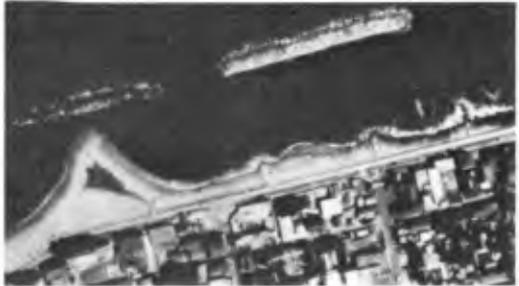
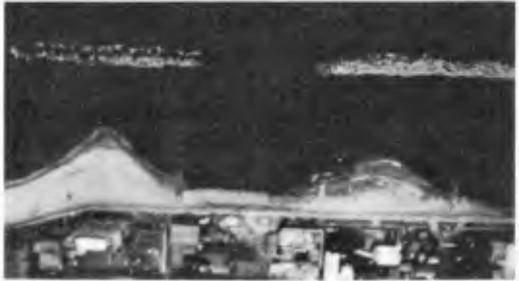
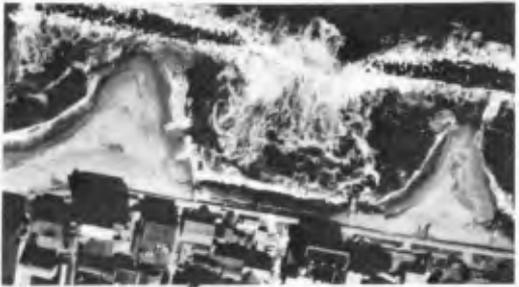
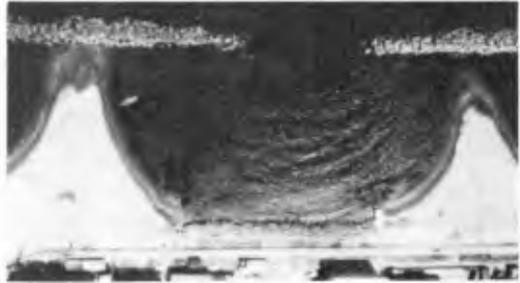
Fig.18 Aerial view of the Nos. 1 and 2 breakwater and tombolos by means of a radio controlled model plane.

1) July 27 '72
No.2 breakwater is under the construction.

- 2) Aug. 24 '72
Just after the construction.

- 3) Sept. 11 '72
Small tombolo appears.

- 4) Sept. 29 '72
The tombolo grows larger gradually.

- 5) March 9 '73
Strong waves attack the
breakwaters and tombolos.

6) April 25 '73
The tombolos are stable.

At the Kaike coast, the progress of the construction of the breakwaters and changes in shoreline features have frequently been recorded by means of the radio controlled model plane. From the sequential aerial photographs, we can see the development of the tombolos and the refracting wave patterns due to the breakwaters.

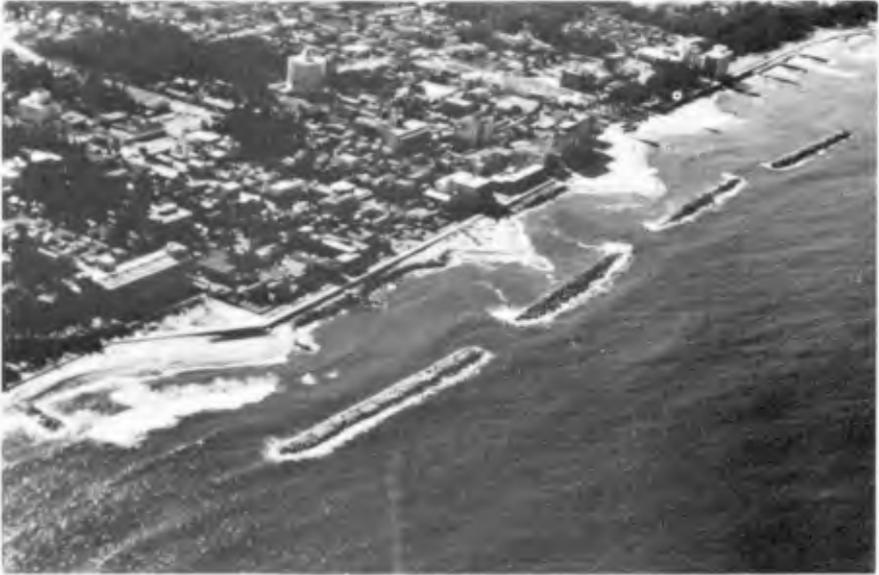
Fig.22 The latest aerial view of the Kaike coast (in 1975).
