# VARIATION OF FORESHORE DUE TO DETACHED BREAKWATERS

Osamu TOYOSHIMA

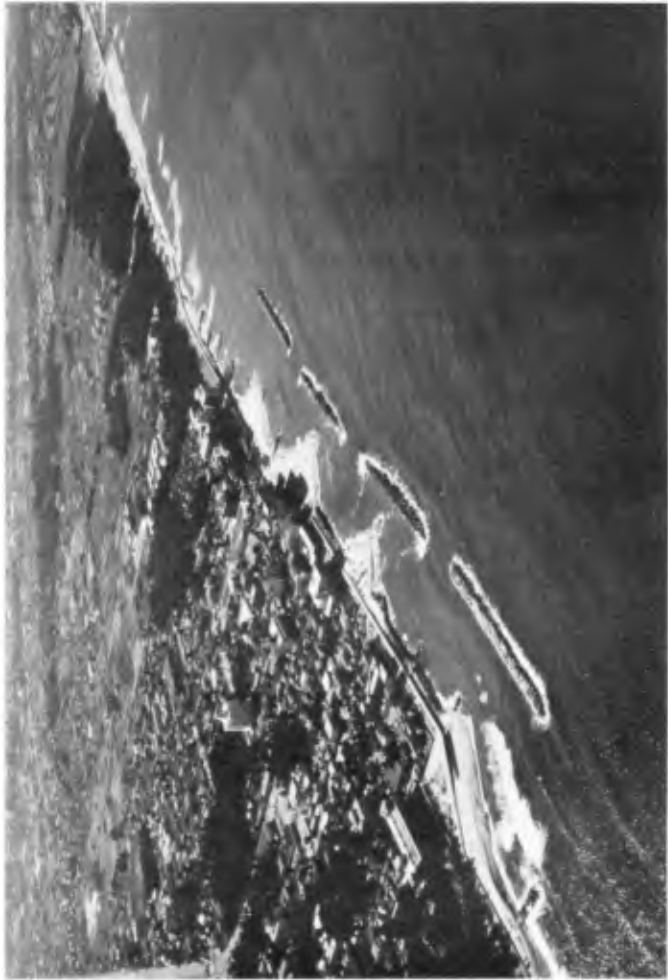
Photo 1 The aerial view of the Kaikō coast and four detached breakwaters on October 1974.
