CHAPTER 23
LITTORAL DRIFT PROBLEMS IN PORTUGAL WITH SPECIAL
REFERENCE TO THE BEHAVIOR OF INLETS
ON SANDY BEACHES

Carlos Krus Abecasis
Director Engineer, Maritime Services
Department of Hydraulics, Ministry of Public Works
Lisbon, Portugal

After a brief description of the littoral drift regimen in the west and south coasts of Portugal, review is made of the behavior of the works performed in three lagoon inlets located on these coasts and some general principles are inferred which are felt to be valid in the treatment of any similar problems.

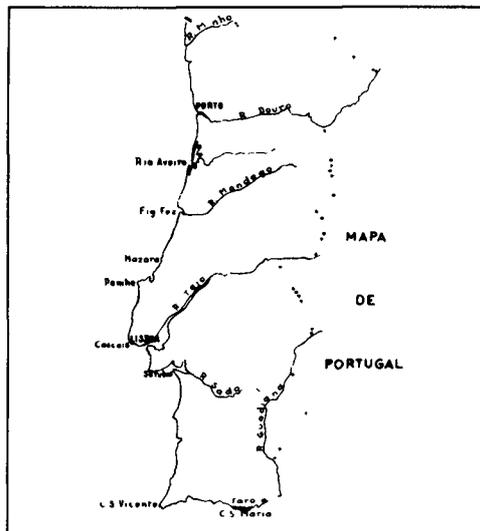
Fig. 1. The coastline of Portugal.

The coast line of continental Portugal has a total length of about 480 miles, of which 380 miles form the west coast, from the mouth of River Minho to the Cape of St. Vincent, and the remaining belong to the south coast, from this Cape to the mouth of River Guadiana (see Fig. 1).

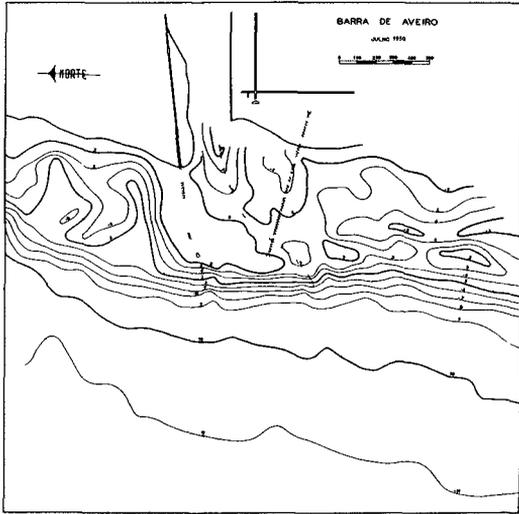
Fig. 2. July - August 1950

Hydrographic Surveys of the Inlet of Lagoon of Aveiro

In the previous paper (C. Abecasis, 1954) we gave a description of the very interesting case of the Aveiro lagoon, as known from the Xth century up to the results of the improvement scheme being carried on by the middle of 1954. We shall not repeat the description, but we re-insert, for the sake of confront, the hydrographic survey of the inlet in August 1950, when the scheme was started (see Fig. 2).

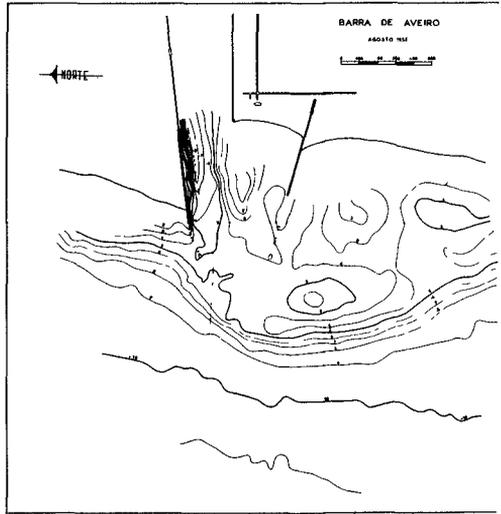
Fig. 3. August 1955

It is now convenient to bring up to date the analysis of the behavior of the inlet channel in its reaction to the works undertaken. For the purpose, we shall insert in the graphs and tables of the preceding study the data collected since their publication, retaining the same designations and the numbering of the tables. Some of the hydrographic surveys on which those data were based are also included (see Figs. 3 to 5).

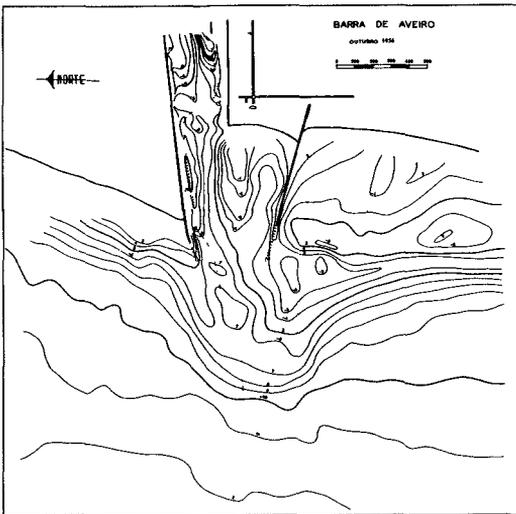
Fig. 4. April 1955

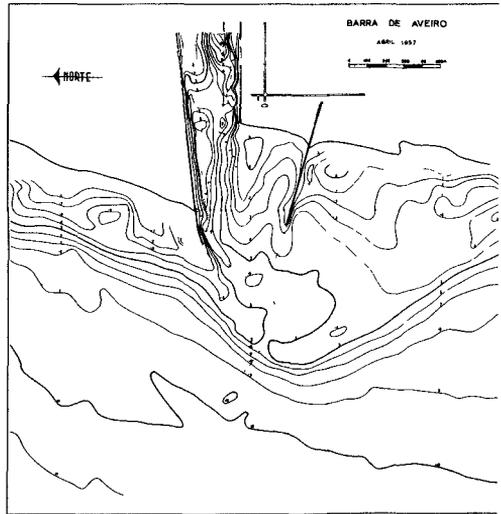
Fig. 5. April 1957

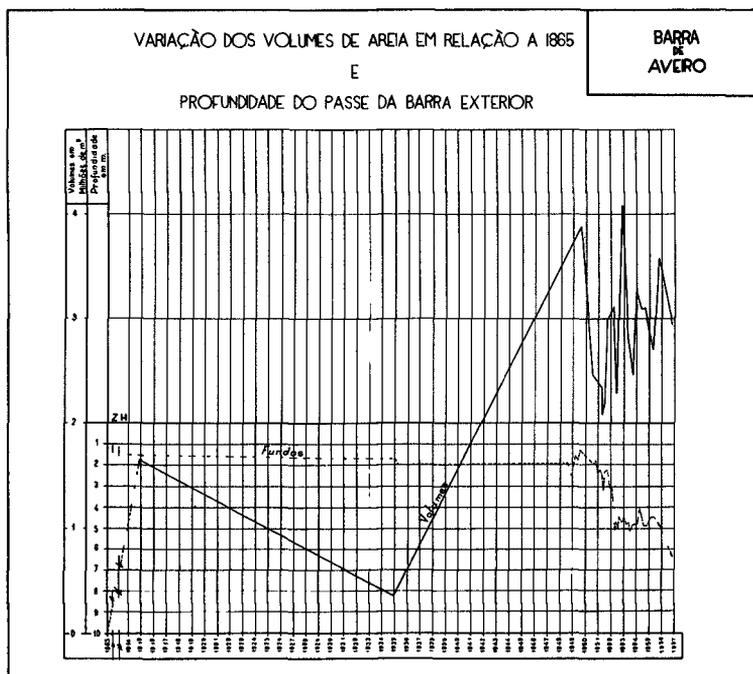
Fig. 6. Variation of the volume of sand in the outer bar of Aveiro

Table 1 and Fig. 6 show that the volume of sand in the outer bar platform remains stable, with the seasonal variations assigned before. As meteorologically anomalous years did not occur, no systematic alteration can be traced.

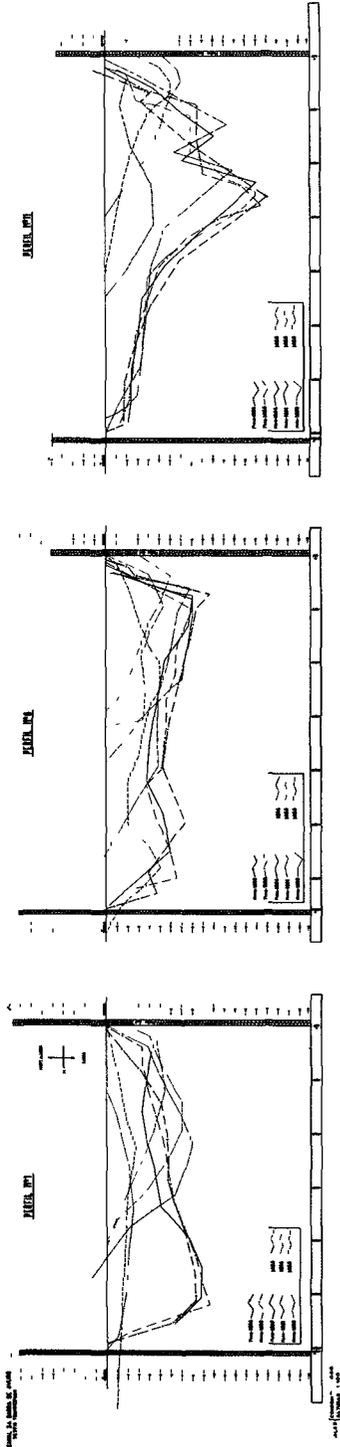
Fig. 9 - Evolution of the inlet channel's cross sections due to the works (range no.1)

Fig.10 - Evolution of the inlet channel's cross sections due to the works (range no.6)

Fig.11 - Evolution of the inlet channel's cross sections due to the works (range no.11)

Tables 3 and 4* and Figs. 9 to 12 demonstrate that the inlet channel's hydraulic characteristics favorable reaction to the works is consolidated, if not slightly improved, which, as previously stated, is of vital importance to the maintenance of depths in the whole access to the port.

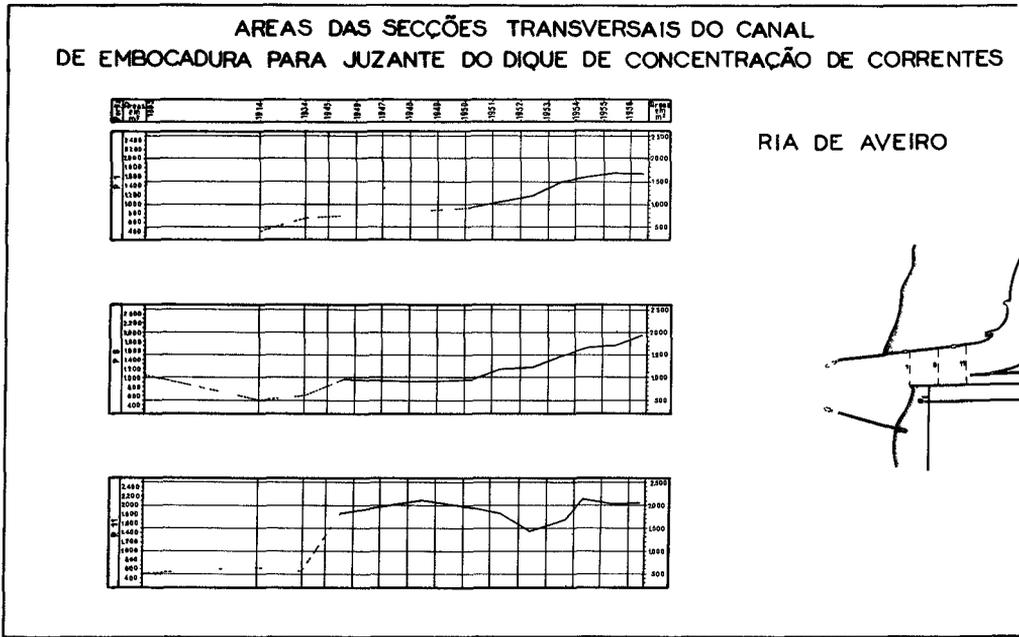
Fig. 12. Variation in the areas of cross sections at the same ranges

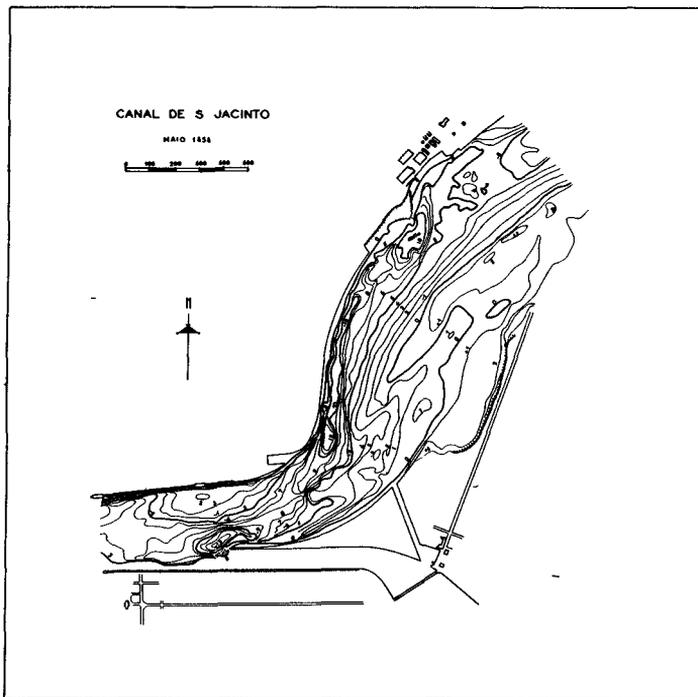
Fig. 13. Hydrographic survey of the inner channel in May 1956

In the preceding paper we pointed out the great significance of the behavior of the inner bar as an index of the soundness of the inlet's improvement scheme being executed. Fig. 13 to 16 and Table 5 show that the favorable results obtained can now be considered definitively acquired.

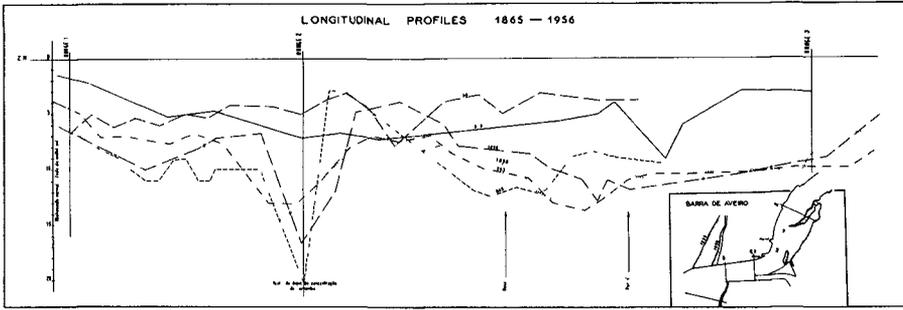
Fig. 14. Longitudinal profiles along the talweg between the inlet's mouth and S. Jacinto, from 1865 to 1956

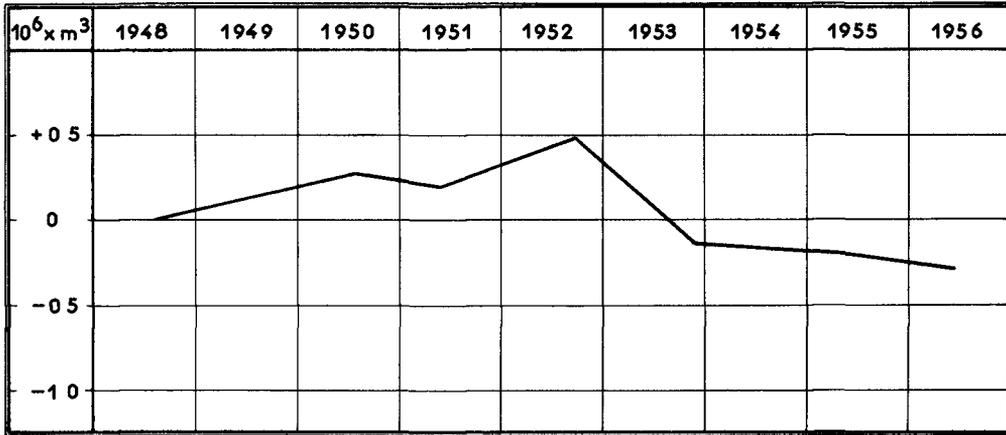
Volume P 16 → P 29

Fig. 15. Variation in the volume of sand on the inner bar from 1948 to 1956

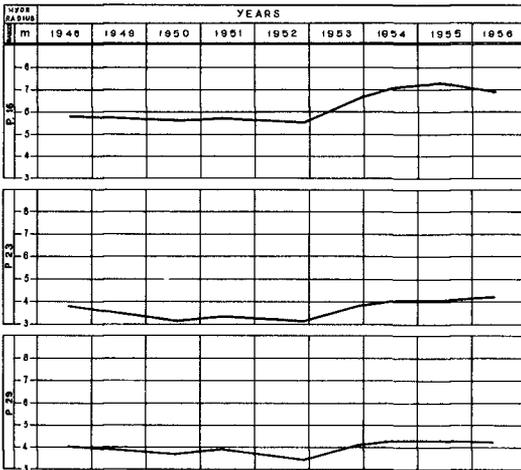
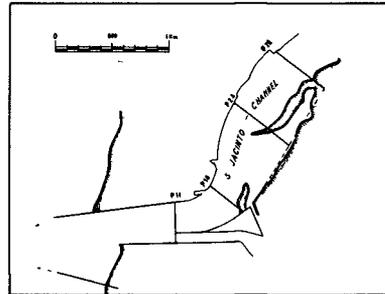
Lagoon of Aveiro
 Evolution of the inner bar's channel - Cross sections' hydraulic radius

Location of ranges

Fig. 16. Variation in the hydraulic radius of the inner channel's cross sections from 1948 to 1956

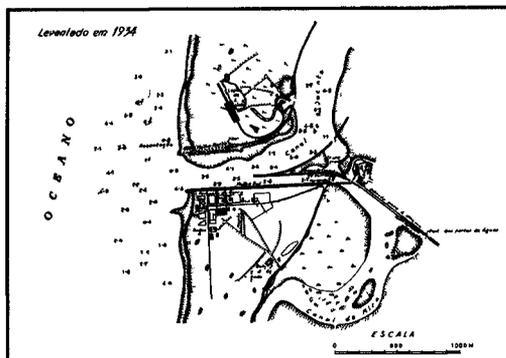
Fig. 17. The Mira inner channel lay-out

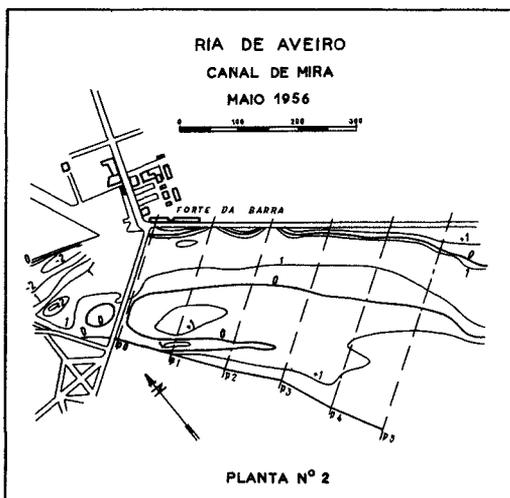
Fig. 18. The Mira channel of the Lagoon: hydrographic survey of the downstream section in 1956

Moreover, additional data show that these beneficial results are not restricted to the area of the inner bar on the main lagoon channel. Thus, the access channel to the southern lagoon branch of Mira, which for many years had been starving and slowly shoaling, spontaneously deepened, specially since 1953 (see Figs. 18 and 19).

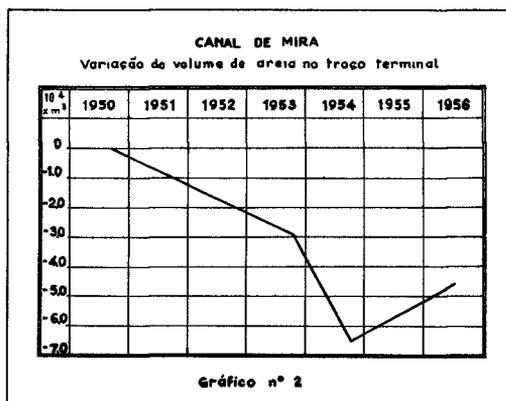
Fig. 19. Variation in the volume of sand on the same section of the Mira channel from 1950 to 1956

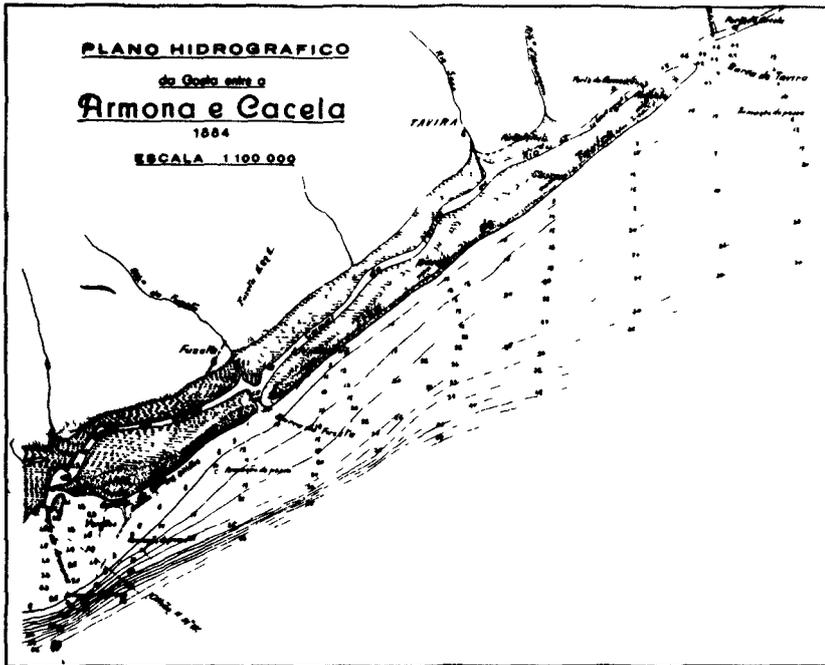
Fig. 21. The eastern part of the south coast Lagoon

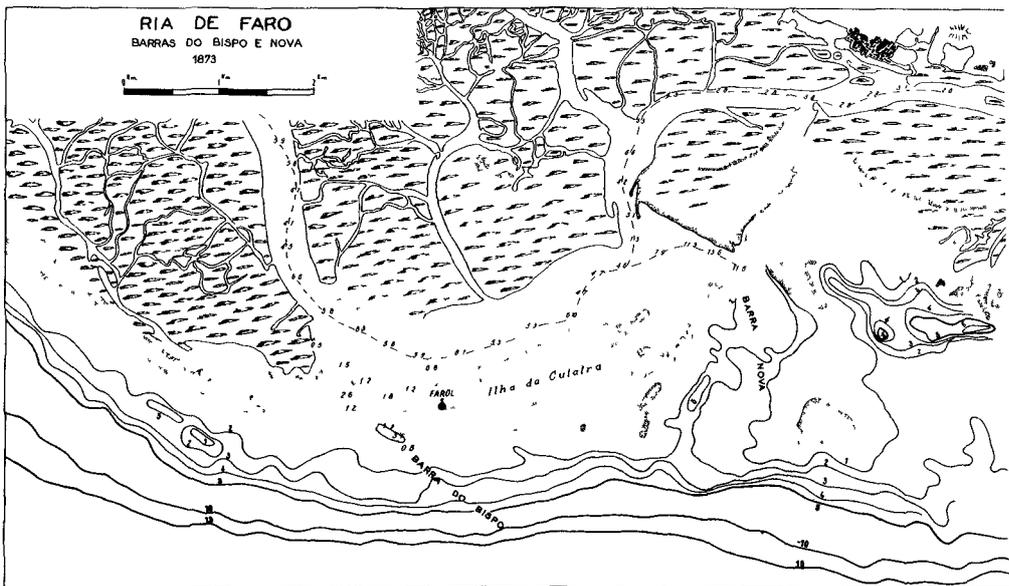
Fig. 22. The inlets of Faro - Olhao in 1873

This lagoon section is connected with the adjoining ones by narrow and shallow channels and with the sea by two inlets: one which was artificially opened and canalized near the Cape in 1928, and another one, about three miles eastward, which is called "Barra Nova", i.e. "New Inlet", a natural one (for approximate locations see Fig. 22).

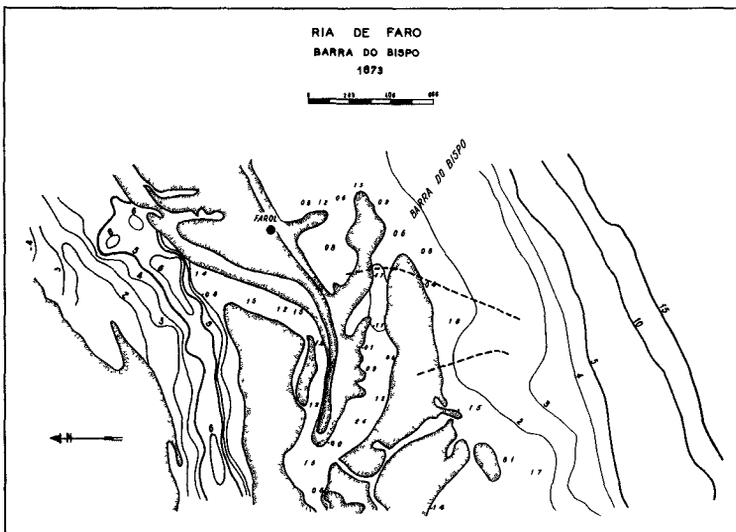
Fig. 23. The inlet of Cape Santa Maria by 1873

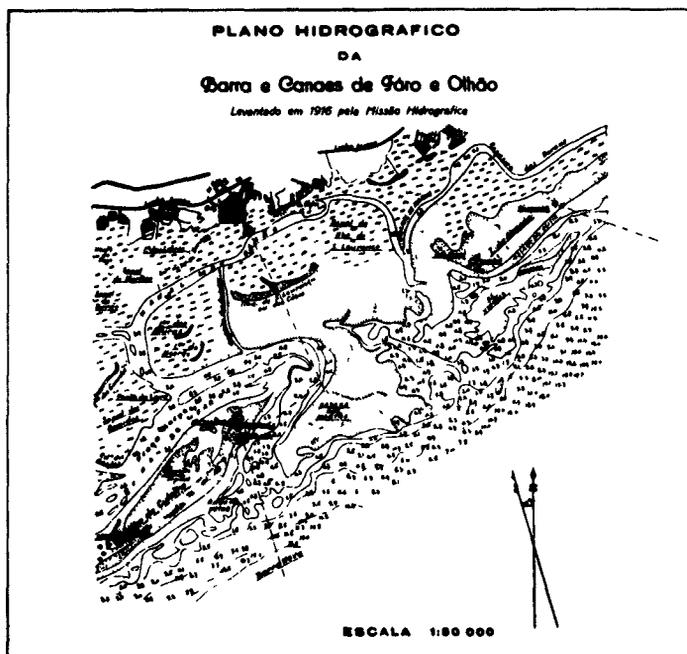
Fig. 24. The "Barra Nova" inlet in 1916

The subsequent free evolution of this natural inlet which for about thirty years was practically the only one connecting the main lagoon body to the ocean, as shown in Figs. 24 and 25, deserves a careful and detailed analysis by any one who may be interested in this kind of problem. For the moment, we simply want to point out that in spite of its size, of the big tidal flow circulating through and of the massive barrier of sandy islands and shoals lying down-drift, this inlet badly deteriorated and migrated eastward in the course of the years.

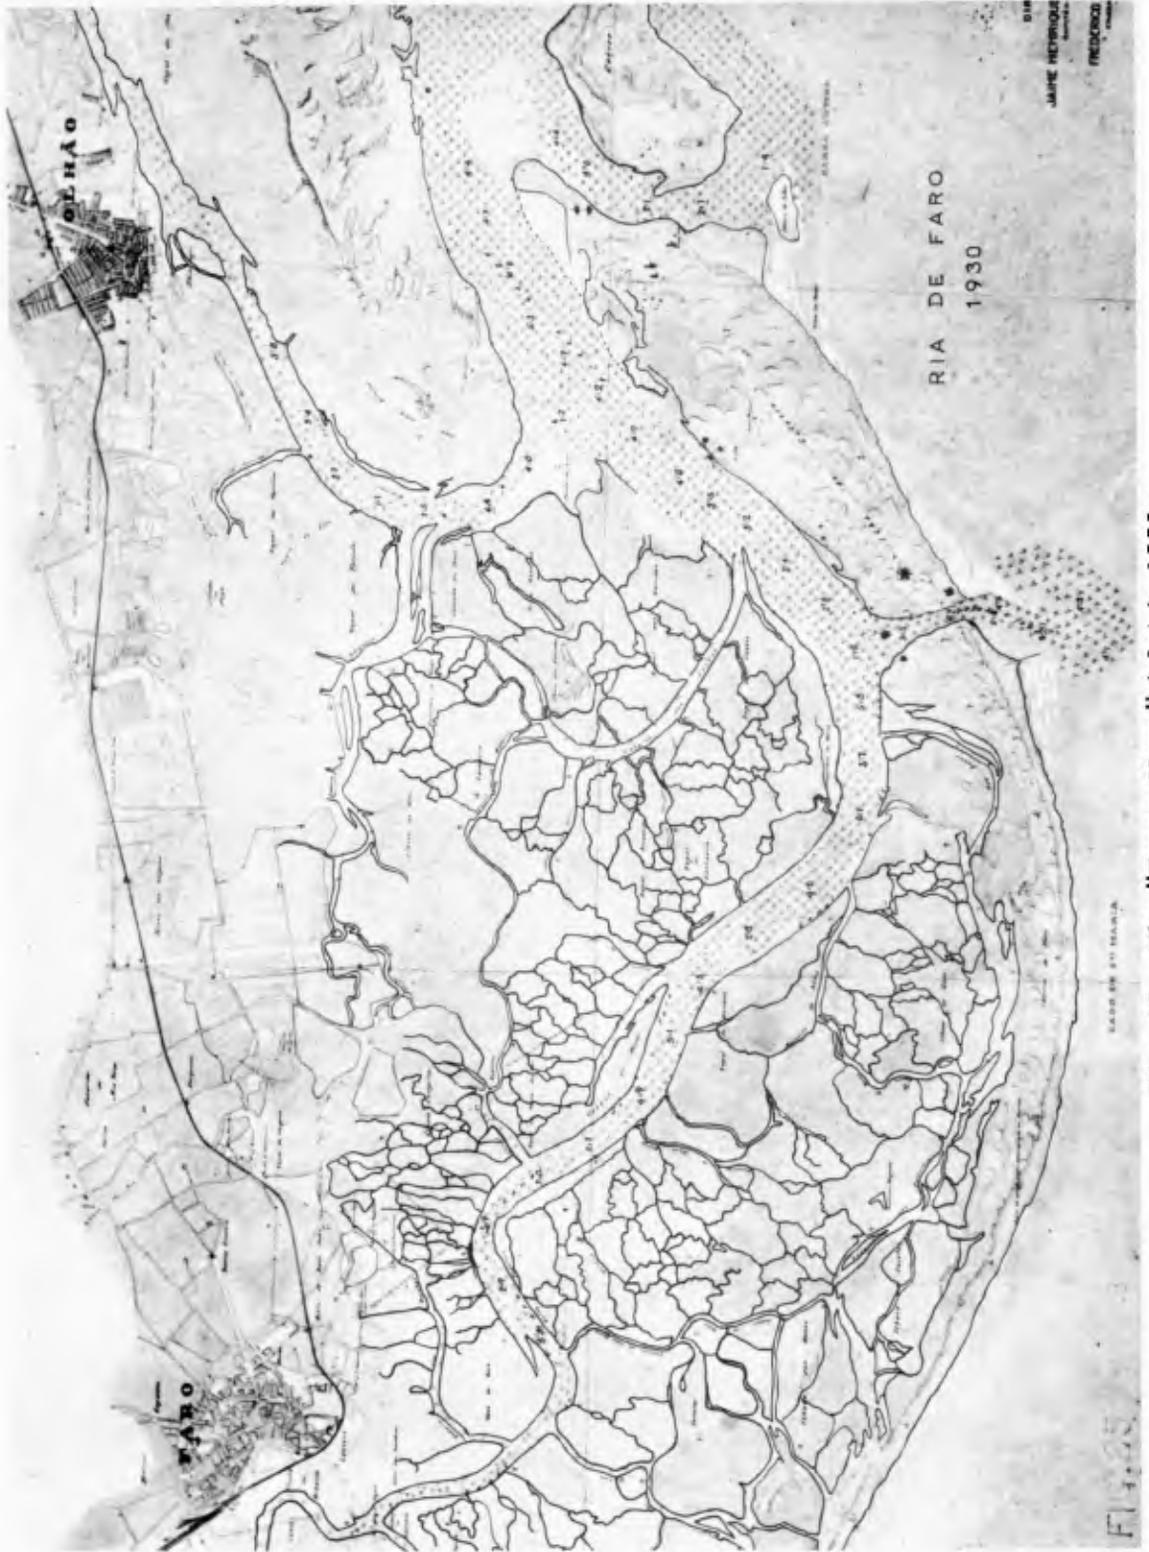
Fig. 25. The "Barra Nova" inlet in 1930

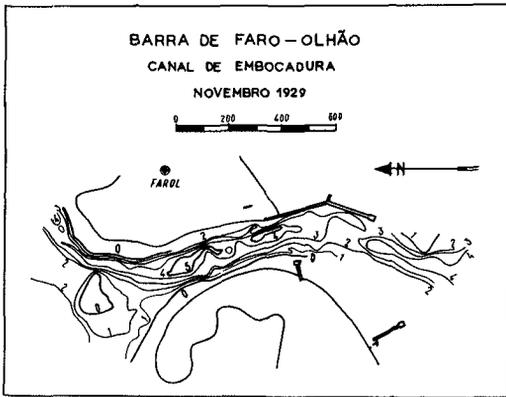
Fig. 26. November 1929

Hydrographic Survey of the Artificial Inlet near Cape South Maria

Results obtained can be seen in the hydrographic surveys (Figs. 26 to 31) and in the graphs and tables which are included and are similar to those concerning the inlet channel of Aveiro.

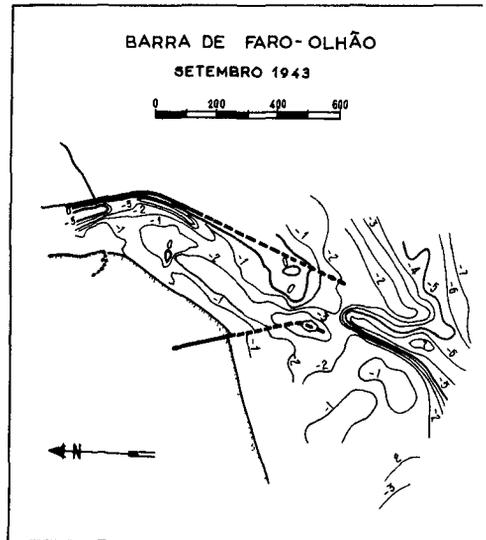
Fig. 27. Setembro 1943

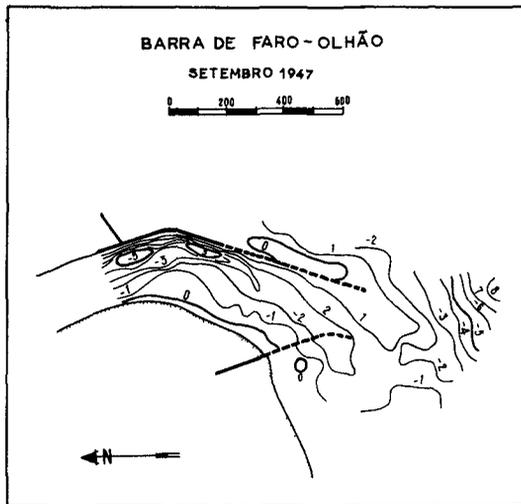
Fig. 28. Setembro 1947

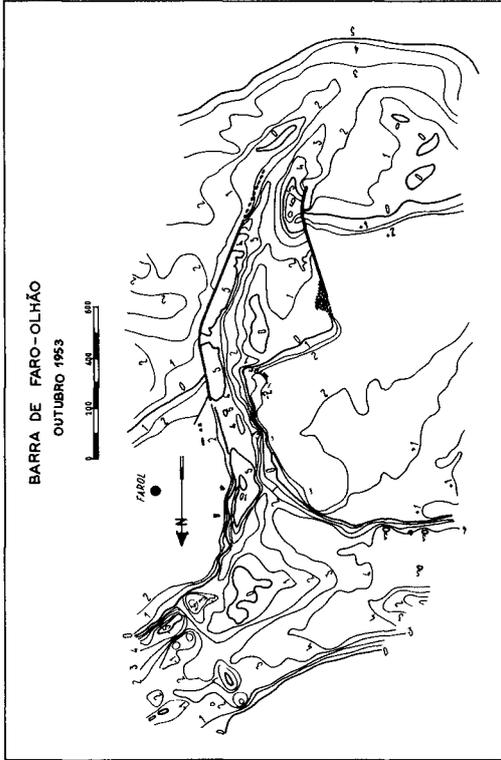
Fig. 29. October 1953

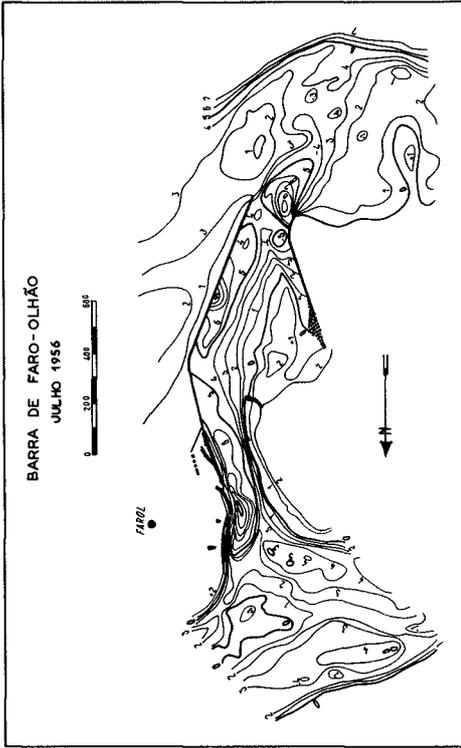
Fig. 30. August 1956

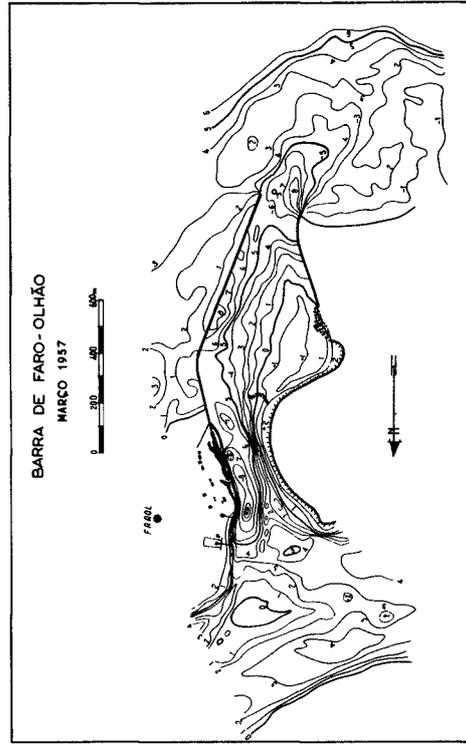
Fig. 31. March 1957

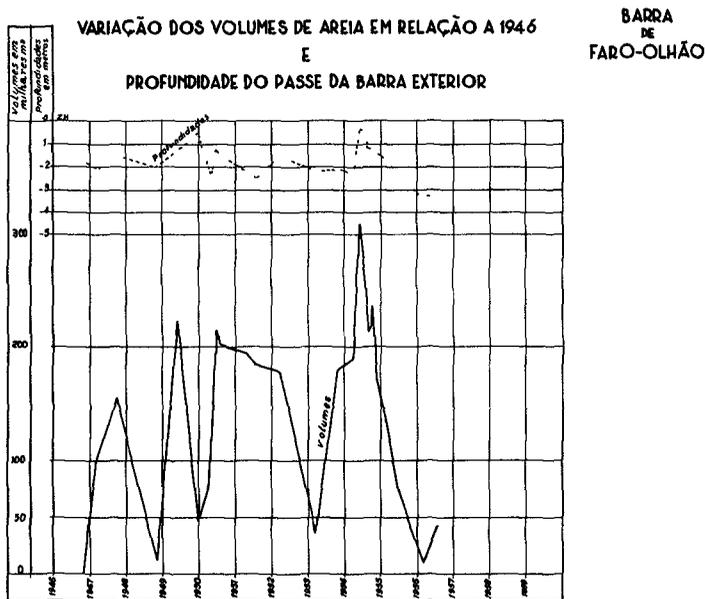
Fig. 32. Variation in the volume of sands and
 controlling depths on the outer-bar of the Faro-
 Olhao inlet

The slower reaction of the inlet to the improvement works is quite evident in the variation of the volume of sands and the controlling depths on the outer bar (see Table 6 and Fig. 32). These data also show that the meteorological influence on the volume of sands lying on the bar is of an entirely different order of magnitude than it was in the western coast's inlet. So, it is not extraordinary that the deepening of the outer bar crest was not noticed until nearing the completion of the breakwaters in 1955 (see Fig. 33). This effect was then helped by dredging in 1955-1956 some 100,000 cubic meters of sand in the outer bar and entrance channel.

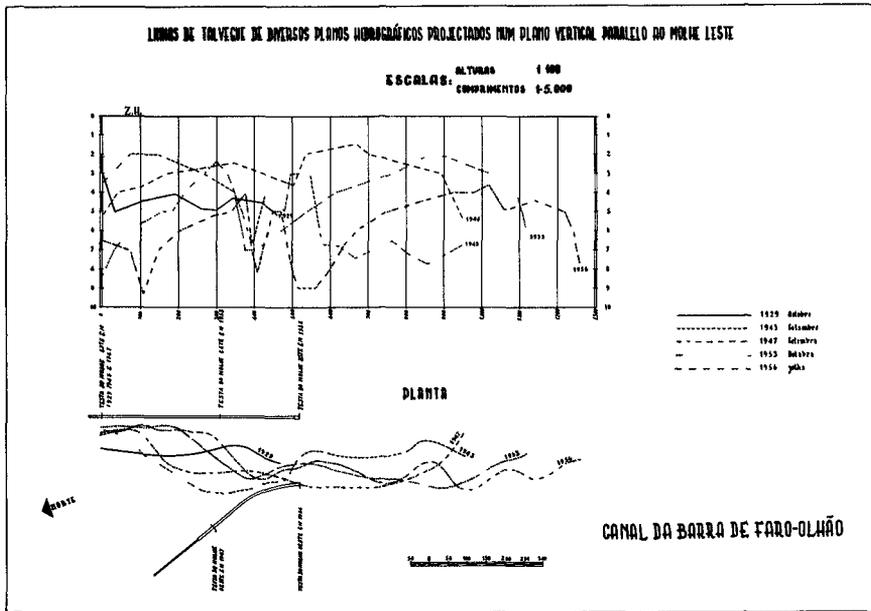
Fig. 33. Inlet of Faro-Olhão: longitudinal profiles of the entrance channel projected on a vertical plane parallel to the outer stretch of the east breakwater

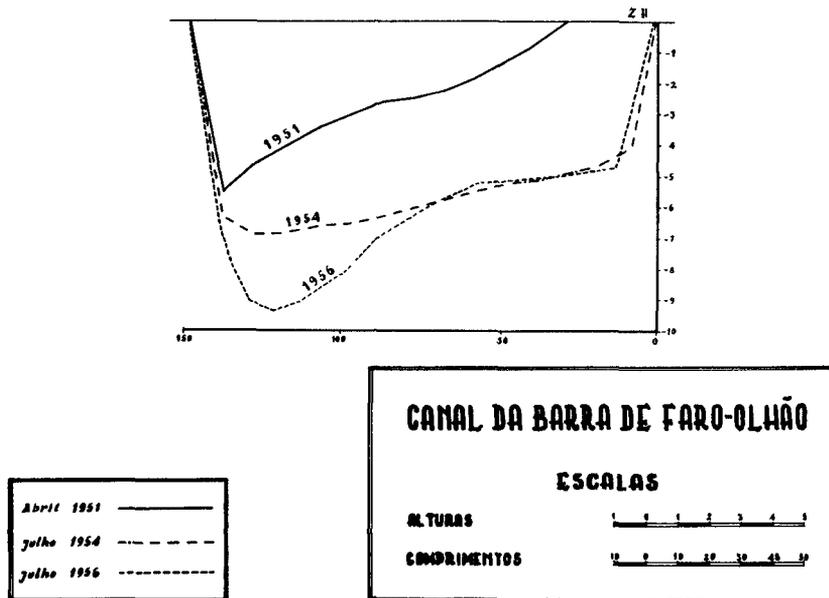
PERFIL N.º 0

Fig. 34. Evolution of the inlet channel's cross sections due to the works (range No. 0)

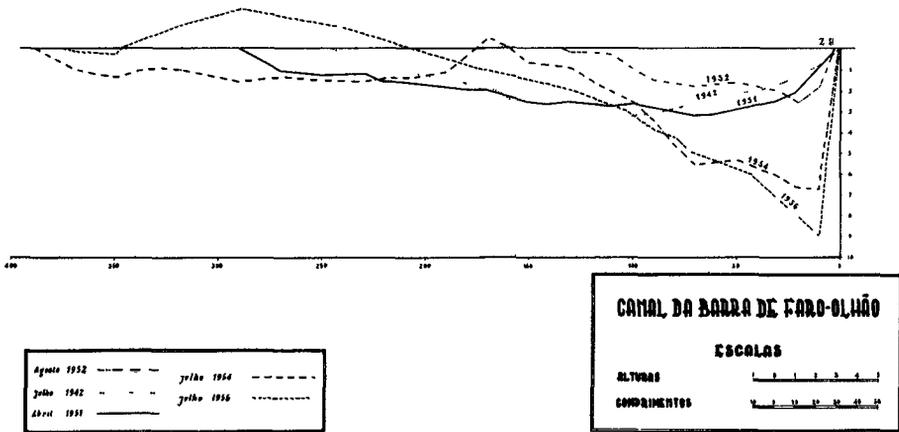
PERFIL N.º 8

Fig. 35. Evolution of the inlet channel's cross sections due to the works (range No. 8)

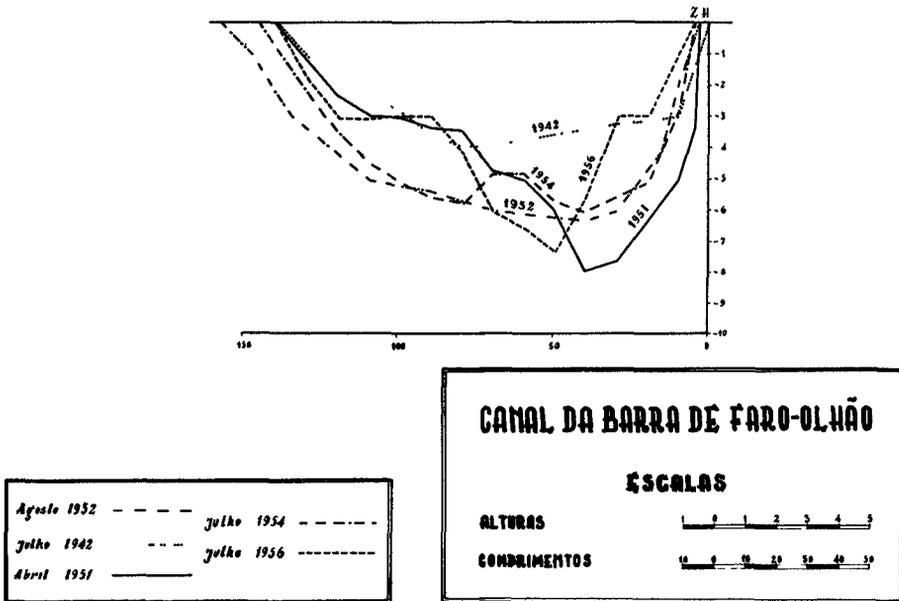
PERFIL N.º 20

Fig. 36. Evolution of the inlet channel's cross sections due to the works (range No. 20)

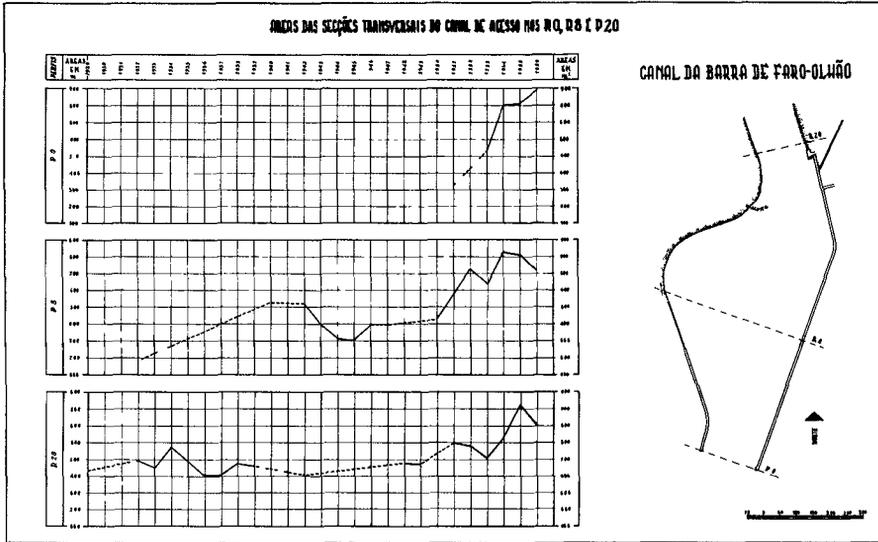
Fig. 37. Areas of inlet's cross sections

But where the progressive beneficial results of the improvement works could be noticed almost step by step was in the amelioration of the hydraulic characteristics of the inlet channel as the works proceeded and in the spontaneous disappearance of the inner bar in the branch channel that leads to Faro (see Table 7 and Fig. 34 to 37). This is the best guarantee of an easier circulation of the tidal flow, which in turn is the most efficient agent for the maintenance of depths in the entrance channel (Fig. 38).

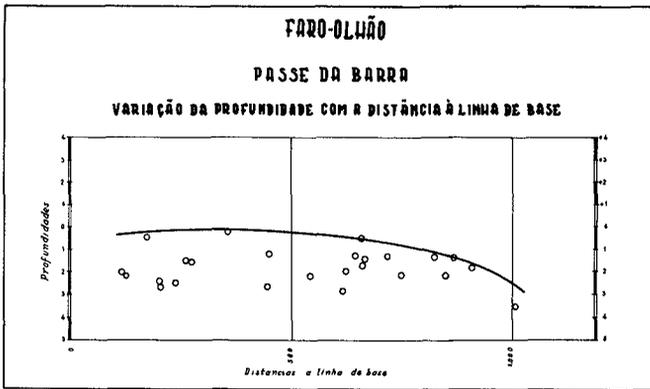
Fig. 38. Controlling depths on the outer bar of Faro-Olhao as a function of its distance to a base line

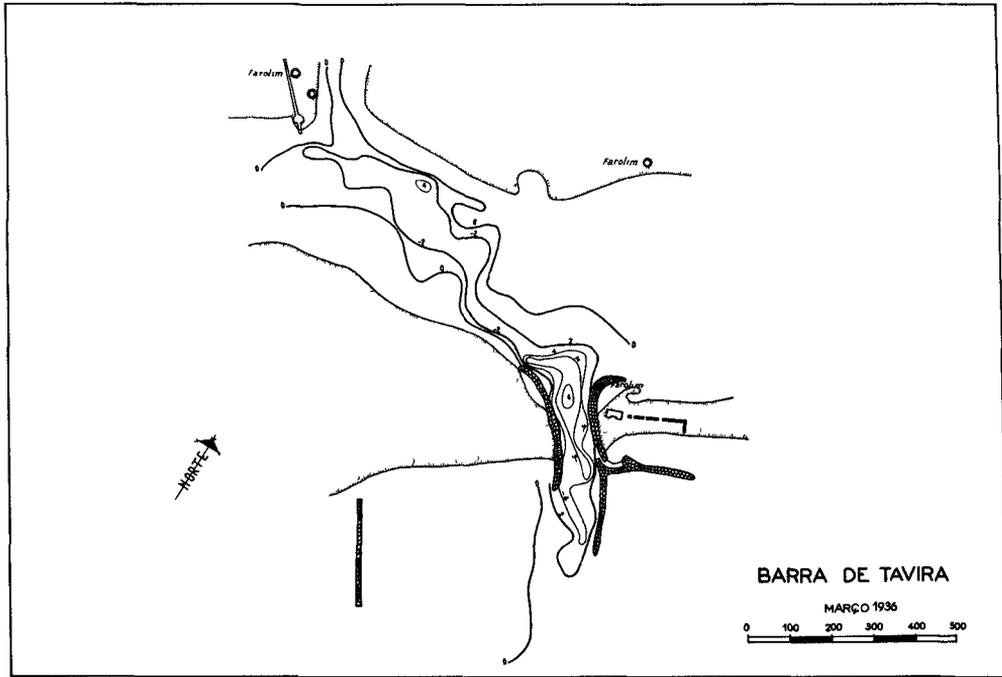
Fig. 40. Tavira inlet's hydrographic survey in March 1936

The 1936, 1942, 1944 and 1956 hydrographic surveys herein presented show what results were obtained by the initial works and the additional amendments (see Figs. 40 to 43).

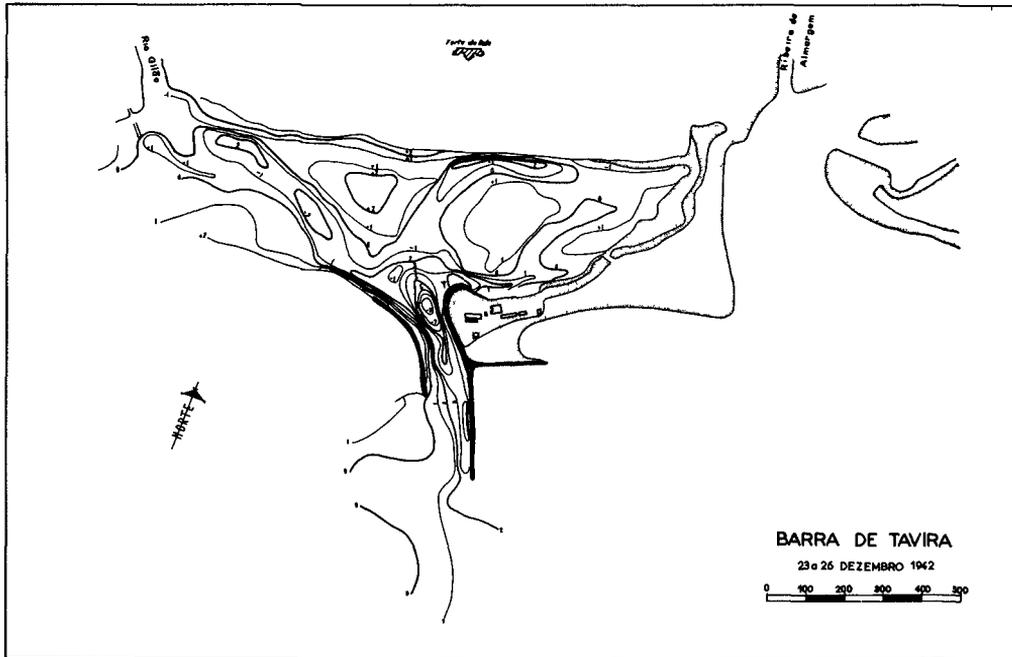
Fig. 41. Tavira inlet's hydrographic survey in December 1942

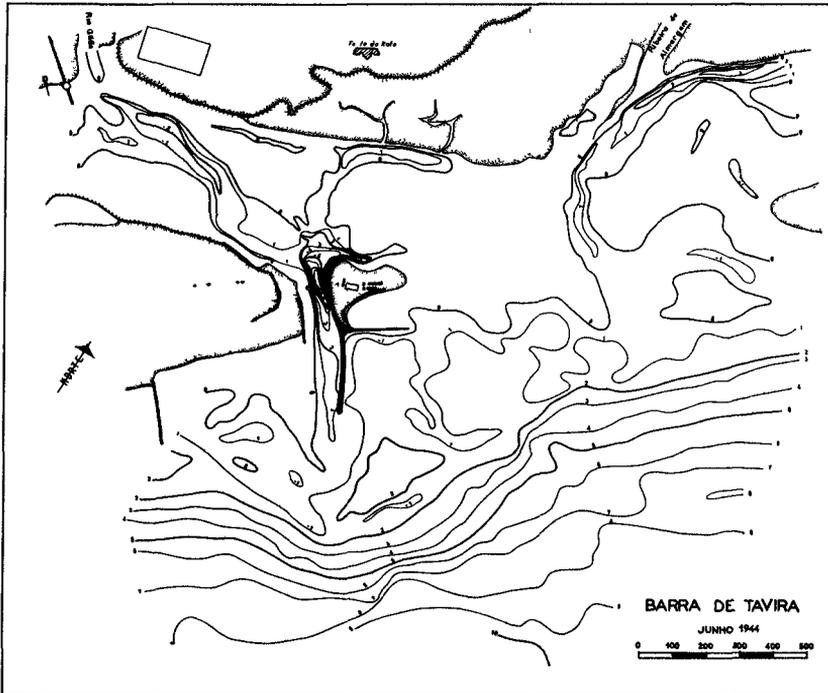
Fig. 42. Tavira inlet's hydrographic survey in July 1944

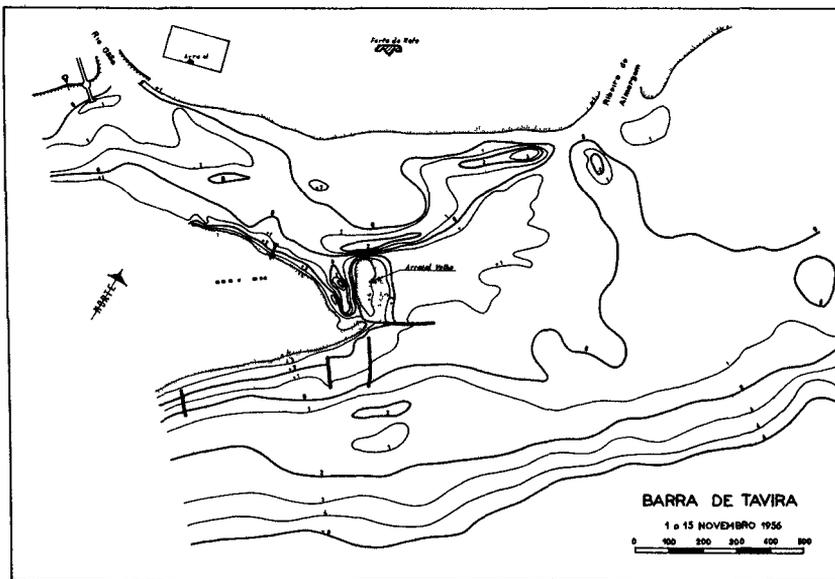
Fig. 43. Tavira inlet's hydrographic survey in November 1956
