## CHAPTER 146

### EFFECT OF BROKEN DOLOSSE ON BREAKWATER STABILITY

D. Donald Davidson<sup>1</sup> and Dennis G. Markle<sup>2</sup>

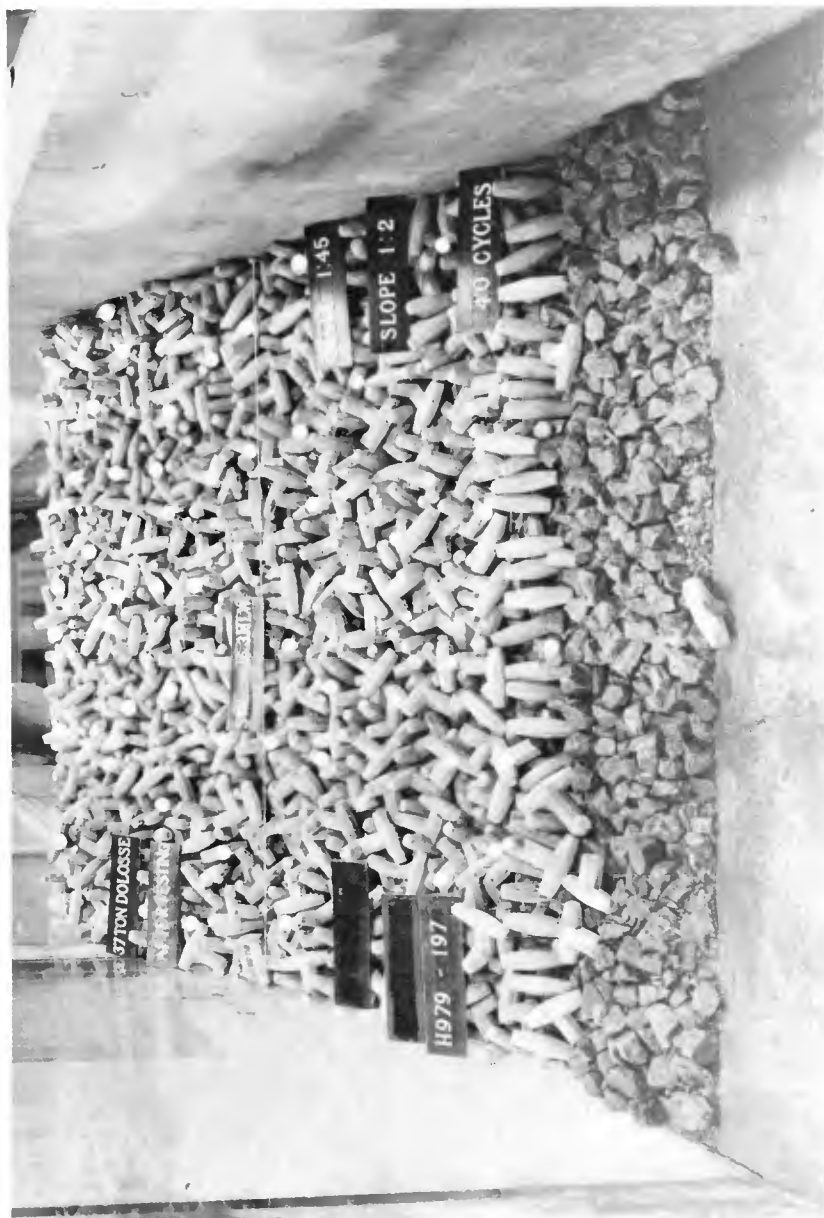
Photograph 4. Test section with 20 percent of the top layer of dolosse broken and uniformly distributed after testing with a design condition of 16-sec, 40-ft waves at a swl of +16.3 ft mlw.

Observed results of the 5 and 10 percent broken unit tests indicated that individual dolosse were not displaced or did not move in place any more than that which occurred with a test section of whole dolosse. Photograph 2 shows an after testing view of a test with 10 percent of the top layer of dolosse broken and uniformly distributed (dots on the photo represent the breakage density). Tests with 15 percent of the top layer of dolosse broken indicated that there was a slight readjustment of a few of the units in the top layer of dolosse (Photograph 3). This readjustment was not significant to the overall stability, but one could tell some renesting had occurred. It is believed that 15 percent uniform breakage is the upper limit in which this type breakage can be allowed without initiating small areas of spot damage. After testing, results of the tests with uniform breakage of 20 percent (Photograph 4) and 25 percent (Photograph 5) substantiates this belief in that spot damage tends to increase with breakage above the 15 percent level. During the 5 to 15 percent uniformly distributed broken dolos tests, it was observed that the individual broken pieces of dolosse were not significantly displaced up and down the slope but tended to nest into the void areas nearest their initial position. As the broken percentage increased (20-25 percent breakage), the half pieces reached such numbers that they began to break down the interlocking characteristics of the whole units and displacement of both the whole and half dolosse was more evident.

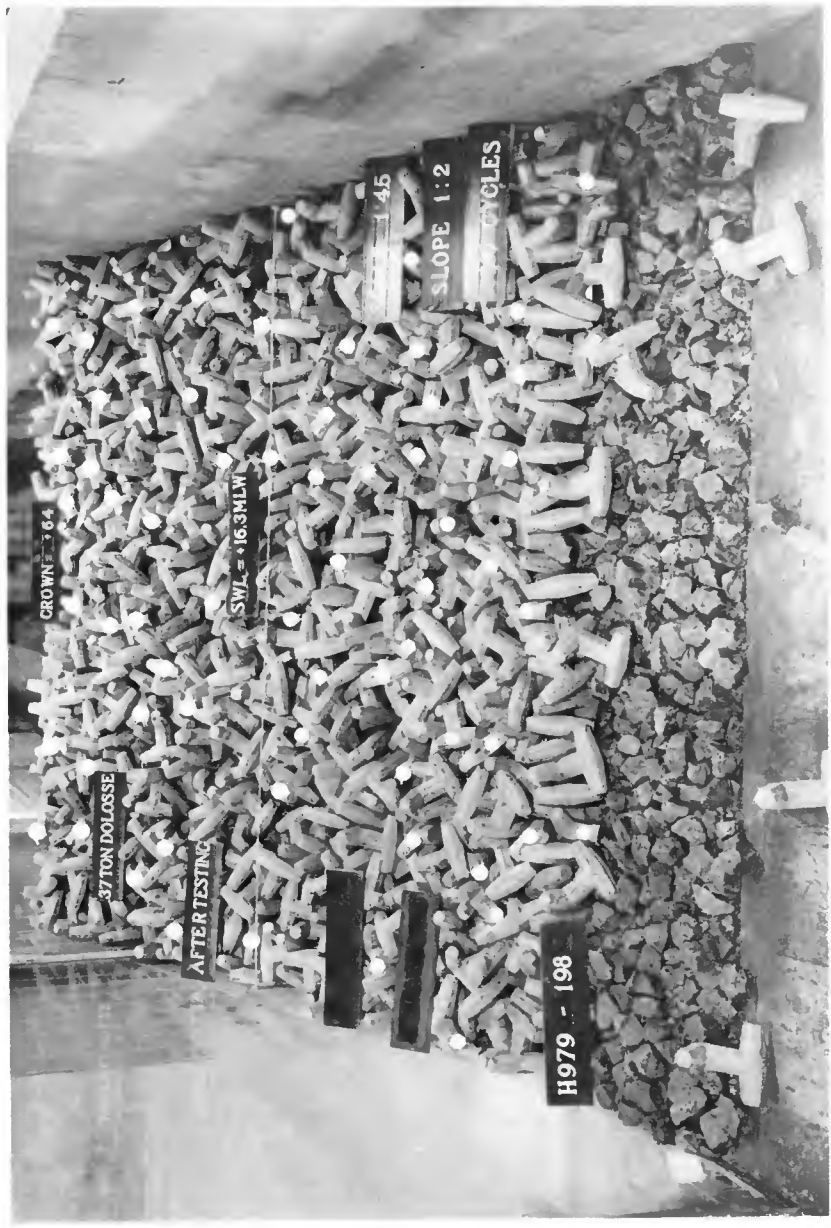
Photograph 5. Test section with 25 percent of the top layer of dolosse broken and uniformly distributed after testing with a design condition of 16-sec, 40-ft waves at a swl of +16.3 ft mlw.

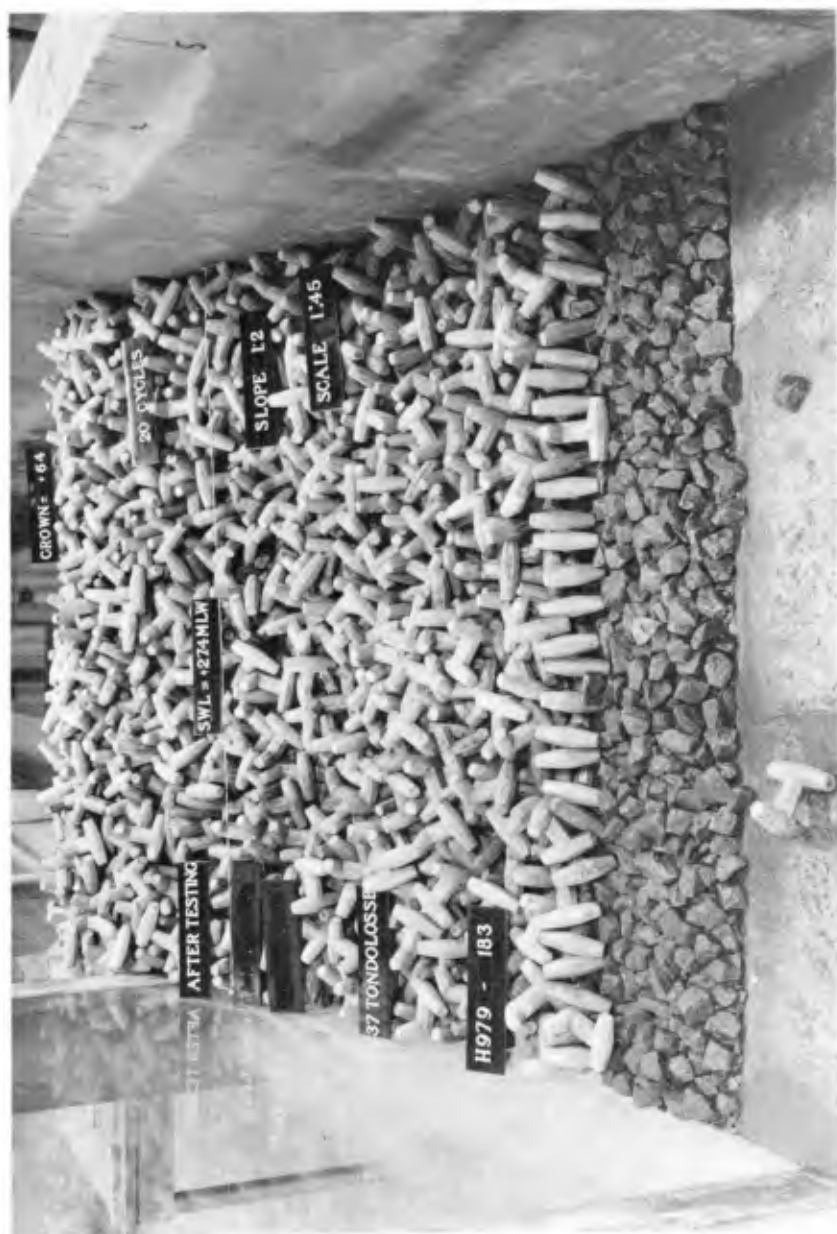
Photograph 6. Test section of whole dolosse after testing with an extreme wave condition of 15-sec, 48-ft waves at a swl of +27.4 ft mlw.

Photographs 6, 7, and 8, respectively, show a whole dolos test section, a test section with 10 percent of the top layer broken and uniformly distributed, and a test section with 15 percent of the top layer broken and uniformly distributed after testing with the extreme wave conditions. Again, the results show that uniformly distributed breakage up to about 15 percent of the top layer of dolosse did not show significant change in stability relative to that for unbroken units.

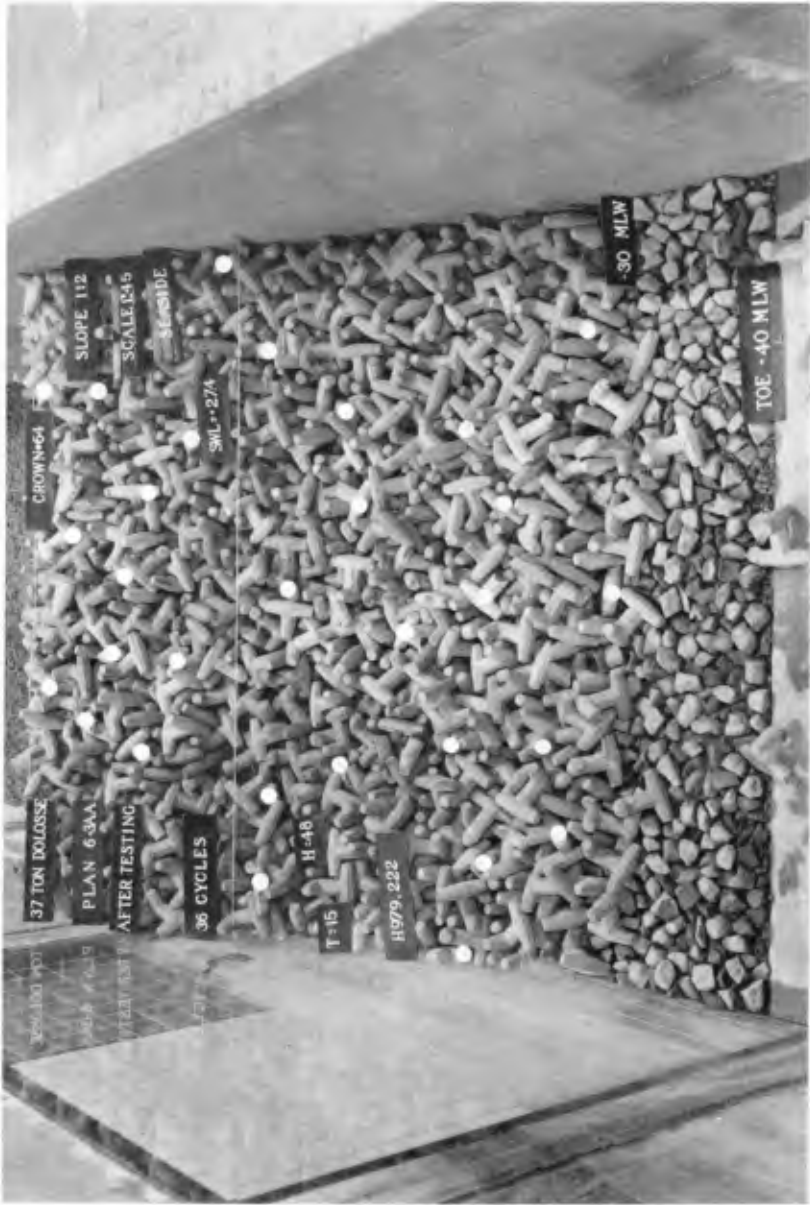
Photograph 7. Test section with 10 percent of the top layer of dolosse broken and uniformly distributed after testing with an extreme wave condition of 15-sec, 48-ft waves at a swl of +27.4 ft mlw.

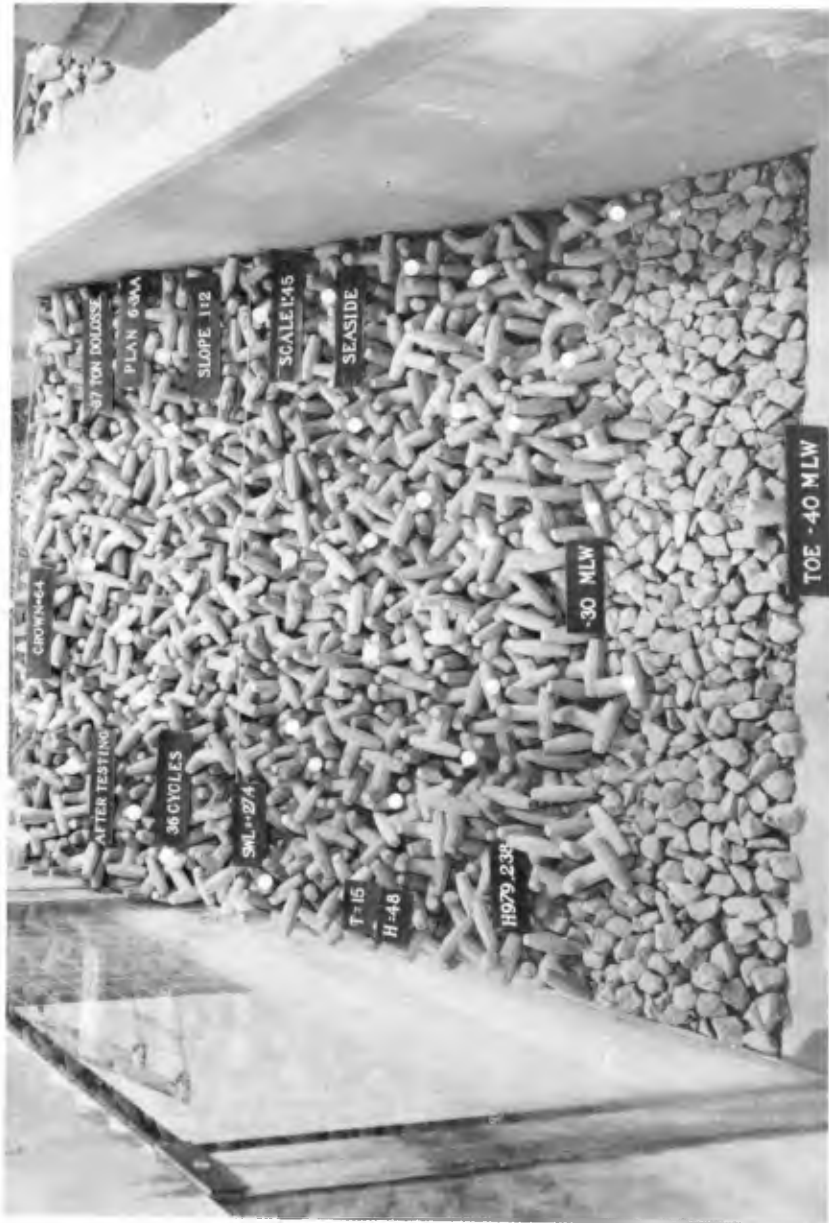
Photograph 8. Test section with 15 percent of the top layer of dolosse broken and uniformly distributed after testing with an extreme wave condition of 15-sec, 48-ft waves at a swl

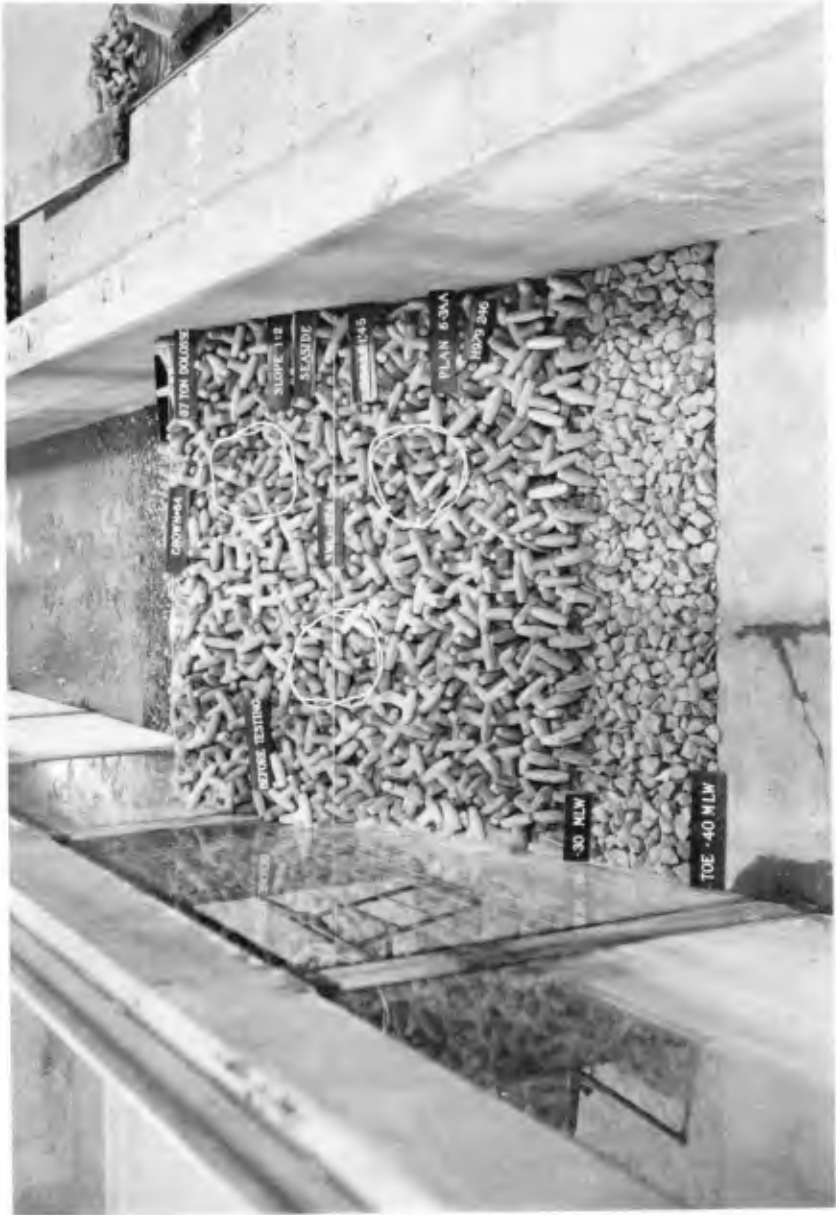
Photograph 9. Test section indicating the positioning of the cluster breakage used in the two-dimensional tests.

Since prototype armor breakage could occur in concentrated numbers as well as randomly, two-dimensional tests of the extreme wave condition were extended to include units broken in clusters. These tests consist of 10, 5, and 3 dolos units broken in a cluster. For each set of cluster breakage, individual broken clusters were positioned on the structure at the swl, about halfway between the swl and the toe of the structure, and about halfway between the swl and the structure crown (Photograph 9). Similar to the uniform breakage construction procedure, it is believed these tests present a certain amount of conservatism since the test sections were constructed with unbroken dolosse, then for each cluster the respective number of dolosse were removed through both layers and the correct number of broken dolosse dropped into the hole. Even though this was done as gently as possible, these procedures could not help but disrupt the interlocking action of the armor units.

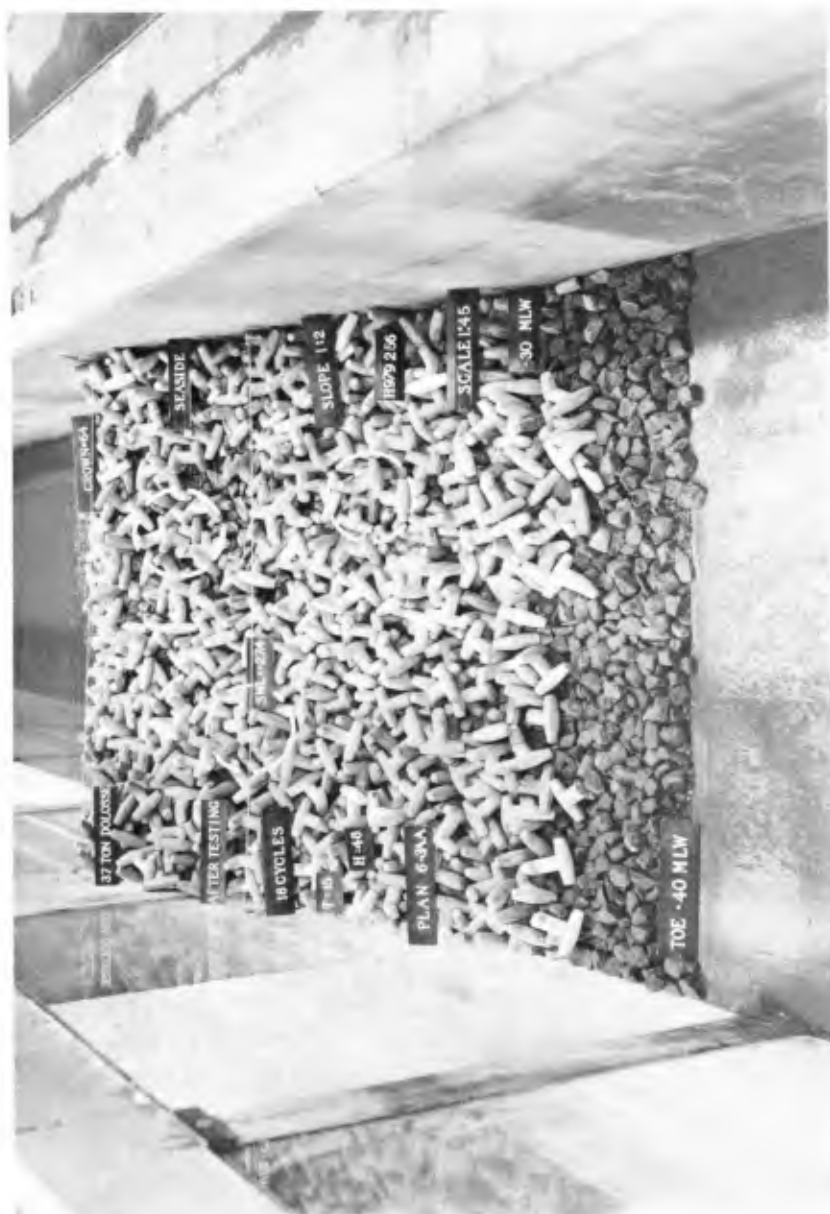
Photograph 10. Test section with 10-unit clusters broken after testing with an extreme wave condition of 15-sec, 48-ft waves at a swl of +27.4 ft mlw.

Results of this type of cluster breakage indicate that clusters of 10 broken units would allow deterioration of the cover layers (Photograph 10, dashed circles represent initial positions of clusters) and could, with extended storm duration, cause major damage that might or might not be repairable. The results of tests using the 5 broken unit clusters also indicate deterioration (Photograph 11); however, it is not as severe and takes longer for the damage to occur, thus the more likelihood the area influenced by the cluster breakage can readjust to interlocking. During the 5 and 10 broken unit cluster tests, the failure of the breakage area seemed to occur in the following manner. The first few waves settled the broken units into rather tight clusters and the unbroken dolosse surrounding the clusters did not have any place to interlock; consequently, the unbroken dolosse around the clusters were displaced. This caused a loosening of the armor units in the area of the cluster until such time that the broken units had no "pocket protection" and were themselves displaced, which added to deterioration of the cover layer. Test results for the cluster of 3 broken units (Photograph 12) do not show this characteristic; and, in fact, indicate that clusters with three broken units are similar in stability to that of the unbroken dolos tests.

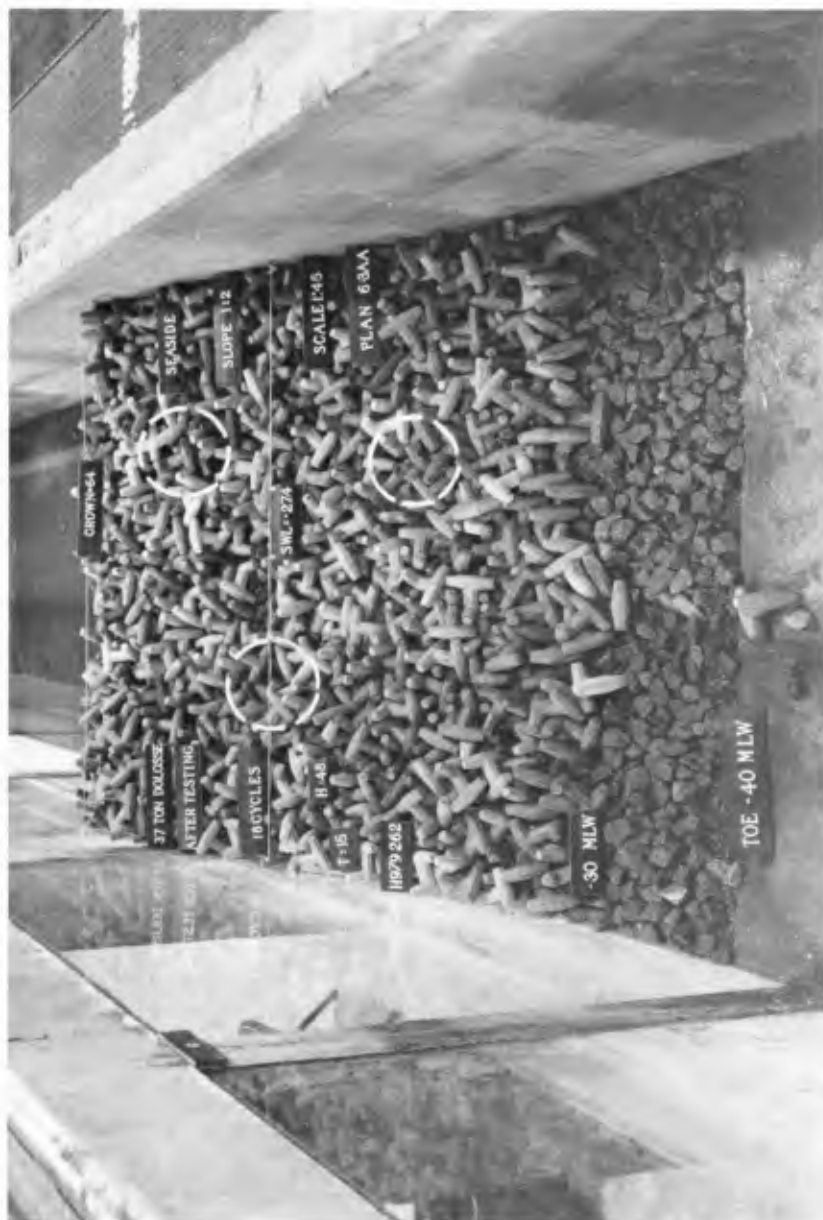
Photograph 11. Test section with 5-unit clusters broken after testing with an extreme wave condition of 15-sec, 48-ft waves at a swl of +27.4 ft mlw.

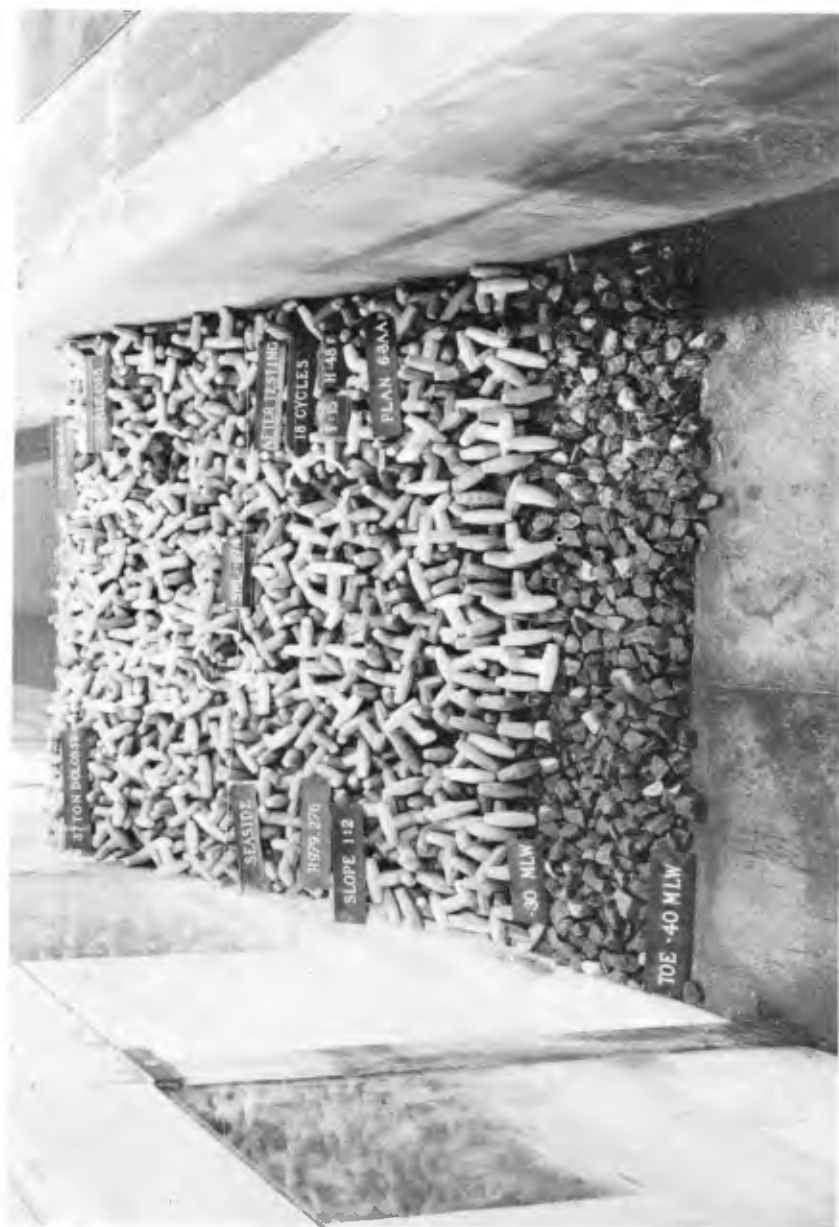
Photograph 12. Test section with 3-unit clusters broken after testing with an extreme wave condition of 15-sec, 48-ft waves at a SWL of +27.4 ft MLW.

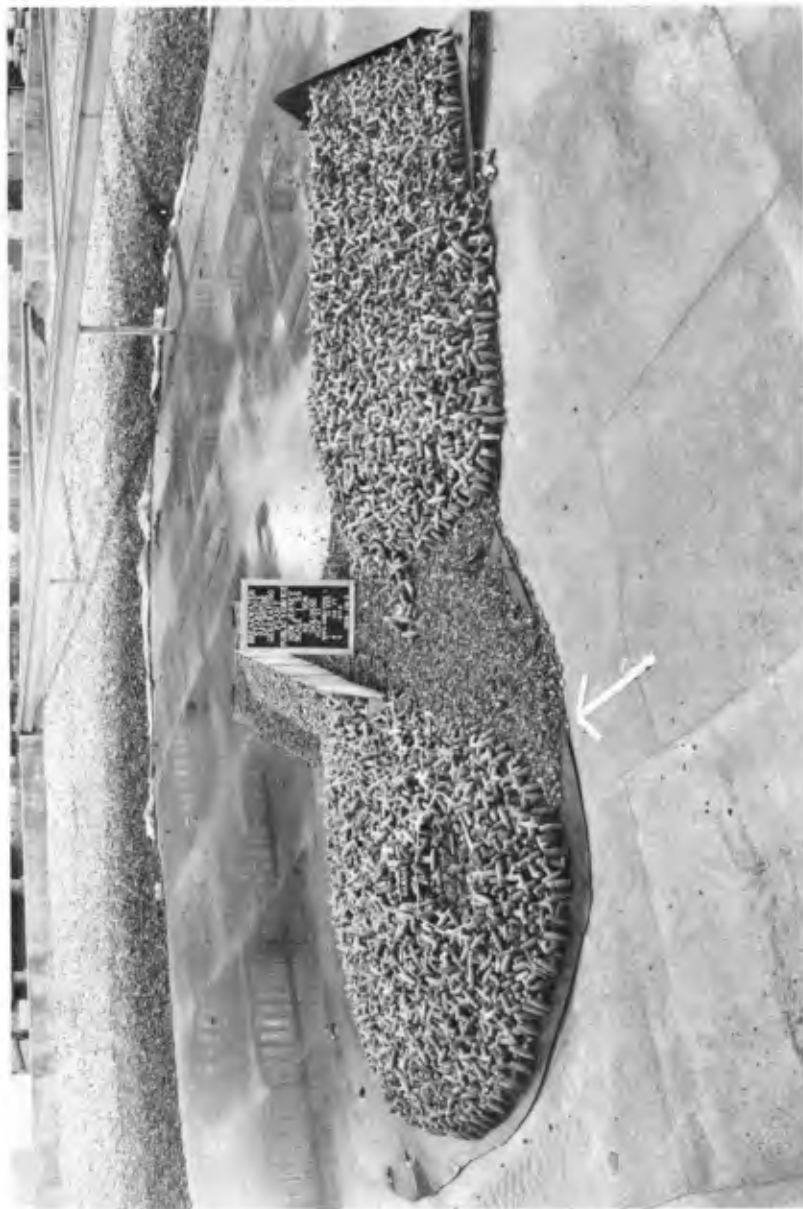
Photograph 13. Three-dimensional test section of whole units after testing with an extreme wave condition of 15-sec, 48-ft waves at a swl of +27.4 ft mhw.

indicated earlier, it was expected that both the whole dolos test section and the 15 percent broken unit test section would sustain damage for the extreme wave condition (Photographs 13 and 14, respectively). However, the point to be made is that the results show that similar damage occurred for both the broken unit condition and the whole unit condition. This is in agreement with the two-dimensional tests and indicates that if the breakage is uniformly distributed, up to 15 percent of the top layer of dolosse can be broken without having a detrimental stability effect over that obtained using unbroken units under similar conditions.

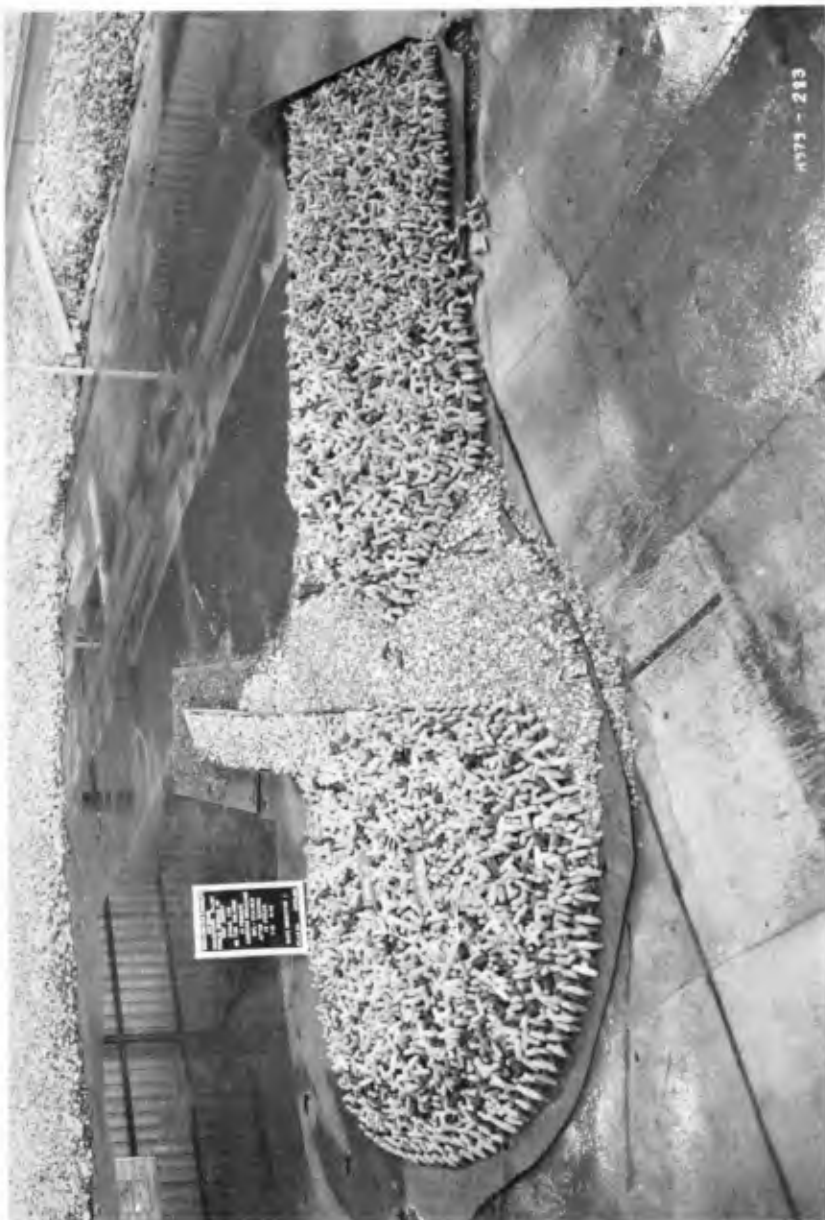
Photograph 14. Three-dimensional test section with 15 percent of the top layer of dolosse broken and uniformly distributed after testing with an extreme wave condition of 15-sec, 48-ft waves at a swl of +27.4 ft mlw.
