CHAPTER 245

The Durban Beach Restoration Scheme after 30 years

W I Laubscher*, D H Swart*, J S Schoonees*, W M Pfaff** and A B Davis**

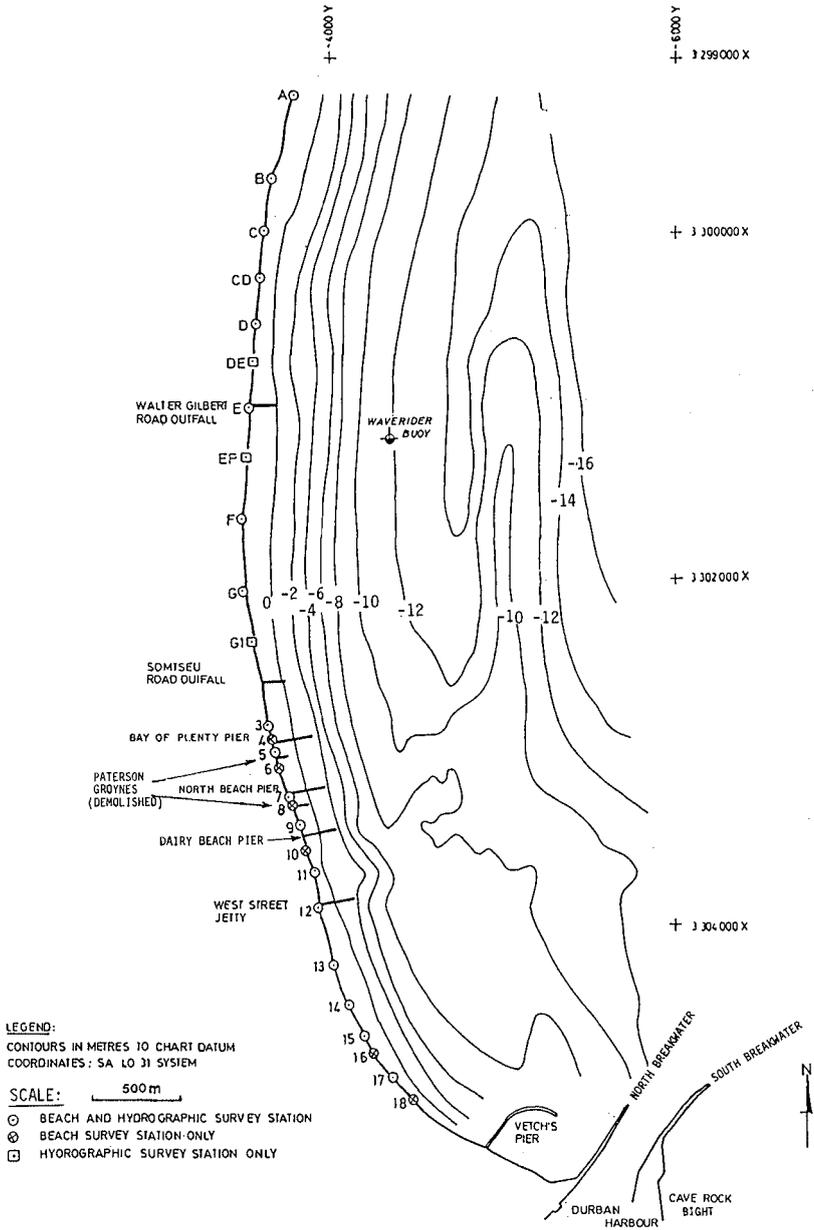
FIGURE 2 : BATHYMETRY OF THE DURBAN BIGHT

In 1982 an initial bulk placement of 600 000 m³ was carried out on Addington and South beaches (between Survey Stations 13 and 16 - Figures 1 and 2) in addition to the renourishment scheme.

A further component of the restoration scheme consisted of the replacement of the old Paterson groynes by two low-level groynes. The position of the groynes are shown on Figure 2. The basic design concept for the new structures was that of a low-level groyne which allows sand to pass over it once the design beach profile, and therefore the desired beach width, have been attained. Both the feasibility study and the subsequent design and construct contract were awarded to a contractor who came forward with several alternative designs based on performance requirements laid down by the Durban Corporation. The resulting design was that of a combined pier/groyne structure, the pier consisting of a deck and two rows of piles with the groyne comprising rock placed between the piles to form a low-level obstruction. The hydraulic design of these two new groynes was carried out by the CSIR on the basis of small-scale physical model tests. Construction of the piers, known as the North Beach Pier and the Bay of Plenty Pier respectively, started in September 1983 and both piers were completed in June 1985. Removal of the Paterson groynes followed and was completed by October 1985.

In 1987 the Durban Corporation decided to construct a third pier/groyne, named the Dairy Beach Pier, with a design similar to of the older two piers (see Figure 2 for the location).

This pier was needed to provide a usable recreation beach adjacent to West Street jetty (Figure 2) in an area where encroachment into the dynamic

- (i) Beach and bathymetric surveys (see Figure 2 for an example as well as for the position of the survey sections).
- (ii) Sedimentological surveys and computation of volumes of sand lost and gained from the beaches as well as the volumes of sand pumped onto the beaches. In total, 1 175 000 m³ of sand has been placed on the beaches between 1984 and 1988.

used as input wave data from voluntary observing ships, dredging data from Cave Rock Bight (the harbour sand trap - see Figure 2) and beach surveys. The dredger records cover a 60-year period - see Campbell *et al.* (1985). A combined estimate of the loss rate, based on the theoretical and empirical results, was made. It was found to be about 200 000 m³/yr with a corresponding replenishment rate of 210 000 m³/yr to cater for additional losses caused by a steepening of beach profiles as a result of a seaward advancement of the shoreline. Long-term changes in the deep-sea wave climate, especially the wave direction, caused the loss rate to vary significantly over time.

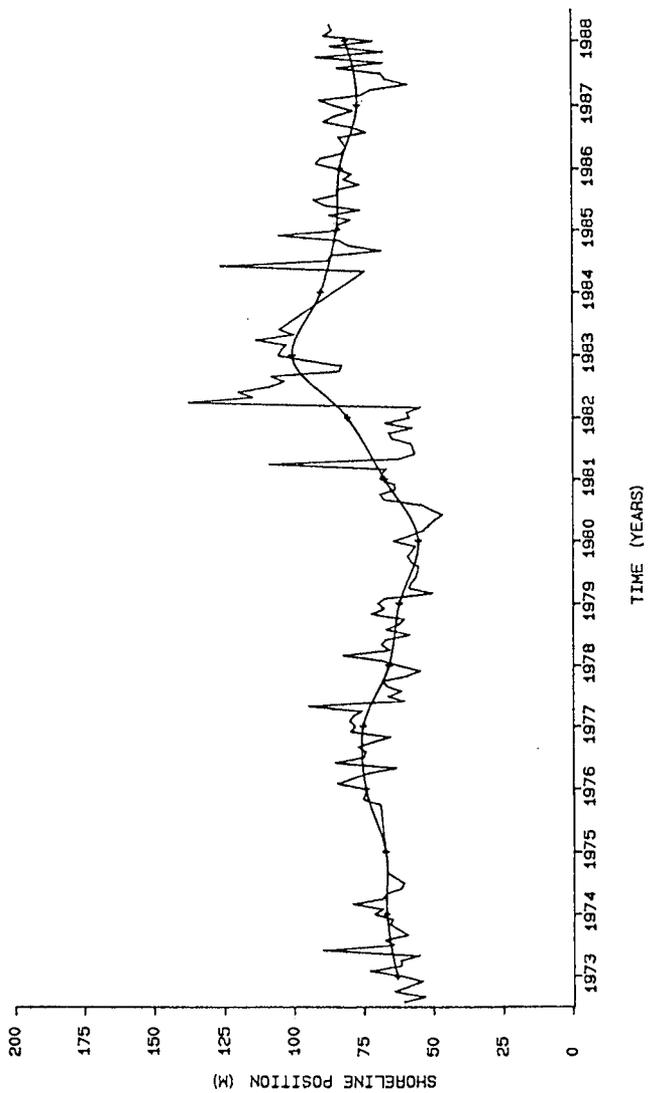
FIGURE 3 : VARIATION IN THE POSITION OF THE +1m CD CONTOUR

(v) The long-term stability (over a 15-year period) of the Bight beaches was determined using the beach surveys since 1973. This study indicated as had been stated previously, that the beaches between the Mgeni River and Somtseu Road are in equilibrium. Figure 3 shows the variation in the shoreline position at Section 14 over time. It is clear from this and other similar figures that the beaches south of Somtseu Road are at present in the best state since 1973.

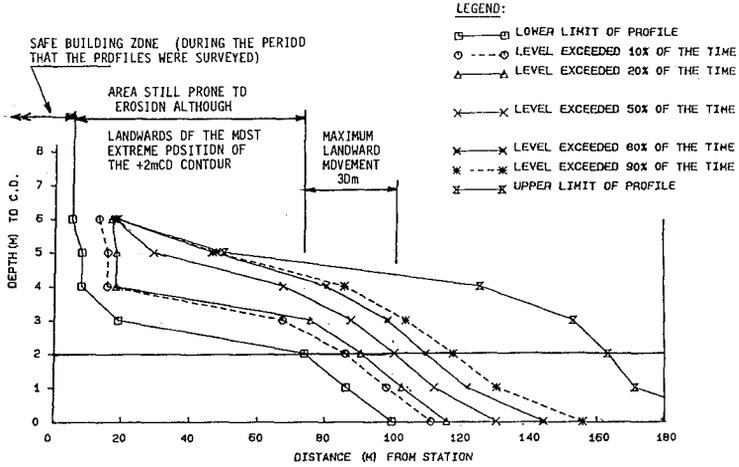
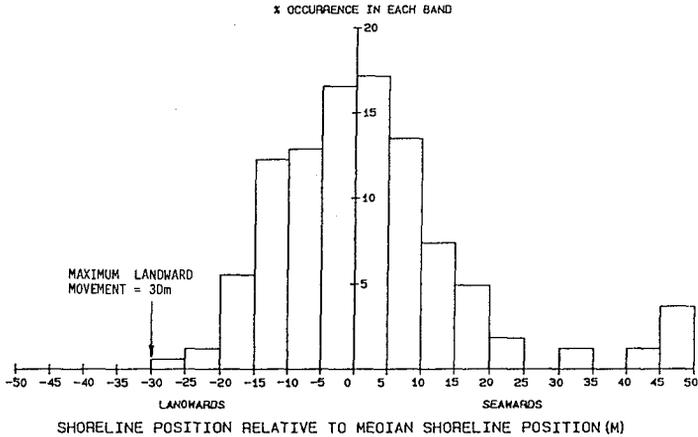
A. PROFILE ENVELOPE

B. RESPONSE HISTOGRAM AT +2M CD

FIGURE 4 : BEACH PROFILE RESPONSE AND EROSION SETBACK LINE AT SECTION A

(vi) A new potential erosion line for the Bight was determined through a combined numerical and empirical method. A building control zone for the Bight has also been defined. It was found that by specifying the potential erosion line as simply a fixed distance behind the median position of a certain beach profile level (for example +1 m to mean sea level) can be misleading if the slope of the lower limit beach profile is rather flat. Figure 4, taken from CSIR (1990), illustrates this point.
