IMPACT OF NOURISHMENTS ON NEARSHORE CURRENTS AND SWIMMER SAFETY ON THE DUTCH COAST

Assessing swimmer safety along the Dutch coast entails more than only assessing the risk of rip currents. Seven criteria have been formulated to make a comprehensive assessment of swimmer safety along the Dutch coast. These are based on interviews with lifeguards, rescue report statistics and detailed lagrangian measurements of the current patterns and bathymetry in the shallow nearshore, at three different field sites along the South-Holland coast.

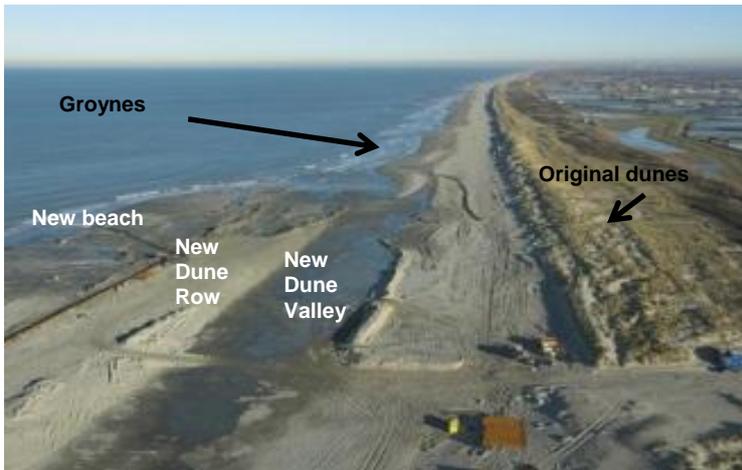
Figure 2: Aerial photograph of the Vlughtenburg field site during construction of the nourishment in 2009. Original beach and vegetated dunes visible on the left. (source: www.delflandsekust.nl)

Vlughtenburg beach was characterized by groynes until 2008. Extensive beach and foreshore nourishments in 2008 and 2009 created a new beach configuration. An entire new dune row and valley were constructed. Figure 2 shows the execution of the nourishment and the original dune, beach and coastline with groynes. Figure 3 shows the northern part of the construction, showing the groynes more clearly. After construction, the coastline was shifted several hundreds of meters seawards covering all groynes with sand.

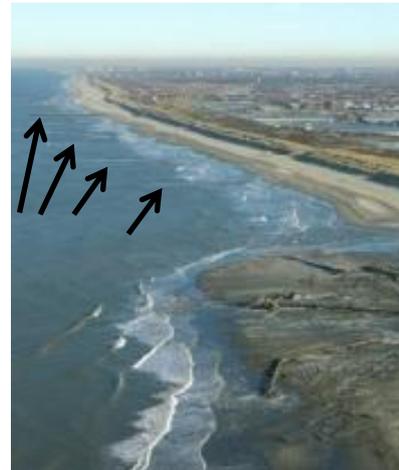
Figure 3: Aerial photograph of the northern end of the Vlughtenburg field site during construction. Groynes at the southern end are already covered with sand. (source: www.delflandsekust.nl)

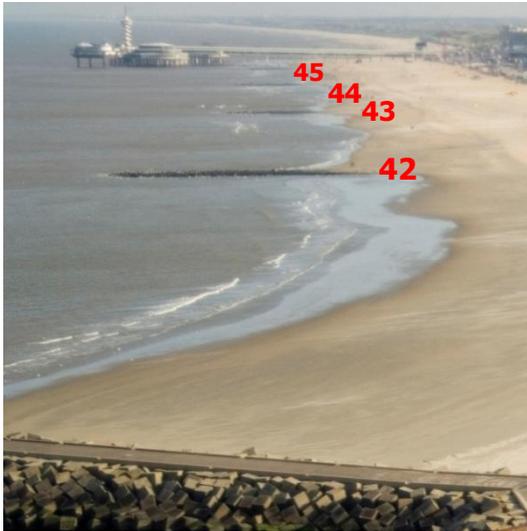
Figure 4: Beach of Scheveningen prior to the nourishment in 2009. Numbers correspond to individual groynes. (source: www.kustfoto.nl)

Scheveningen beach is the main tourist beach of the city of the Hague, located just north of the harbour moles. Figures 4 and 5 show the beach of Scheveningen before and after the nourishment of 2010 respectively. The nourishment covered the groynes completely with sand. The alongshore (lateral) boundaries of the nourishment initially resulted in sharp alongshore gradients in the coastline.

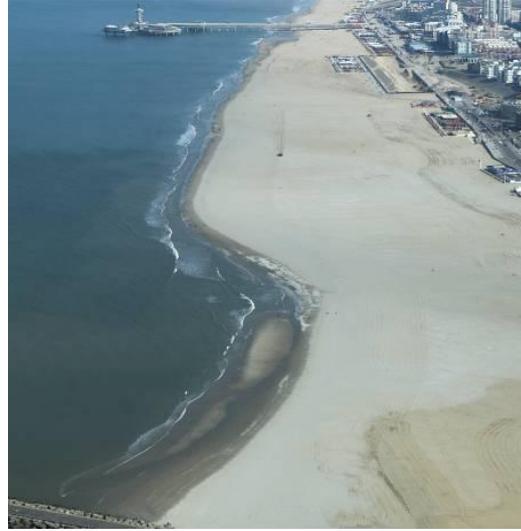
Figure 5: Nourished beach of Scheveningen in 2010. Groynes 42 to 44 are covered by the nourishment, 45 still present. (source: projectbureau Combinatie Delftlandse Kust)

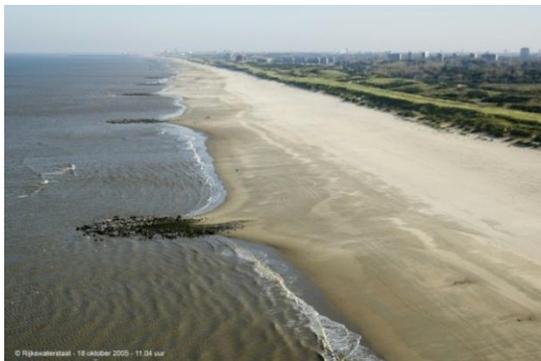
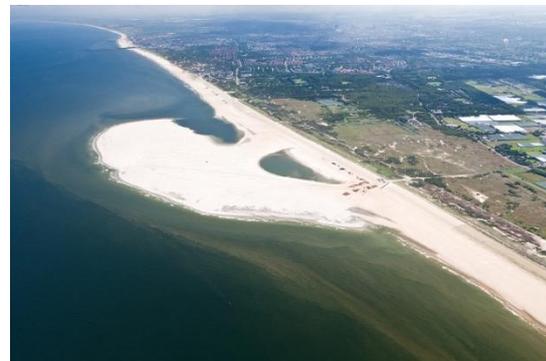
Figure 6 and 7: Coastline between The Hague and Ter Heijde before and after the mega scale nourishment 'The Sandengine'.

The third field site is the mega scale nourishment just north of Ter Heijde and south of The Hague (HVRB post 1), called the Sandengine (see Fig. 1). Approximately 19 Mm^3 sand has been nourished along a 2.5 km stretch of coast. The nourishment is designed as sediment supplier for the adjacent coast and provider of extra natural and recreational area. Like the other field sites, existing groynes were covered with sand as a result of the nourishment and an entirely new coastline and beach configuration was created (Figures 6 and 7).

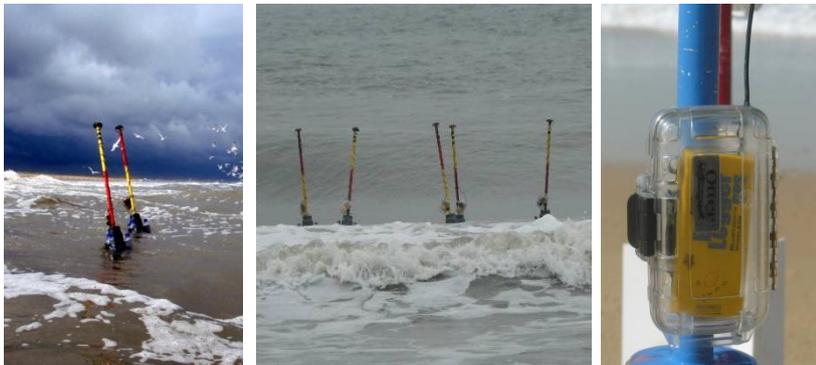
Figures 8, 9 and 10: GPS data loggers attached to PVC buoys. (GPS drifters)

The GPS drifters are free-floating devices used to derive the velocities of the top layer of the watercolumn. The GPS records the position of the drifter with high accuracy enabling to calculate the velocities and to make a coupling of drifter trajectories with the bottom contours. The GPS drifters (Figures 8 to 10) are built similar to the design described by MacMahan et al. (2009). They consist of a buoyant 0.1 m by 0.3 m PVC body on which a 0.7 m by 0.03 m PVC mast is attached. The GPS antenna is mounted on top of the drifter on a metal disk with a diameter of 0.05 m. Three fins along the shaft of the body are attached for sail area under water. The drifters are designed to minimise surfing back to the beach on the roller of a breaking wave, as they tilt on wave impact. A flat plate attached to the bottom reduces surfing and ballast weights attached to the bottom increase stability of the drifters. The drifters were shown to closely follow simultaneous dye release and passive swimmers.

The GPS data loggers are housed in a waterproof box attached to the mast, see Figure 10. The loggers internally record carrier phase information on one frequency at a sampling frequency of 0.5Hz. The capacity of the loggers allows for measurements up to three hours. Position accuracy is in the order

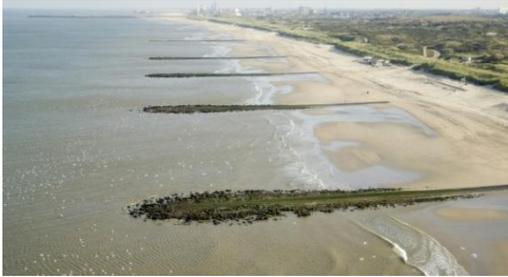
Figure 11: Picture of groynes beach around low tide. (source: www.kustfoto.nl)

Prior to the nourishments, the typical beach configuration along the South-Holland coast is a groyned beach, see Figure 11. It consists of a row of dunes, a fairly wide upper beach (O (100 m)) and a dissipative, mildly sloping inter- and sub tidal beach face (1:50 – 1:100). The groynes are separated 250 – 500 m in alongshore direction, are 100-200 m long with crest levels around MSL. The predictable morphology (in space and time) in between the groynes is gently sloping in both along and cross shore direction. Often one or two bars are present between the groynes, incised with a shallow rip channel (O (10 - 50 cm) relative to the bar top) and a deep channel adjacent to the groynes (Fig 12.). The predictable character of the morphology in between the groynes was perceived to be beneficial to swimmer safety by the lifeguards.

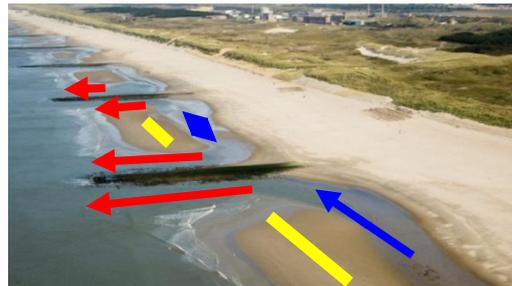
Figure 12: Schematic of permanent rips (red arrows) next to groynes. Breaker bars (yellow lines) and trough/feeder current (blue arrows) are clearly visible in the intertidal bathymetry. (source: www.kustfoto.nl)

Due to the characteristic predictable morphology, the nearshore current pattern was also predictable and well-known amongst lifeguards (due to decades of experience). The groynes with a crest level at approximately MSL deflect wave and tidal alongshore currents in the low tide period and invoke a strong outward flowing current. The current pattern on a beach with emerged groynes shows permanent rips at the upstream side of the groyne due to any longshore current and possibly eddies in the lee side of the groynes, see Fig. 13. The reduced longshore current in between the groynes (indicated as A in Fig. 13) compared to offshore (B, Fig 13) is perceived as a positive effect of the groynes on swimmer safety. On the other hand, the deflected offshore flowing current along the sides of the groynes poses a hazard for swimmers and therefore a negative effect on swimmer safety.

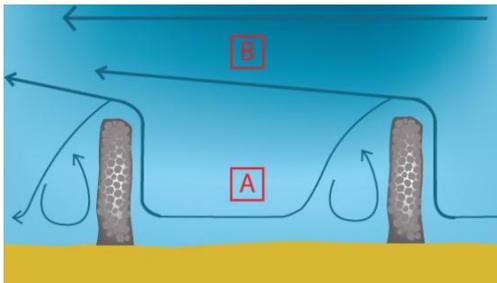
Figure 13: Schematised current pattern under oblique wave incidence or a tidal longshore current. Rip currents on the upstream side, possible eddies in the lee side of the groynes. The thickness of the lines indicates the relative current velocity and the reduction of the longshore current due to the groynes.

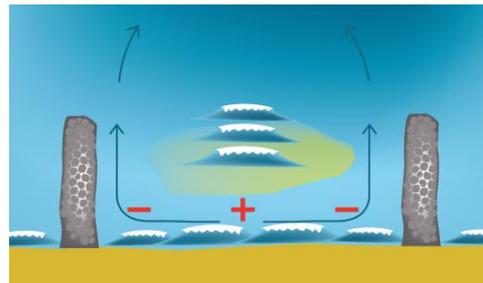
Figure 14: Schematised current pattern under normally incident waves. Shallow submerged bar in between groynes results in water level setup gradients at the shoreline indicated by + and - signs.

Besides rip currents invoked by alongshore currents, near shore-normal wave breaking can also induce rip currents in between the groynes. The associated current pattern due to normal incident wave breaking over the (submerged) bar is schematically indicated in Figure 14. In case of normally incident waves there is some wave breaking directly on top of the groyne, almost no wave breaking in the deep areas next to the groyne and intense wave breaking over the submerged bar(s). The set up in water level increases with increasing wave breaking. Consequently, there is a gradient in water level between the area behind the bar(s) and channels. This causes a current towards the channel: the feeder current. The rip currents are stronger with increasing wave breaking over the bar. Besides the gradient in water level, mass flux by and breaking of waves causes a net onshore directed flow over the bar, which flows back offshore through the feeder en rip current channel, enhancing the rip circulation. Generally, a combination of both current patterns will develop, depending on the conditions.

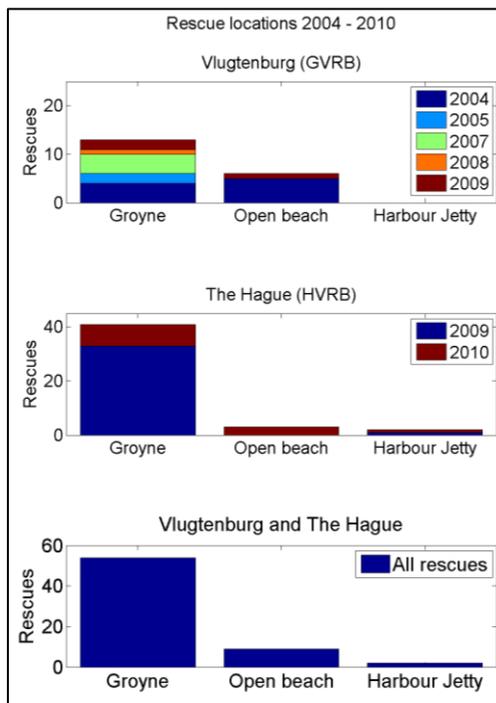
Figure 15: Rescue reports sorted to the location of the rescues, categorized as near groyne, open beach and harbour jetty for the years 2004 – 2010 at Vlughtenburg site (top), Scheveningen site (middle) and both sites combined (bottom).

Interviews with lifeguards and statistics of the rescue reports revealed that rips near emerged groynes form the biggest threat to swimmers. Figure 15 shows the amount of rescues performed near groynes and on open (nourished) beaches. Figure 16 shows the amount of rescues plotted against wind directions (and tidal phase (both vertical and horizontal tide). The beaches are facing NW, so clearly the majority of the problems for swimmers are related to longshore current invoked rip currents along the emerged groynes. A smaller part of the rescues is related to shore-normal wave breaking and thus rip currents in conventional sense. Amongst others, Lushine (1991) and Lascody (1998) performed similar research in the US to reveal a higher risk on rips for shore-normal conditions.

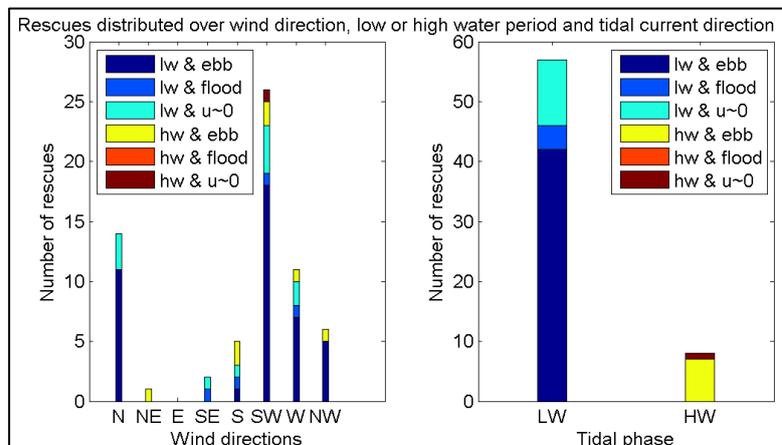
Figure 16: Rescue reports sorted to meteorological conditions and the tidal phase. Left: Rescues distributed over wind direction at times of the rescue. The colours of the bars indicate water level and approximate tidal current direction. Right: Low tide or high tide period at times of rescues.

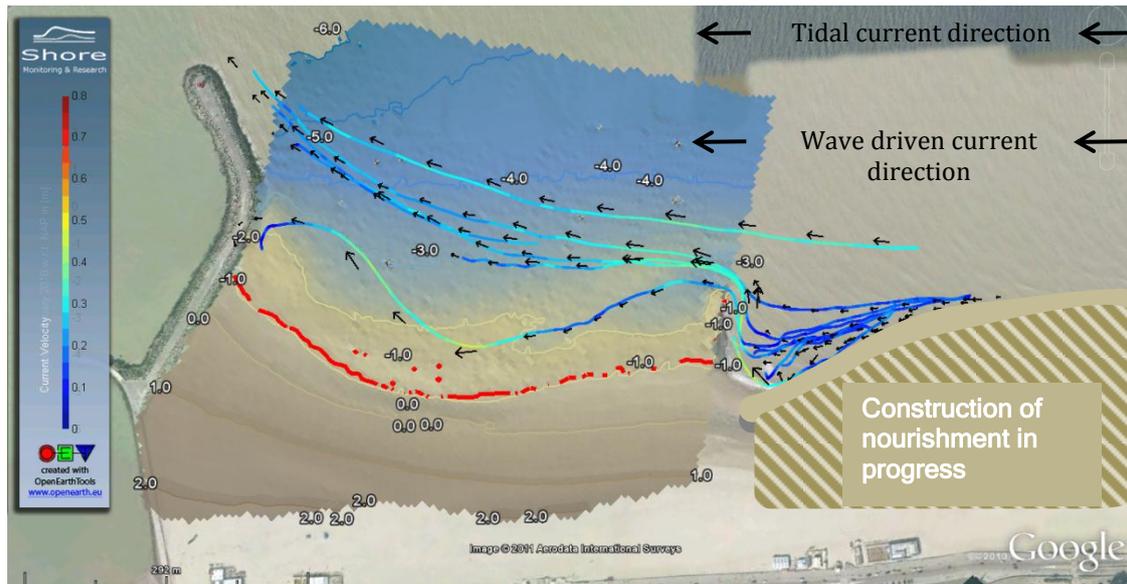
Figure 17: Drifter trajectories near a groyne at Scheveningen. Paths show the drifter trajectories, colors herein correspond to the velocity (m/s) as indicated by left colorbar, black arrows indicate direction. Blue/grey shading and contours indicate bottom elevation in m NAP. Beige shaded thick line indicates approximate waterline due to commenced construction of the nourishment.

Current measurements on the groyned beaches confirm the existence of rip currents along the sides of emerged groynes for any longshore current. Figure 17 shows one of the measurements performed for obliquely incident waves ($H_s = 0.8$ m, $T = 4.3$ s, Dir NNE, $U_{wind} = 5.3$ m/s Dir. NNE) at Scheveningen beach. The measured velocities in the rip current are roughly twice as high as the average alongshore (wave driven) current. The measurements also confirm a stronger tidal alongshore current beyond the tip of the groynes. The GPS drifters caught in the rip current are advected by the tidal alongshore current beyond the tip of the groyne. Velocities can be read from the colorbar which corresponds to the colors of the drifter trajectories in the figure.

When the direction of the wave and tidal driven alongshore current coincide the rip current extends O (20m) offshore and GPS drifters stay closer to the tip of the groyne and beach. On the contrary, for opposing wave and tidal driven alongshore current rip currents extend further offshore, O (100 m), which is an important result of the measurements and practical swimmer safety management.

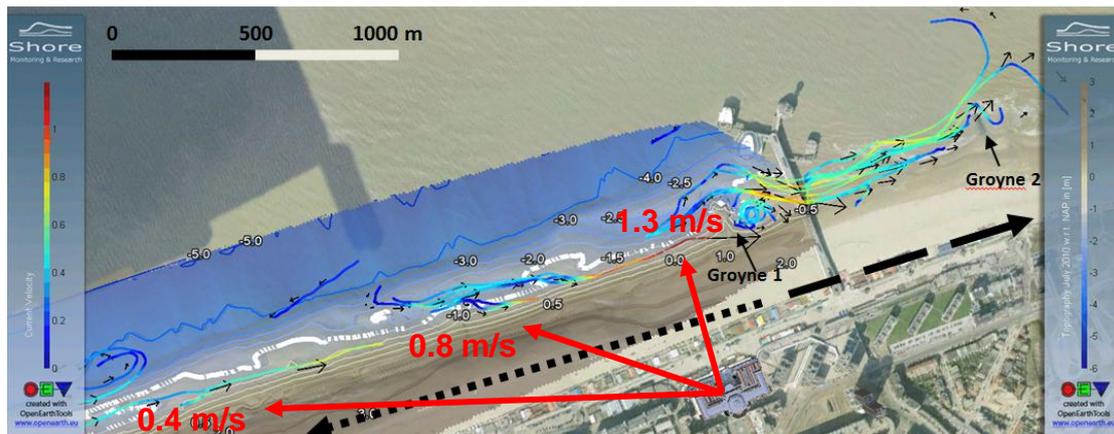
Figure 18: GPS Drifter tracks as measured at Scheveningen ($H_s = 1.65$ m, $T = 5.0$ s, $Dir = SW$, $U_{wind} = 9$ m/s, $Dir = SW$, ebb tidal current), for a nourished (dotted line) and groyned beach (dashed line). Paths show the drifter trajectories, colors herein correspond to the velocity (m/s) as indicated by left colorbar, black arrows indicate direction. Grey/blue color shading and contours show bathymetry (m) with respect to NAP as indicated by right colorbar. Nourished section of the beach shows strong longshore currents. The unnourished part is characterised by rips (groyne 2) and eddies (groyne 1). White dotted line shows the approximate breakerline.

Measurements on the open nourished beach (area indicated by dotted black arrow in Figure 18) revealed strong alongshore currents close to the waterline for most measurements and no rip currents for obliquely incident waves, see Fig. 18. This is almost the opposite situation compared to the groyned beach. The strong longshore current close to the waterline could be explained by the steep beach profile post nourishment, see Fig. 19, and the absence of groynes.

To illustrate the big difference between the current pattern between the two beach configurations Figure 7 also shows the current pattern near the groynes outside the nourishment area (area indicated by dashed black arrow in Figure 7). It clearly shows the offshore invoked rip currents at groyne 2 (notice the offshore extent of the rip due to opposing wave and tidal driven current). In the lee of groyne 1 an eddy was measured with offshore velocities larger than 0.4 m/s.

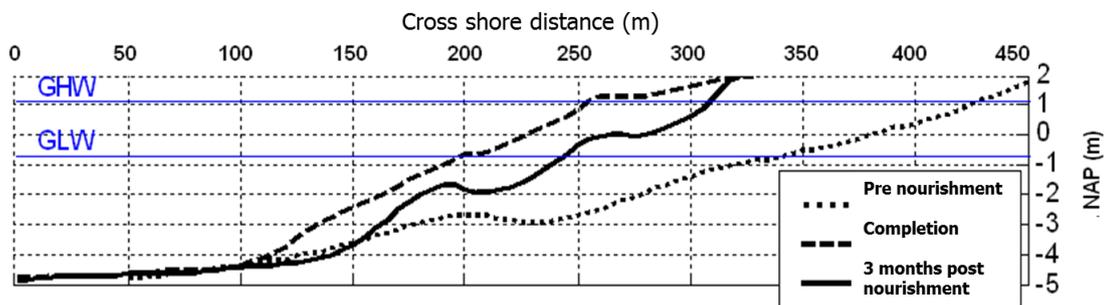
Figure 19: A beach profile at Scheveningen pre-nourishment (dotted), at completion of the nourishment (dashed) and 3 months post-nourishment (solid).

Generally an alongshore (oblique) trough and bar system developed, see also Fig. 19. Combined with a strong longshore current, several hazardous situations were reported. Bathes were drawn to the

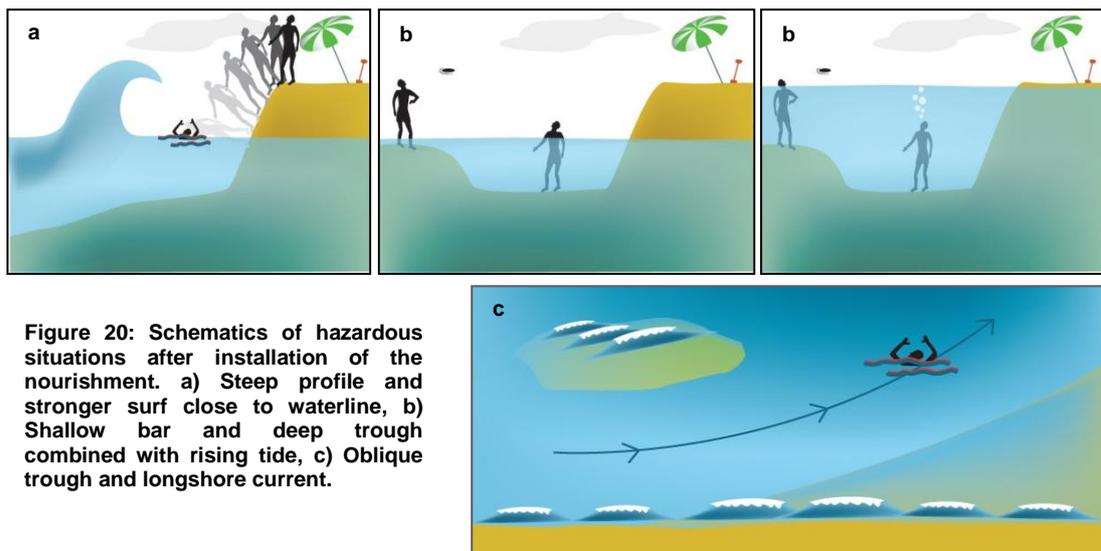
Figure 20: Schematics of hazardous situations after installation of the nourishment. a) Steep profile and stronger surf close to waterline, b) Shallow bar and deep trough combined with rising tide, c) Oblique trough and longshore current.

After construction of the nourishments steep profiles were observed, causing shorter, stronger surf close to the beach. At many locations scarps formed. Figure 20a illustrates the hazardous nature of the strong surf and steep profile for bathers. Besides the hazard to swimmers, the scarps also blocked their view on the waterline from their observation stations.

bar at low tide to which they, in that tidal phase, could wade. With rising tide the alongshore current increases and the trough becomes too deep to wade through, forcing people to swim back to the beach and at the same time drifting alongshore, see Fig. 20b. At some locations the through was orientated obliquely offshore forming a very hazardous situation, see Fig 20c.

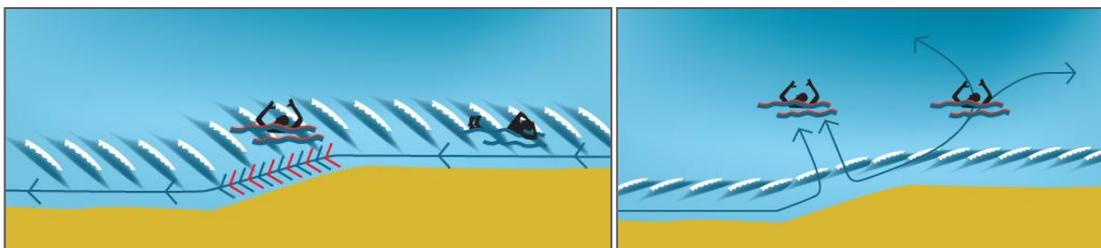
Figure 21: Schematics of hazardous situations near the lateral boundaries of the nourishment. Alongshore coastline gradients can cause alongshore flow acceleration (left) or rip currents depending on wave direction and shoreline orientation.

The lateral boundaries of nourishments often introduce gradients in the coastline. The smoother these gradients are, the less the local hydrodynamics and morphology differ from the rest of the beach. However, these gradients are often clearly visible and not very smooth. At these gradients accelerations of the longshore wave driven current and variations in beach profiles are observed, see Fig. 21.

When wave angle of incidence and the shore-normal at the gradient are parallel rip currents can also form. The lifeguards of Vlughtenburg have reported serious incidents with swimmers at similar locations as shown in Figure 21.

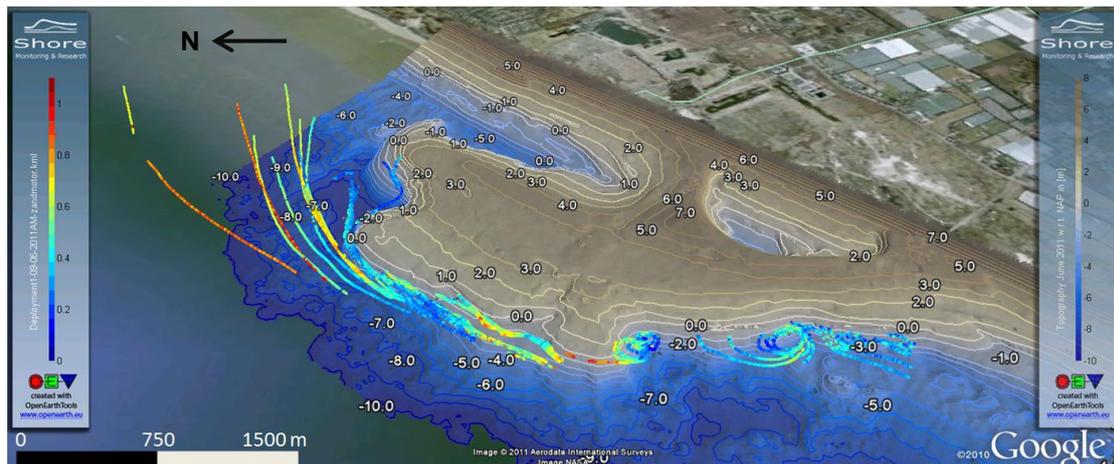
Figure 22. GPS Drifter tracks as measured at the Sand engine. Paths show the drifter trajectories, colors herein correspond to the velocity (m/s) as indicated by left colorbar, black arrows indicate direction. Grey/blue color shading and contours show bathymetry (m) with respect to NAP as indicated by right colorbar.

Observations at the mega scale nourishment, the Sand engine peninsula highlights the danger of gradients in the coastline (Fig. 22). As the nourishment protrudes far from the surrounding coastline, the alongshore gradients in the coastline in combination with an alongshore current are clearly important in the assessment of the local swimmer safety here. Bathers caught in the alongshore current risk being transported alongshore at 1 m/s finding themselves more than 1500 m removed from the closest coastline. In the GPS drifter experiment shown in Fig 22, wave, wind and tidal driven current all acted in northeast alongshore direction, amplifying the danger for ocean bathers.

Note that at the SW facing flank of the Sand engine peninsula the waves were near shore-normal incident and while alongshore currents are small, clear rip currents were observed.
