### **CHAPTER 88**

### ESTABLISHMENT OF A COASTAL SETBACK LINE IN FLORIDA

#### James A. Purpura Associate Professor

### Coastal and Oceanographic Engineering Laboratory University of Florida, Gainesville, Florida, U. S. A.

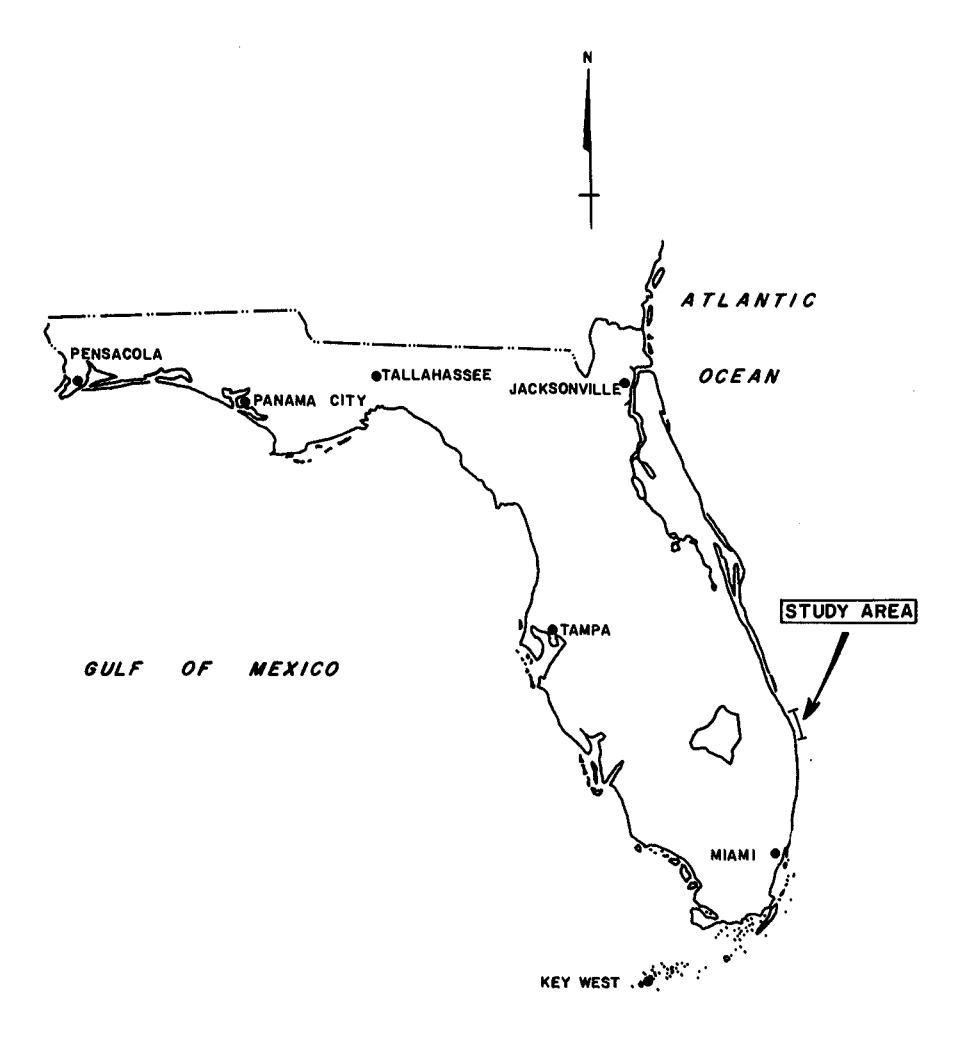
Based on existing shoreline conditions, and at the request of local officials, the Bureau of Beaches and Shores designated Martin County as the first county in which the required studies would be made. The study area consists of 22 miles of Atlantic Ocean beachfront dissected by St. Lucie Inlet, a major tidal inlet. The area consists of barrier islands, namely Hutchinson Island between the north Martin County line and St. Lucie Inlet and Jupiter Island from St. Lucie Inlet to the Palm Beach County Line. The locality is shown on USC & GS charts Nos. 846, 1247, 1248 and Figure 1 of this report.

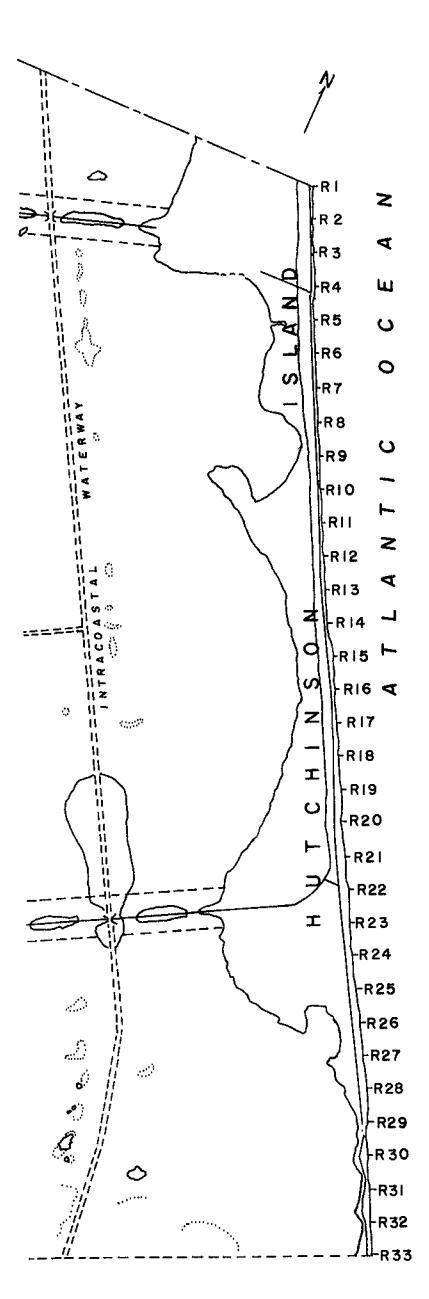
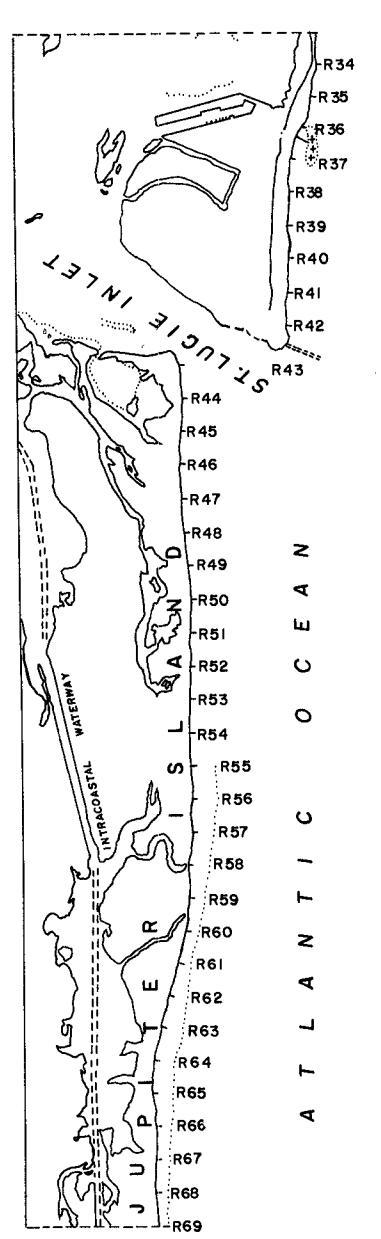
FIGURE 2 PROFILE STATIONS

A comprehensive field investigation of the study area was carried out as follows: As required in the law, monumented stations approximately 900 ft. apart were placed parallel to the shoreline (127 stations) from the northern county line along the coast to the southern county line, a distance of approximately twenty-two miles. (Figs. 2 and 3). Each station was carefully

surveyed in and tied to the State Plane Coordinate System.

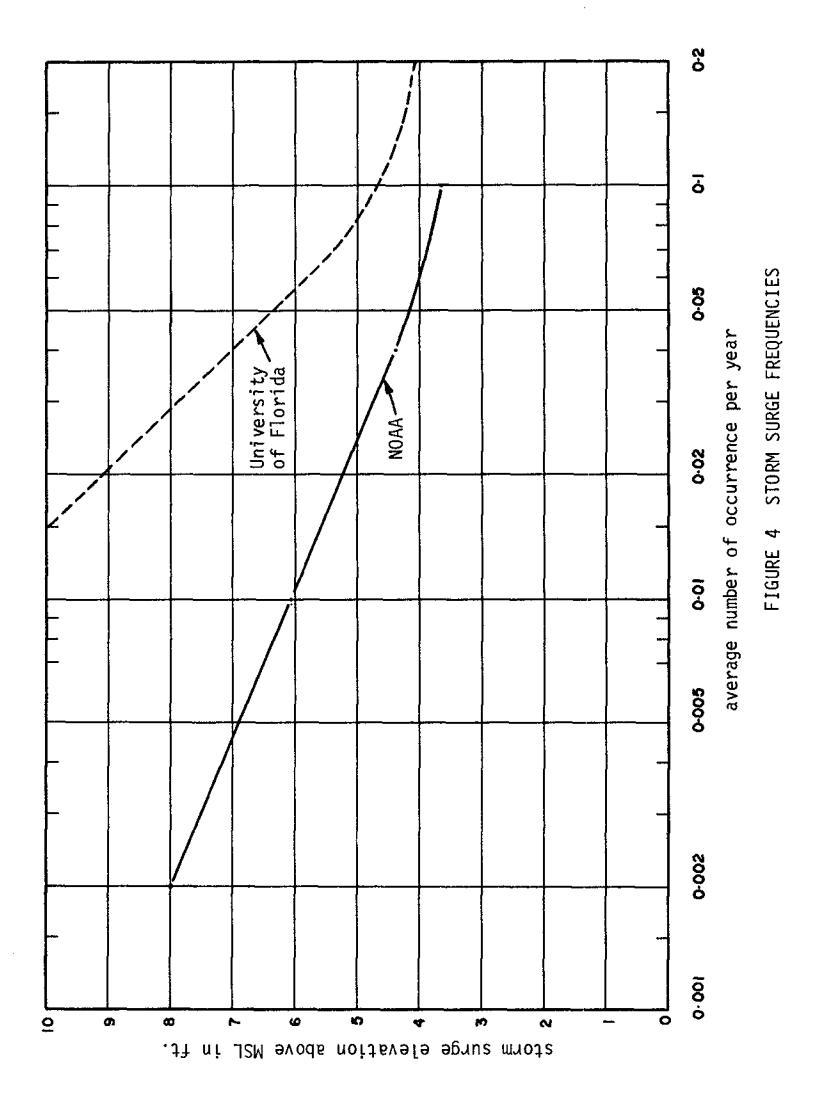
For comparison the interpolated surge elevation-frequency curve in the Univerversity of Florida's report is also shown in Figure 4 which indicates a much higher trend. In view of the documented<sup>3</sup> surge of 8.5 ft. (MSL) in St. Lucie River caused by the August 1949 hurricane, the curve with higher surge trend may prove to be valid, however, the newly compiled curve by NOAA was used for this study.

Storm surge is the vertical rise in the still water level near the coast caused by wind stresses on the water surface. No reliable records are available of water levels on the open coast during major hurricanes which have occurred in the past few decades. In a study of storm tides in Florida<sup>2</sup>, the Department of Coastal and Dceanographic Engineering, University of Florida has analyzed the normal yearly high tides and high water levels caused by hurricanes and expressed the results as frequency of occurrence for a certain water level to be equaled or exceeded. In that study, all available normal and storm tide data before 1959 along the coast of Florida were analyzed and correlated to provide the tidal level-frequency information for the open coast of Florida. Unfortunately there were a lack of data for the study area. Thus the interpolated storm surge frequencies given in that report may be less reliable than the new information furnished by National Oceanic and Atmospheric Administration (NOAA). For this reason, it is chosen to adopt the NOAA's information and frequency.

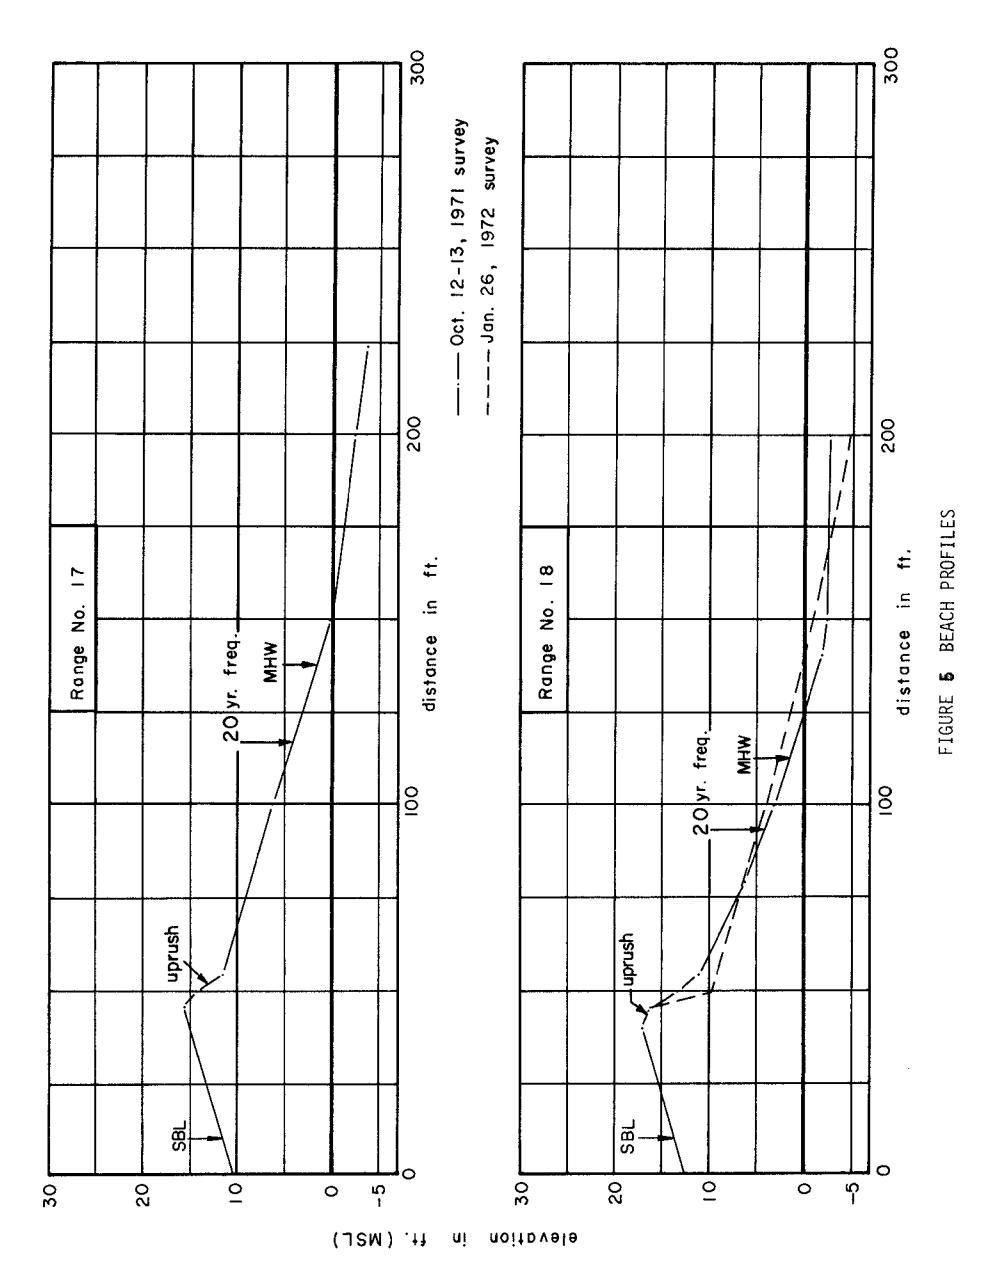
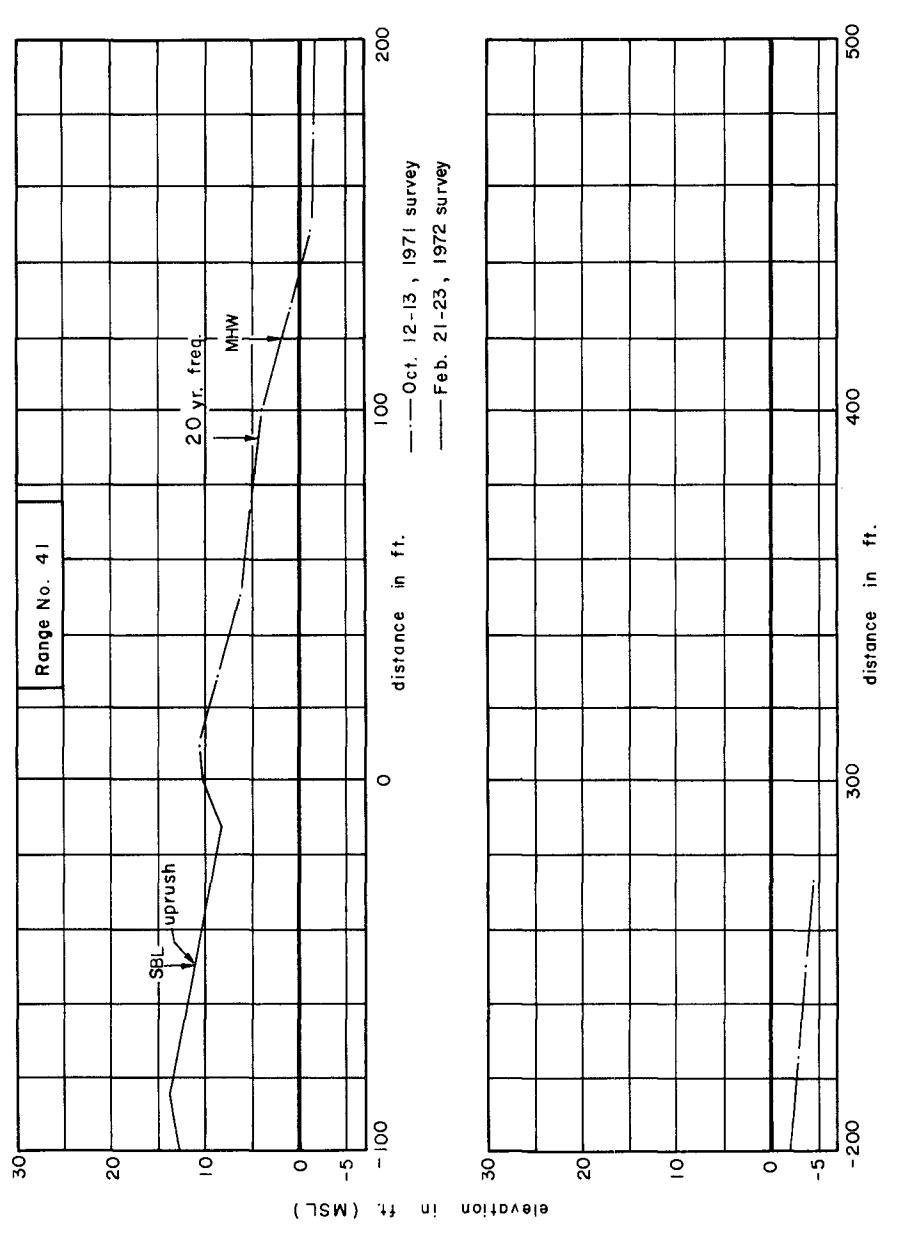
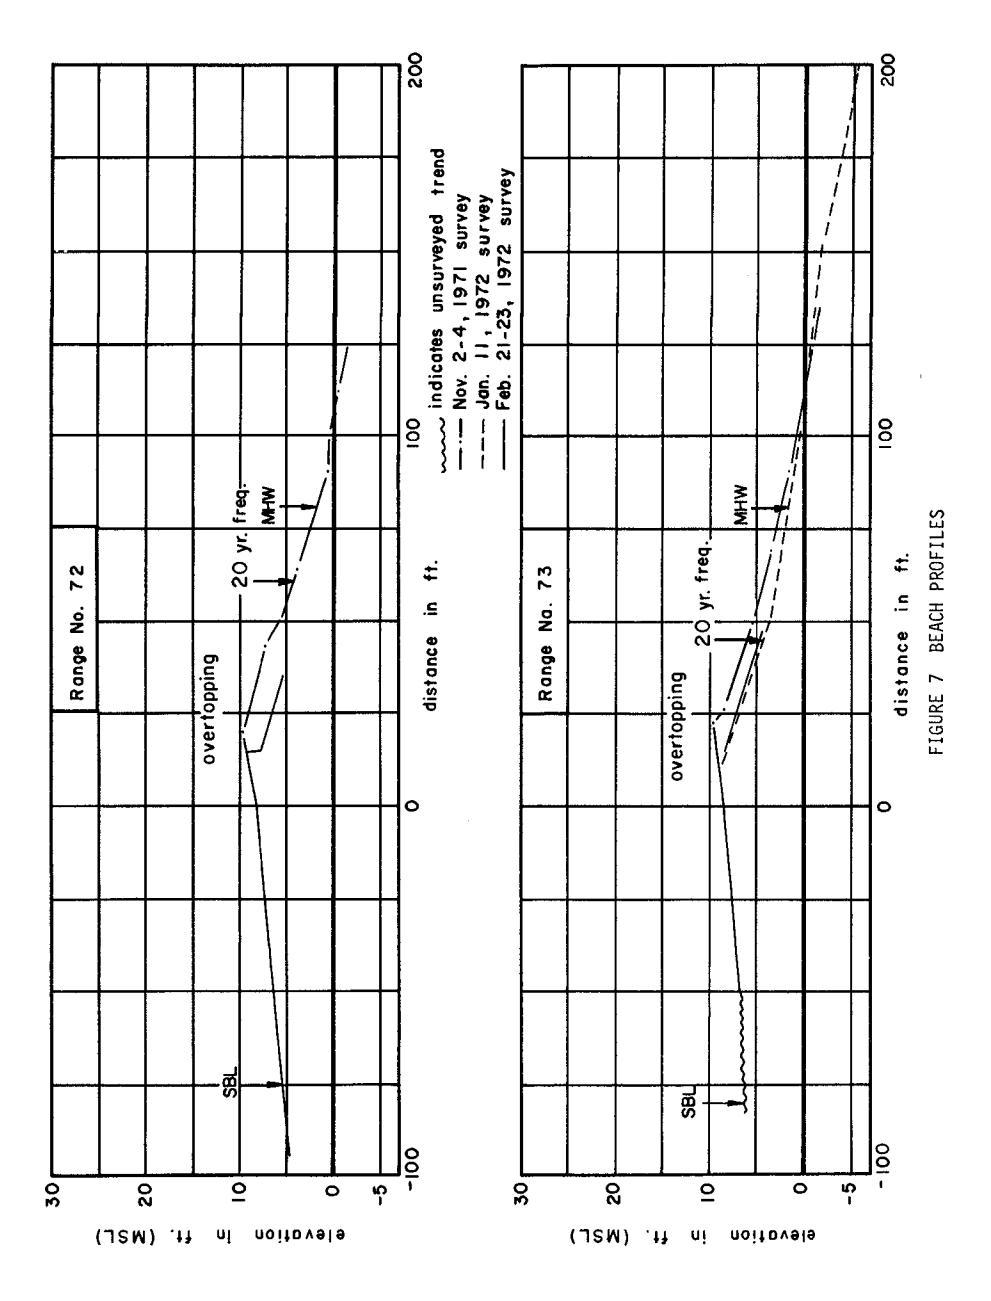
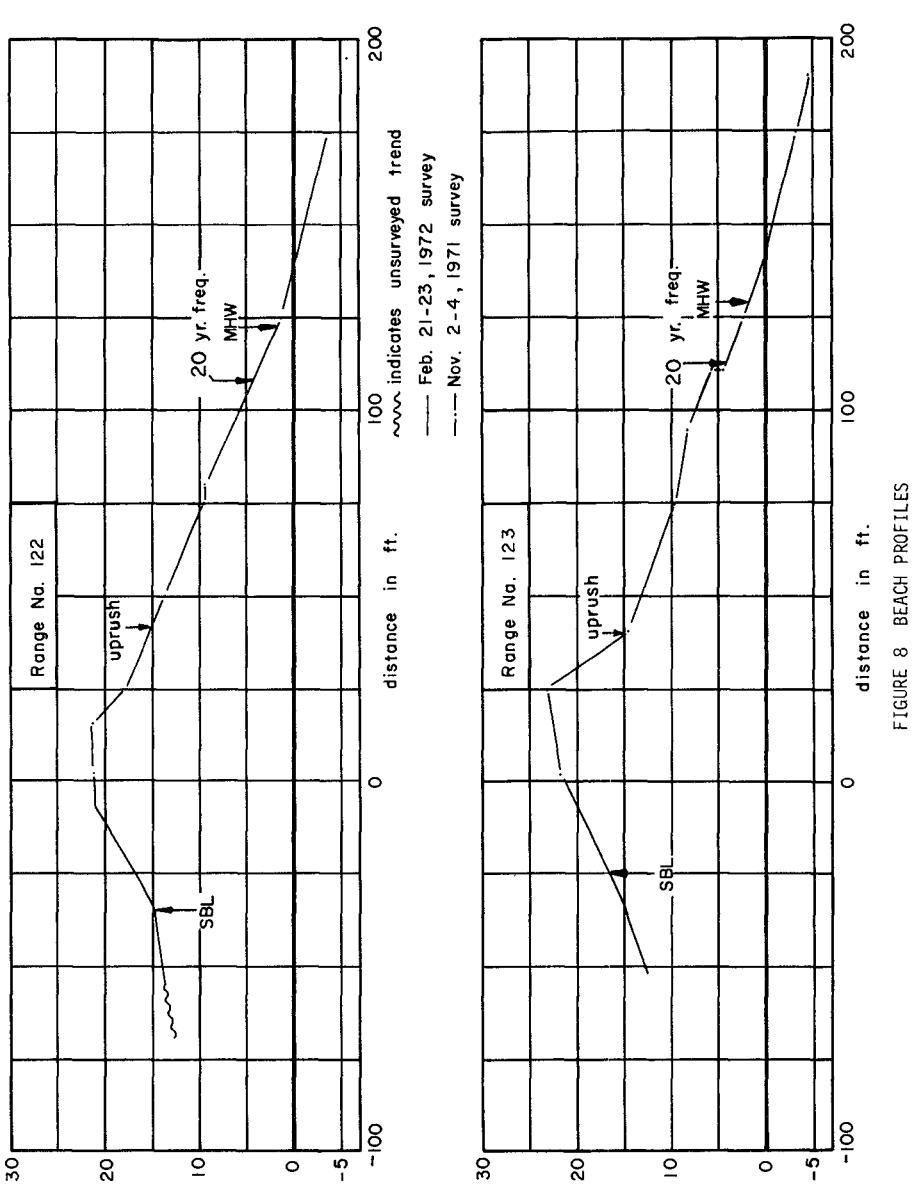
Figures 5 to 8 show some typical profiles with the setback line (SBL), surge level (20 year frequency, see V.1.), and computed wave uprush.

Using the above criteria, the uprush limits were plotted on the beach profile and aerial plans as a first approximation of the setback line.

A minimum distance of 40 ft. from the present dynamic beach face was used to provide for the extraordinary beach fluctuation. This distance was further adjusted to the annual erosion rate using a further setback of annual rate times 5 years.

A minimum distance of 25 ft. from the most seaward dune crest (if present) was used for protection of the dune system.
