CHAPTER 76

Rear Side Stability of Berm Breakwaters

O.H. Andersen¹, J. Juhl¹ and P. Sloth¹

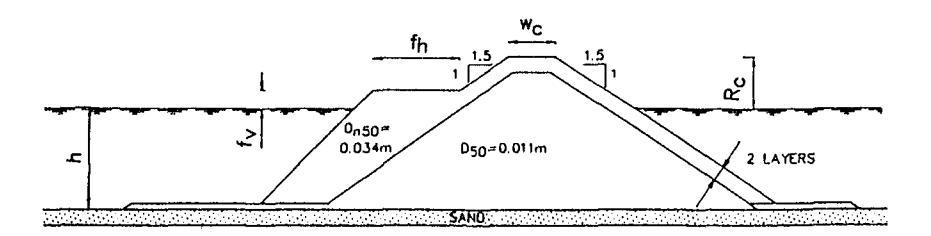
A wave flume with a length of 65 m and a width of 1.8 m was used for model testing in four water depths of 0.67 m, 0.77 m, 0.87 m and 0.97 m. The profile tested is shown in Figure 1. Crushed stones were used both for the core, $D_{50} = 0.011$ m (50% exceedance), and for the berm and armour layer, $D_{n50} = 0.034$ m. D_{n50} is the nominal diameter given as $(M_{50}/\rho_a)^{1/3}$, where M_{50} is the mass of the stones (50% exceedance) and ρ_a is the density of the stones. The grading of the berm and armour material equalled $D_{n85}/D_{n15} = 1.35$ and the relative density equalled $\Delta = 1.68$. The armour layer thickness on the crest and rear side was twice the value of D_{n50} . The model study covered variations in the following parameters:

- w_c , width of the crest, 0.175 m and 0.30 m
- R_c, freeboard of the crest, 0.20 m, 0.30 m and 0.40 m
- f_h , width of the berm, 0.45 m, 0.65 m, 0.85 m and 1.05 m
- f_v , freeboard of the berm, 0.10 m and 0.20 m.

Figure 1. Test profile.

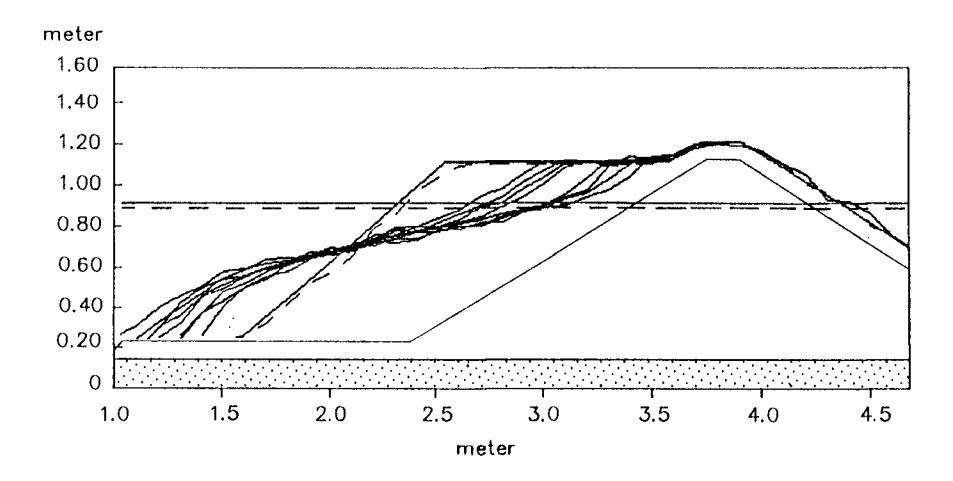
During the tests, it was observed that the developed sea side profile can be characterised as three slopes: an upper steep slope, a lower slope close to 1:4 or flatter and finally a steep slope intersecting the seabed, see Figure 2. This is a well known observation confirmed by several other researchers.

Figure 2. Example of development of sea side profile.

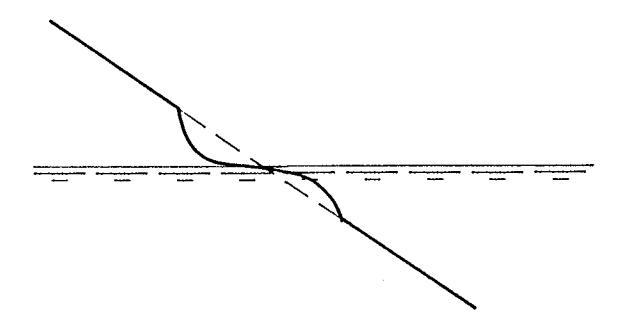
Rear side damage of a trunk section happens at almost fully developed sea side profile. A typical development is that a few stones just above still water level at the rear side are displaced downwards during a series of wave overtoppings (cf Figure 3), and after another few severe wave overtoppings, a settlement of the rear side armour layer occurs, possibly resulting in an exposure of the core.

Figure 3. Initiation of rear side damage.

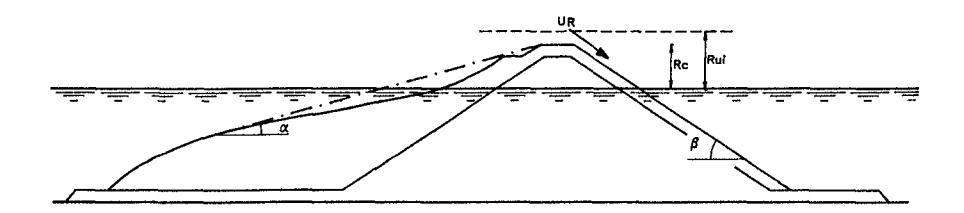
where R_{ui} is the run-up on a hypothetical slope of the sea side, with index i indicating a fraction of the waves. The hydraulic parameters are defined in Figure 4.

Figure 4. Definition of hydraulic parameters.

The effective sea side slope is for the present purpose defined as a straight line through the toe of the lower slope, where the influence of the breaking waves becomes significant, and up to the seaward face of the crest, cf Figure 4.

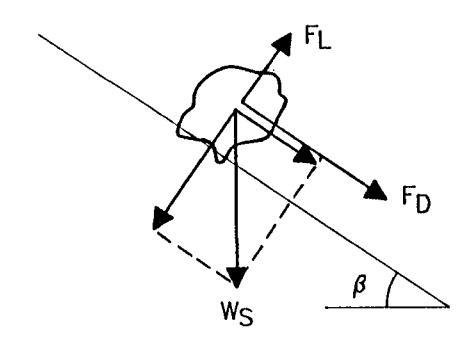
For the berm breakwater rear side, a traditional static stability criterion is applied. The stability of a single stone at still water level is expressed by a force balance parallel to the rear side slope, cf Figure 5:

where F_D is the drag force, F_L is the lift force, W_s is the submerged weight, and β is the rear side slope angle. The resistance against rolling and sliding μ can be found as $\mu = \tan \phi$, where ϕ is the natural angle of repose.

Figure 5. Forces acting on a single stone.

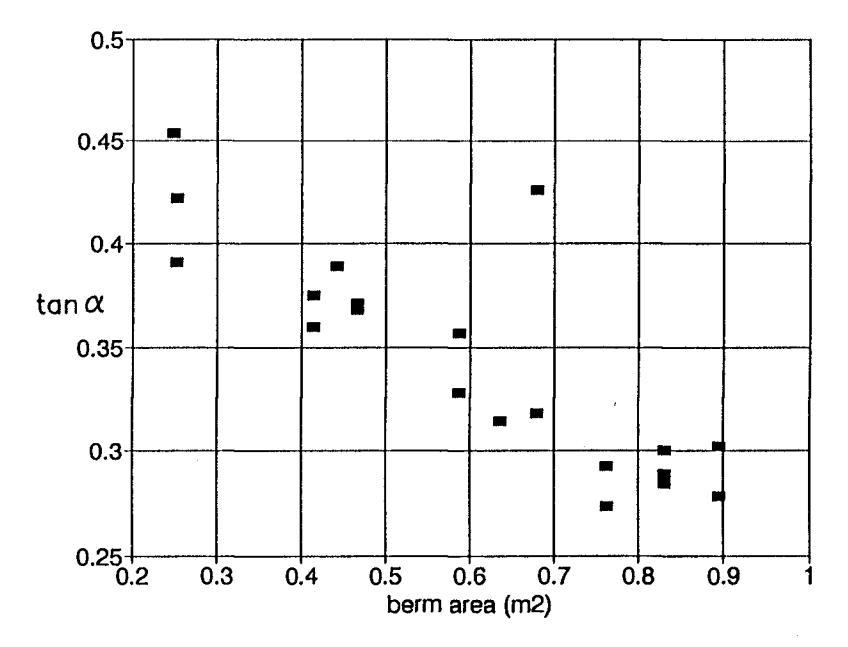
For the specific test programme, the effective sea side slope for the cases with rear side damage has been plotted against the berm area, cf Figure 6. It is observed that the effective sea side slope decreases with the berm area.

Figure 6. Effective sea side slope vs berm area for the cases with rear side damage.

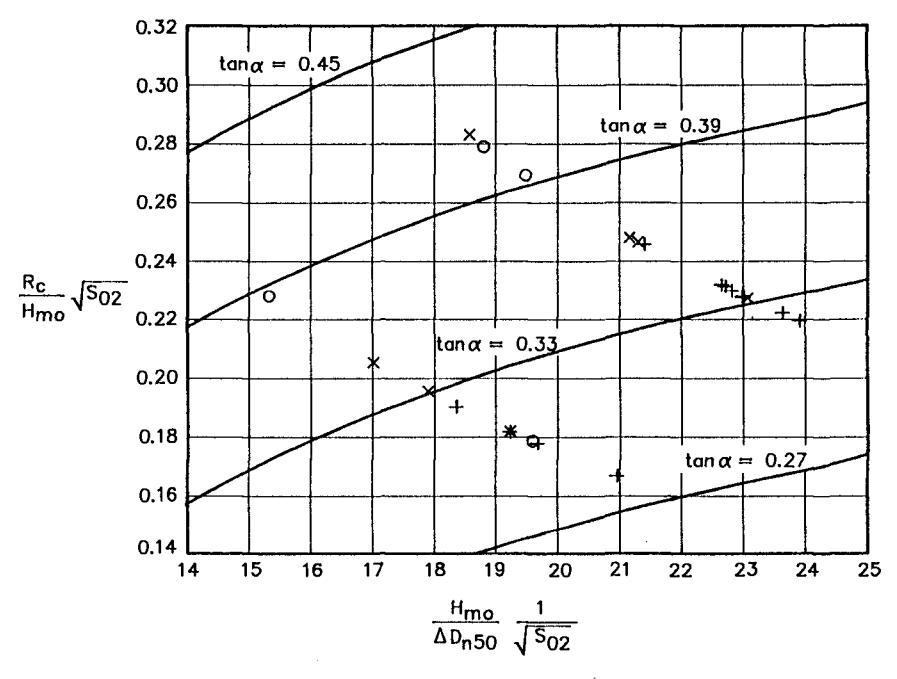
For the stone material applied, μ equals 0.9. For this value, the expression (10) has been calibrated to fit the observations. The best agreement was obtained with ($C_D + \mu C_L$) equal to 0.08. Four different curves representing tan $\alpha = 0.27$, 0.33, 0.39 and 0.45 respectively have been drawn in Figure 7. For all curves, the rear side slope equals the value of the actual test programme: tan $\beta = 1:1.5$.

Figure 7. Stability of rear side.Legend:Measurements: $+: 0.27 < tan\alpha < 0.33$,
 $x: 0.33 < tan\alpha < 0.39$,
 $o: 0.39 < tan\alpha < 0.45$ Full drawn curves show the stability criterion (10)

It is seen that a fairly good agreement between the measurements and the stability expression is obtained. The measurements show that $R_c/H_{mo}\sqrt{s_{02}}$ increases with $H_{mo}/\Delta D_{n50} / \sqrt{s_{02}}$, which again shows that in the stability expression (10) the tan α term as well as the term including $H_{mo}/\Delta D_{n50} / \sqrt{s_{o2}}$ are of importance.
