CHAPTER 191

EROSION AND OVERTOPPING OF A GRASS DIKE LARGE SCALE MODEL TESTS

G.M. Smith¹⁾, J.W.W. Seijffert²⁾ and J.W. van der Meer¹⁾

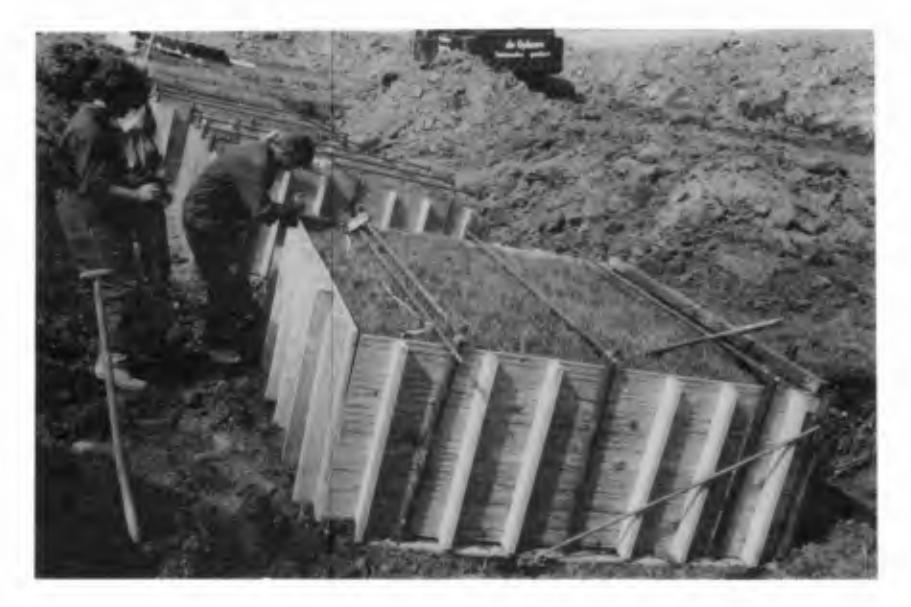
Photo 1 Excavation of sections from the dike

For this project a section of an existing sea dike was excavated and transported to DELFT HYDRAULICS. This was achieved by cutting a total of 16 blocks out of the grass and clay covering layer out of the dike. Each block measured 2.5 m x 2.5 m x 1 m thick (Photo 1).

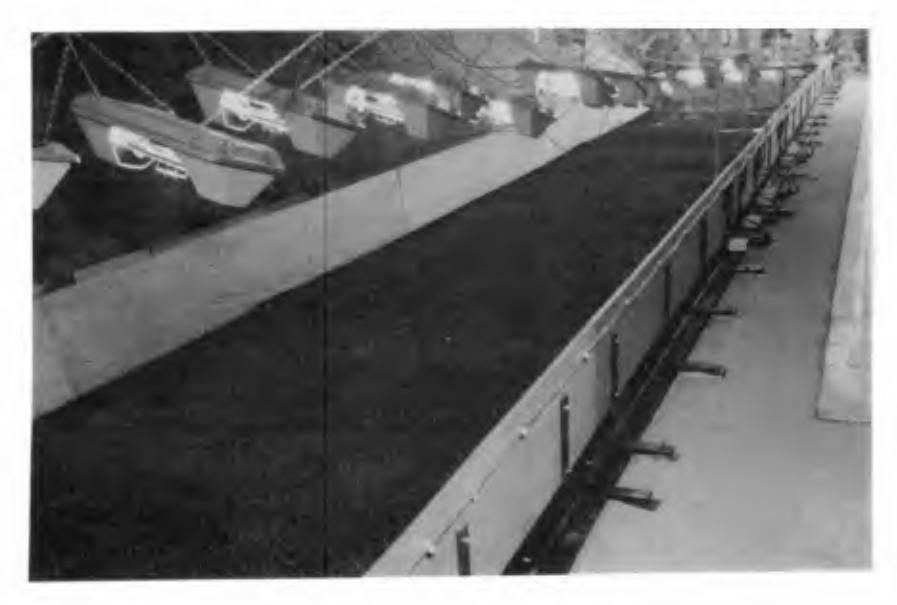
Photo 2 Dike in the Delta Flume prior to testing

The dike section was reconstructed in de Delta Flume and consisted of an outer slope (sea side) of 1:4, a 2 m wide crest at at height of 7 m above the flume bottom and an inner slope (land side) of 1:2.5 (see Figure 1 and Photo 2). The grass section of the dike was located in the centre 2.5 m of the flume, with 1.25 m wide concrete sections on either side. The inner slope consisted of grass from the crest down to an elevation of 3.5 m and below that of concrete to a height of 2.5 m. Behind this slope was the overtopping container, which had a capacity of 17 m³. The grass was placed only in the middle of the flume for three reasons:

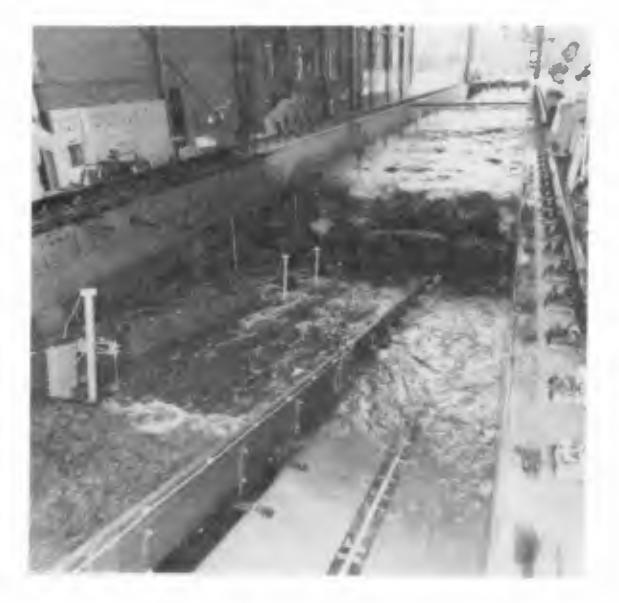
Photo 3 Erosion test 6: $H_S = 1.4 \text{ m}$, $T_P = 4.7 \text{ s}$

The sixth test was performed with irregular waves having $H_S = 1,4$ m and $T_P = 4.7$ s and a water level of 4.8 m (Photo 3). These are the conditions for a design storm along the northern Dutch coast. During the test the waves were interrupted several times for inspections and surveying of the grass surface. After 9 hours of wave attack a hole 0,75 m in diameter and 0,12 m deep was noted 1 m under the still water level (SWL). After 1 more hour of wave attack the hole was measured again and then again after a second hour. The hole had in that time grown to a diameter of 1 m and a depth of 0.15 m (Photo 4).

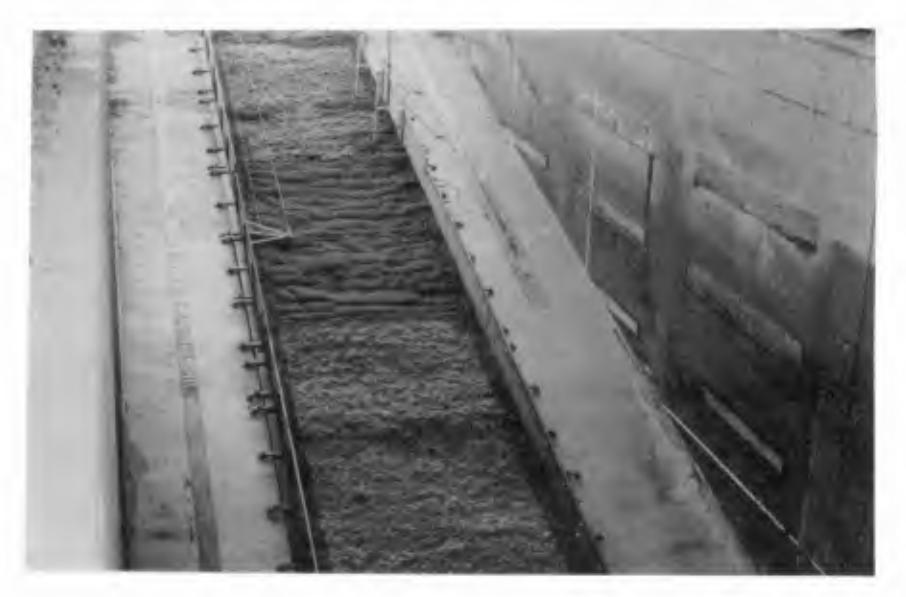
Photo 5 Condition after erosion test 7

The seventh erosion test was performed with small irregular waves ($H_S = 0.75 \text{ m}$; $T_P = 3.4 \text{ s}$) and a lower water level (3.5 m). This lower part of the slope had not been subjected to much wave loading and was considered to still be in the original condition. The purpose of this test was to obtain information over the influence of the wave height on the erosion rate. The test was carried out in the same manner as test number 6, except the inspections and surveys of the surface were made every 4 hours instead of every hour due to the slower erosion rate. After 20 hours of wave loading the test was stopped. No serious erosion had occurred (Photo 5).

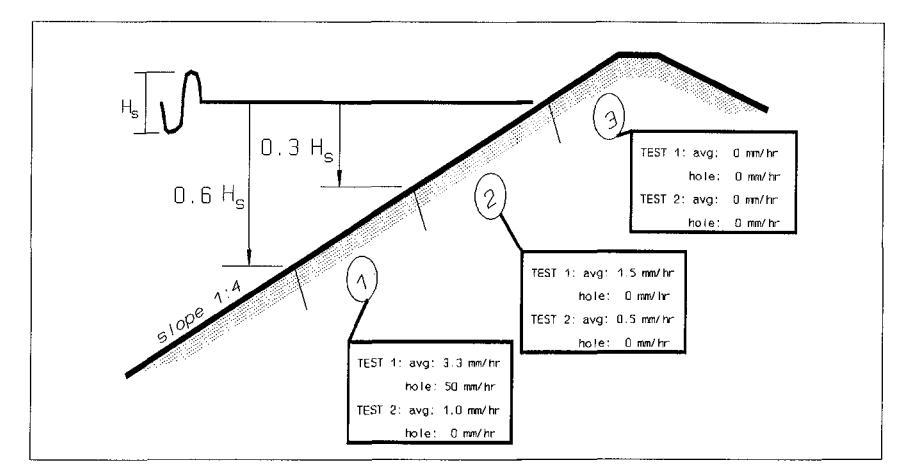
Figure 2 Defined erosion zones

The results of the erosion measurements of these two tests led to the definition of 3 erosion zones over the slope. The most erosion (both hole development and the highest average erosion rate) was concentrated to a depth of $(0.3H_S)$ to $(0.6H_S)$ under the SWL. This is defined as zone 1 (see Figure 2). Between the SWL and a depth of $0.3H_S$ (zone 2), the average erosion rate was half of that in the first zone.

No hole development occurred in this second zone. In the third zone, above the SWL, practically no erosion was noted.

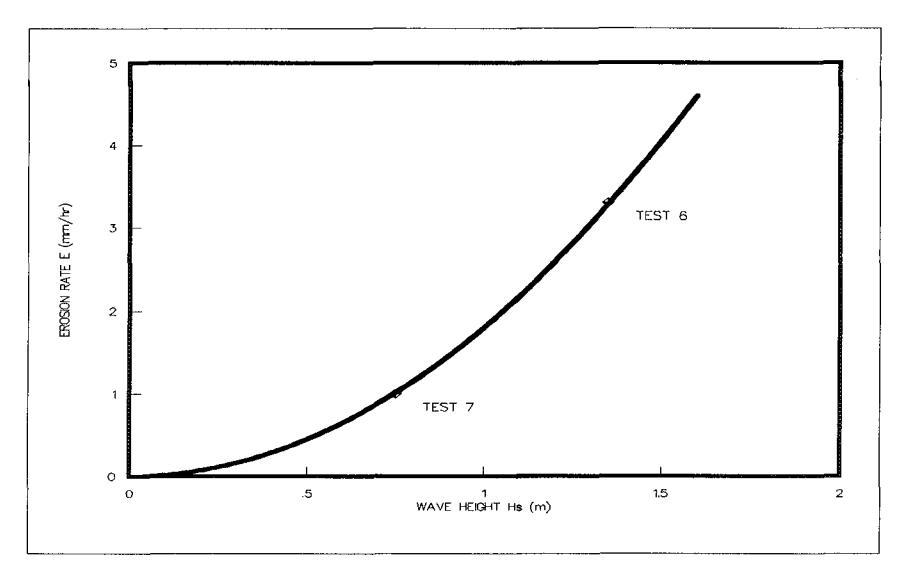
Figure 3 Erosion rate (E) as function of H_S

The results showed clearly that the strength of this particular grass dike lay in the root network which was between 5 and 10 cm thick. It was also noted that the average erosion rate was proportional to about the square of the significant wave height (see Figure 3).

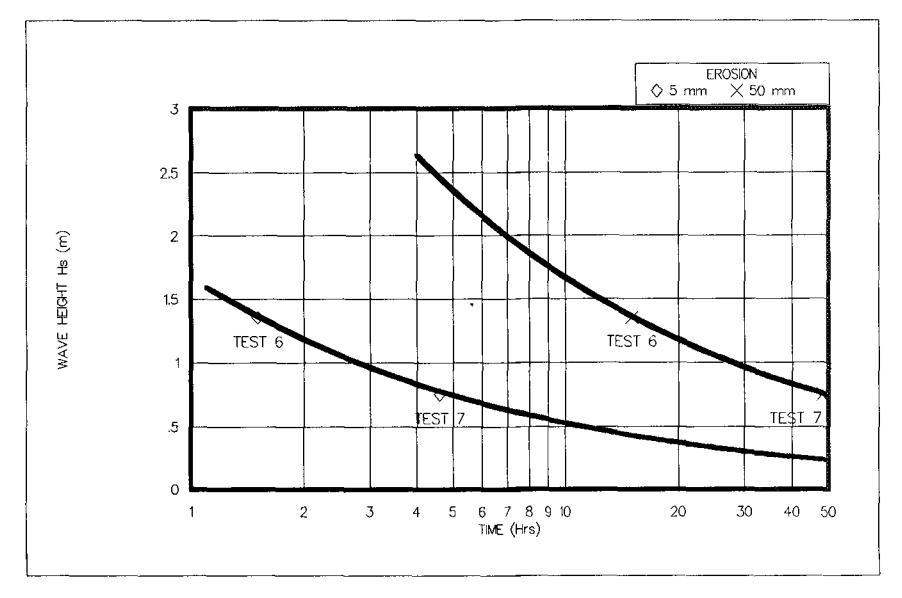
Figure 4 Loading duration for erosion of d = 5 mm and d = 50 mm

Based on these measurements a preliminary model has been developed which allows one to estimate the maximum allowable duration of continuous wave loading before a certain depth of erosion is achieved (Meijer and Verheij, 1994). An example is given in Figure 4 wherein lines of 5 mm and 50 mm erosion are shown. Of course, based on only two tests, this model is very limited. However, more tests have recently been performed with other wave heights on a wide range of different vegetation and subsoil characteristics and it is meant to expand the model with the new information.

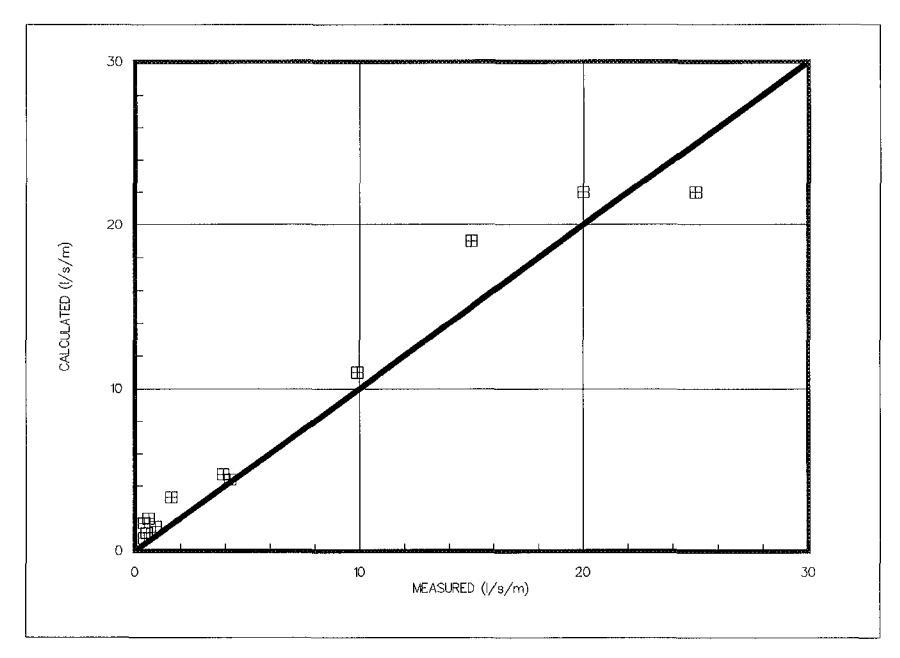
Figure 5 Measured and calculated average overtopping discharges

Figure 5 shows that for the higher overtopping rates the measured data points compare favourably to the predicted values.

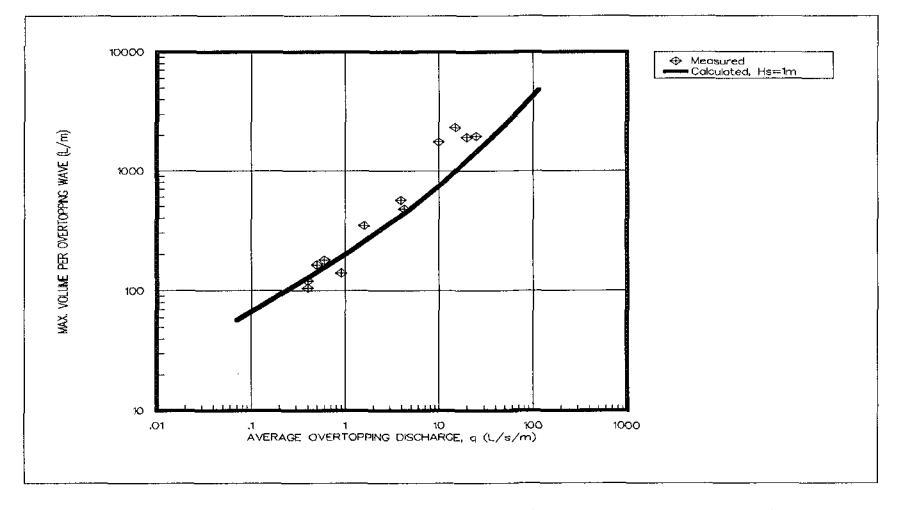
Figure 6 Maximum overtopping volume in a single wave as a function of the average overtopping discharge

The relation between the maximum volume in one wave and the average overtopping discharge is shown in Figure 6. In this figure the calculated line is based on a wave height of 1 m. The data points are for differing wave conditions. For average discharges of less than 10 l/s/m the wave heights were all approximately 1 m. For the higher rates the wave heights were approximately 1.5 m, which is why the data points fall above the calculated line.

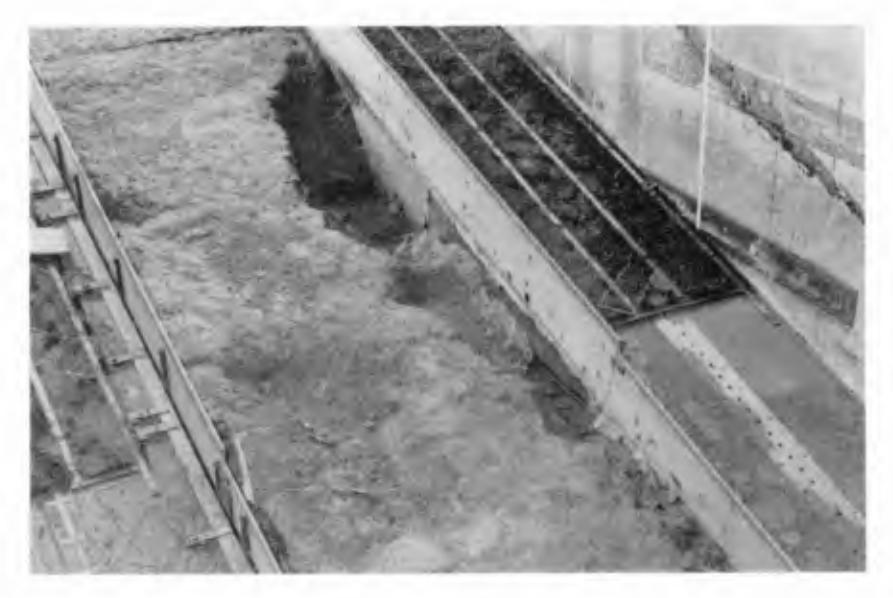
Photo 6 Condtion after residual strength test

After 4 hours of wave loading an under water inspection of the slope was carried out. It was noted that a large hole 0.4 m deep had appeared just under the still water line, along the edge of the grass/clay section of the dike. After 1 more hour of loading this hole had expanded to the full depth of the clay layer and the test was stopped. Photo 6 shows the results.

The growth of this hole must most likely be attributed to edge-effect and these results cannot be interpreted as the behaviour of a pure clay surface. This can be considered representative, however, for a dike with a transition from grass to a "hard" cover layer such as asphalt or a block revetment. Based on these measurements, the residual strength would be (conservatively) estimated at 5 hours.

Measurements of other sections of the surface that were not disturbed by this hole can be used to get an indication of the erosion rate of the clay. These measurements showed 0.25 m erosion over the 5 hours of testing or 0.05 m/hr This compares extremely well with the results from erosion tests 6 and 7: the erosion rate, which can be compared to that for hole development, as well as the location of the erosion agreed with the values for zone 1. This value leads to an estimation of the residual strength as being 16 hours. Based on these two results the residual strength of this 0.8 m thick clay layer is estimated to be about 10 hours.
