COASTAL DEFENCE STRUCTURES IN NSW, AUSTRALIA

S.J. Wyllie, Section Engineer, Manly Hydraulics Laboratory¹ D.B. Lord, Consultant Engineer, Manly Hydraulics Laboratory¹ I.F.W. Jayewardene, Consultant Engineer, Manly Hydraulics Laboratory¹ T. Young, Department of Land and Water Conservation²

ABSTRACT - 100 Years of Experience In a High Energy Wave Climate This paper uses the examples of Coffs Harbour breakwaters and the training wall head on the Richmond River at Ballina to outline some of the developments in coastal engineering design and construction over the last century. Most of the 63 major structures along the New South Wales (NSW) coastline are similar. Recent developments in data collection and analysis as well as the evolution of physical modelling techniques used for coastal structure design at the NSW Department of Public Works and Services' Manly Hydraulics Laboratory (MHL) are discussed using these two projects. The use of computational models in conjunction with physical models and the introduction of new variables such as wave obliquity and groupiness into breakwater design are discussed. The need to evaluate the performance of artificial units such as Accropodes, conc

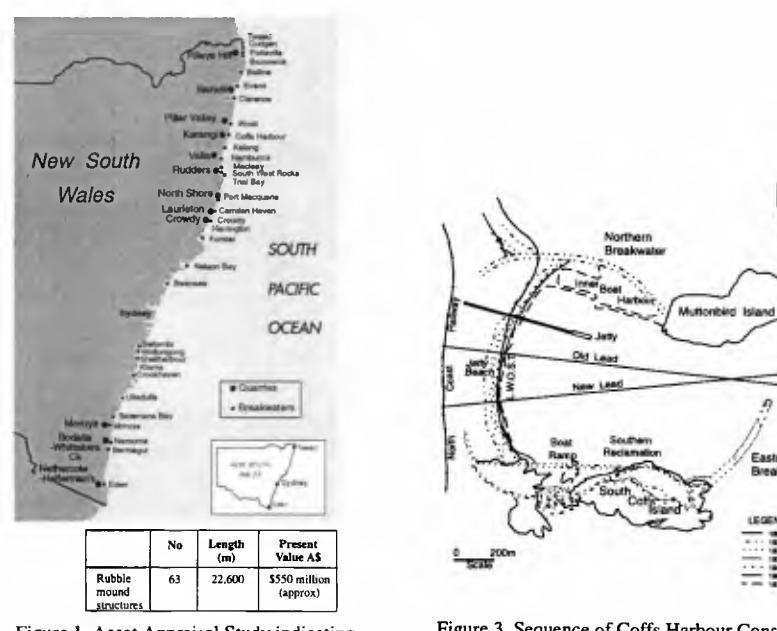
Figure 1 Asset Appraisal Study indicating Location of Rubble Mound Structures on the NSW Coast (MHL648)

The NSW Government recently undertook an asset appraisal of breakwaters and river entrance training walls, including aspects on the history of design, construction and performance over a period of nearly 100 years. A total of 63 structures which are 22,600 m in length (Figure 1) were appraised. The figure also shows the location of 12 rock quarries from which armour was obtained for construction. The study (MHL648 1993) placed the value of the structures at \$550 million.

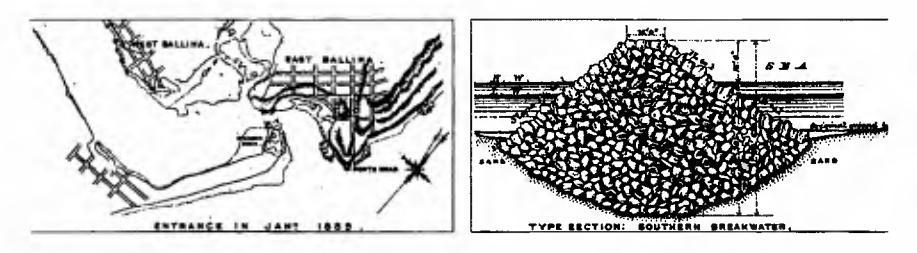
Figure 2 Sketches of the Richmond River Entrance Southern Breakwater Structure (Burrows 1904-05) (Coltheart 1997)

A plan to train the entrance was drawn up by the Chief Engineer of Public Works, Sir John Coode. In 1889 the entrance was completely blocked by natural sand shoals so that produce had to be carted overland to the Clarence River to the south. Work on the entrance training was commenced that year comprising internal training walls and the southern breakwater. Figure 2 shows a design cross-section developed and presented for the Richmond River breakwaters. The design consisted essentially of the placement of a pile of rocks to form the structure, as shown on this original design drawing.

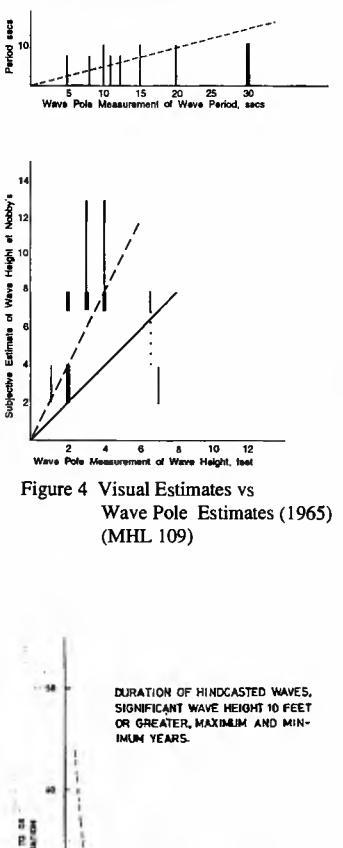
COMPARISON OF WAVE HEIGHT AND PERIOD REPORTED BY NOBBYS SIGNAL STATION, AND MEASURED OFF WAVE POLE BY NEWCASTLE DISTRICT OFFICE

An example of continuous wave data recording prior to the use of data buoys is obtained from wave pole records as reported by White (MHL109 1966) taken half a mile from the coast at Nobbys Head, Newcastle in 1965 (Figure 4). A significant step in wave data analysis on the NSW coastline was taken when wave hindcasts were calculated for Port Kembla for the years 1950 to 1964 by Stone and Foster (MHL109 1966). The results of these analyses are indicated in Figure 5 and compare well with present day hindcast wave data. Long-term continuous offshore wave measurements were begun in Sydney in 1974 and have continued since, using a network of seven wave data buoys. Increased accuracy in extreme wave height (Goda et al 1988) and storm duration (Sobey 1997) analysis are of interest to the coastal engineer. Analysis techniques have been developed over the last three decades to make maximum use of short time series. The relevance of long-term wave measurement is seen in the variations obtained for the 100-year wave height for Port Kembla (Figure 6). Presently, MHL measures wave height and directions using a number of methods such as a network of wave data buoys (Kulmar 1995). These include a directional buoy in Sydney (Figure 6); radar imagery; aerial photography; electromagnetic current meters; hindcasting and satellite imagery. Whilst the data buoy network is a

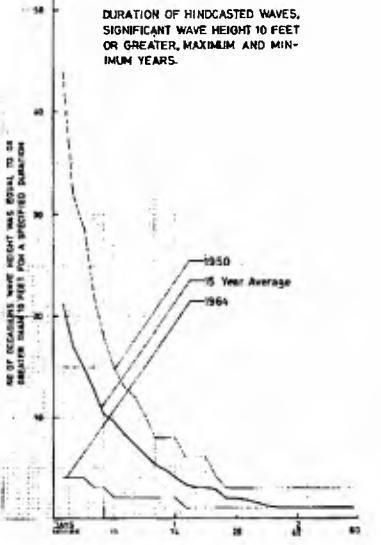
Figure 5 Return Periods for Hindcast Waves (1965) (MHL109)

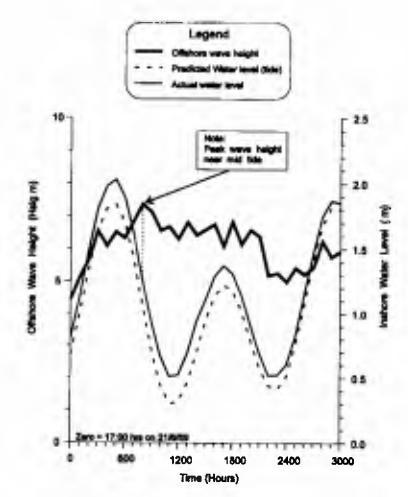
Figure 7 Coffs Harbour Water Level and Offshore Wave Height Data) (May 1997 Storm) (MHL914)

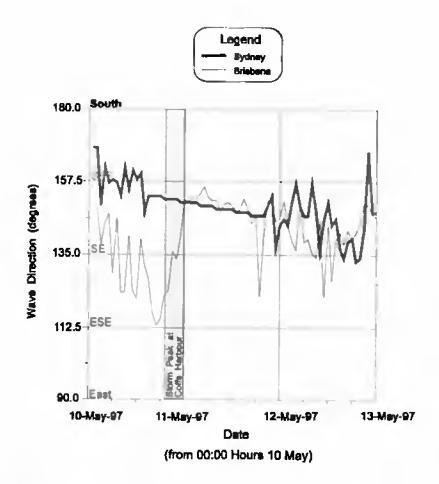
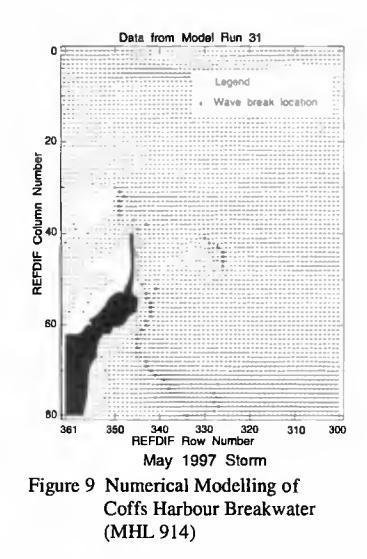
Figure 8 Coffs Harbour Offshore Wave Direction Data (May 1997 Storm) (MHL914)

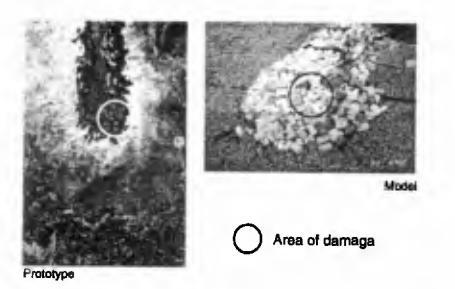
Figure 10 Replicating May 1997 Storm Damage in a Physical Model

Hindcast wave data was used to obtain the deep water design wave for the 1966 model (MHL 109 1966). Extreme wave analysis was carried out to obtain design wave data for the 1998 model (MHL 914 1997). Regular waves were used in the early model whereas long crested irregular waves were used in the more recent model. Irregular waves have been used in physical models since the late 1970s and the advantages over regular wave modelling are well documented in the literature (Graveson 1974). In the mid-1980s the importance of wave grouping in harbour layout and the importance of correct reproduction of these groups particularly for ship movement investigations was established (Sand 1983, Bowers 1988). This is probably the reason for the observation made at the conclusion of the 1966 study that "Reproduction of the surge motion by detailed observation of the prototype were not successful in the model" (MHL110 1966). Accurate wave height (Figure 7) and wave direction (Figure 8) data during the May 1997 storm in conjunction with numerical modelling (Figure 9) aided in establishing that relatively long period waves (15-17s) of relatively low return period (1-2 year) resulted in the damage of the head. This damage was reproduced accurately in the physical model (Figure 10).
