## THE RECONSTRUCTION OF THE NETHERLAND DIKES AFTER THE STORM OF FEBRUARY 1953 J. B. Schijf

Rijkswaterstaat, The Hague, Netherlands

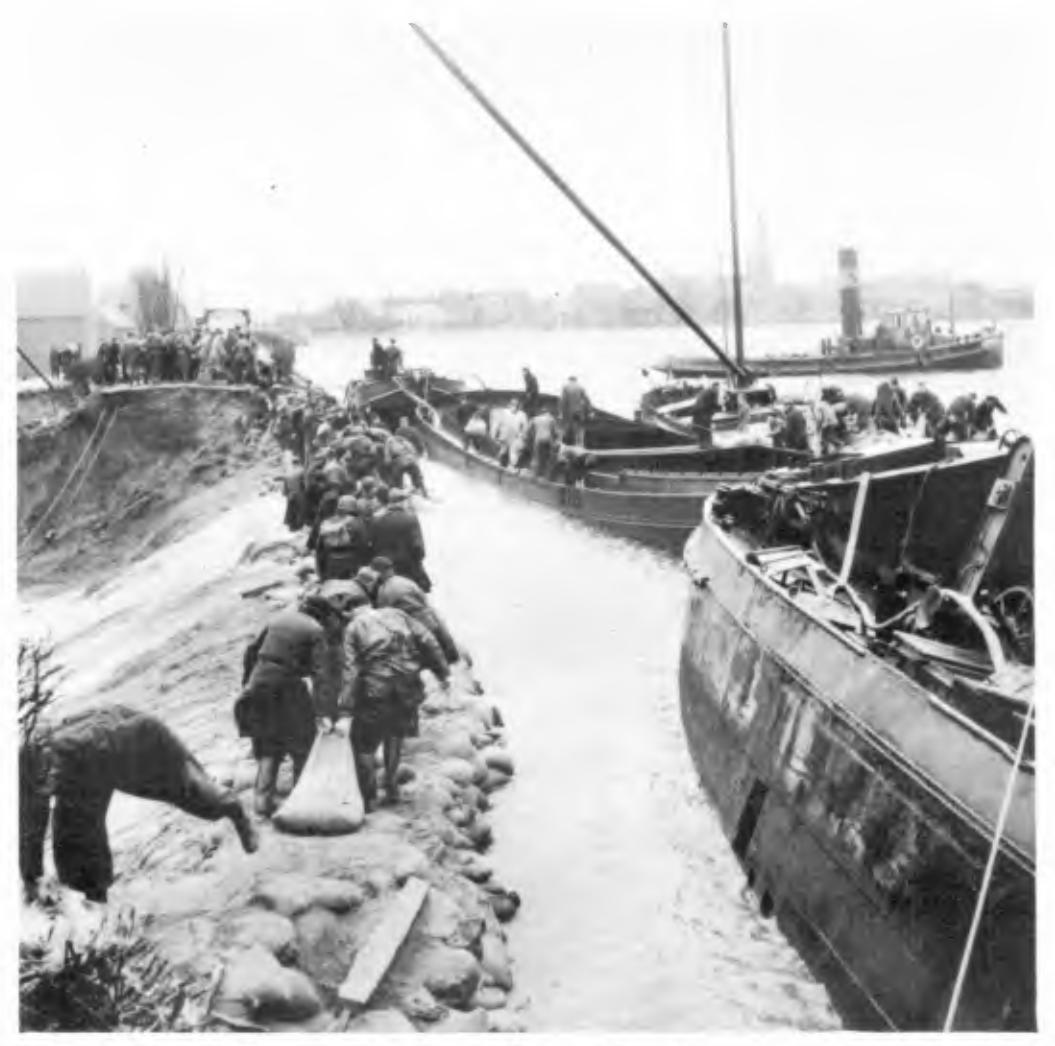
Fig. 1. Placing sandbags.

were used. They were transported by land, by water and by air to the danger spots. Not only sandbags were used, but also the stones from the revetment of neighboring dikes, the paving from the streets and many other improvised materials. Fig. 1 serves to give an impression of this activity.

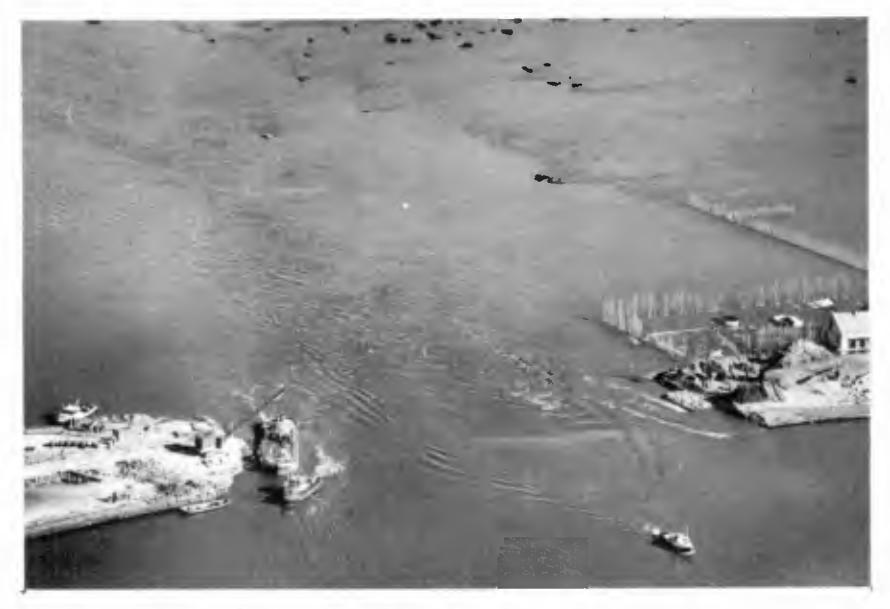
Fig. 5. Breach at Oudenhoorn.

A week after the gale, the breach of Oudenhoorn had a width of about 70 m and a depth of  $5\frac{1}{2}$  m below mean sea level (Fig. 5). At that depth a layer of fairly resistant olay was encountered which for the time being prevented further erosion. At first the area flooded by this breach was 37 sq. km, but by repairing some inland embankments itwas soon possible to reduce the area to 26 sq. km. The terrain was on the average situated slightly above mean sea-level. The tidal volume was about 10 million m<sup>3</sup>, which caused maximum velocities in the gap of about 3 m /sec. Fig. 2 shows a few typical tidal curves and the velocity curve in the gap. These curves represent a neap tide. At spring tide the tidal differences and the velocities are higher.

For closing the breach two concrete ships were at hand, which had been used as floating tanks. They had a length of 25 m each and by combining the two by means of steel girders and sheets, a unit could be obtained of 51 m length, 5.8 m in width and 5.6 m in height. At both ends a steel scaffolding was erected supporting steel sheet piles which could be dropped by removing a ratchet. This construction was christened, "guillotine".

In the time needed to lash together the two hulls and to equip this unit with the guillotine and other necessities, the bottom of the gap was raised by brush mattersses and stone to 4.4 m below mean sealevel. The top of the pontoon (5.6 m high) therefore reached to 1.2 m above mean sea-level; that is, the top was slightly above mean high water. The ends of the dike at both sides of the gap were more or less trimmed by stone.

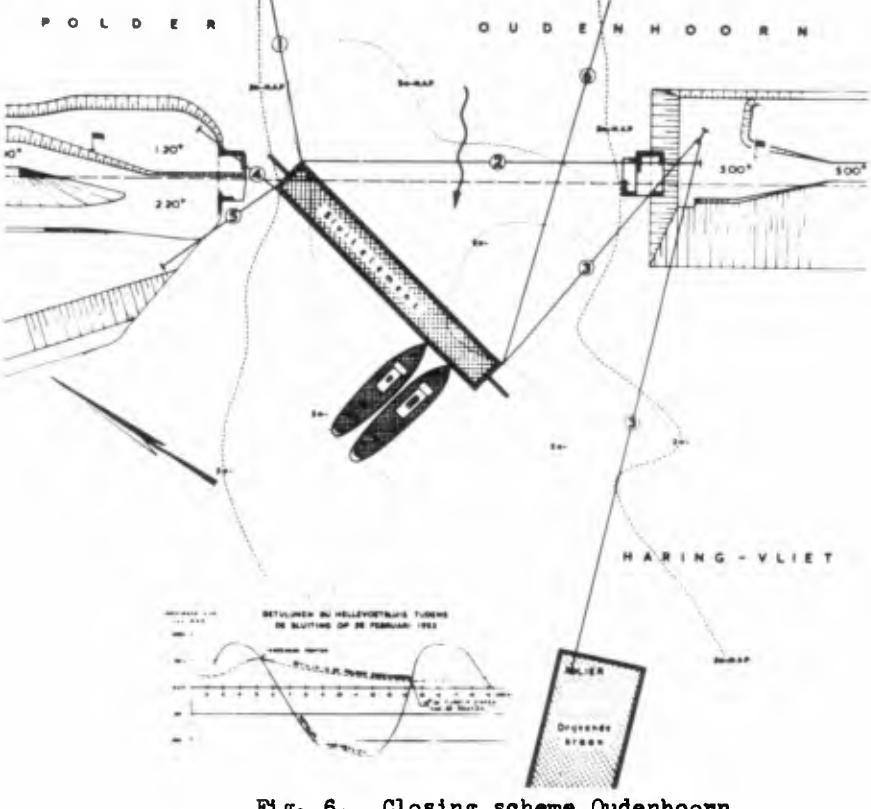
Closing scheme Oudenhoorn. Fig. 6.

Experiments had been carried out in the hydraulic laboratory from which the method shown in Fig. 6 was chosen. The pontoon was moored beforehand at one end by means of cables 1, 4, and 5. The actual maneuvering into position was effected mainly by cable 3, controlled by a winch of a floating crane at anchor. Cables 2 and 6, as well as 1, served only for emergency purposes.

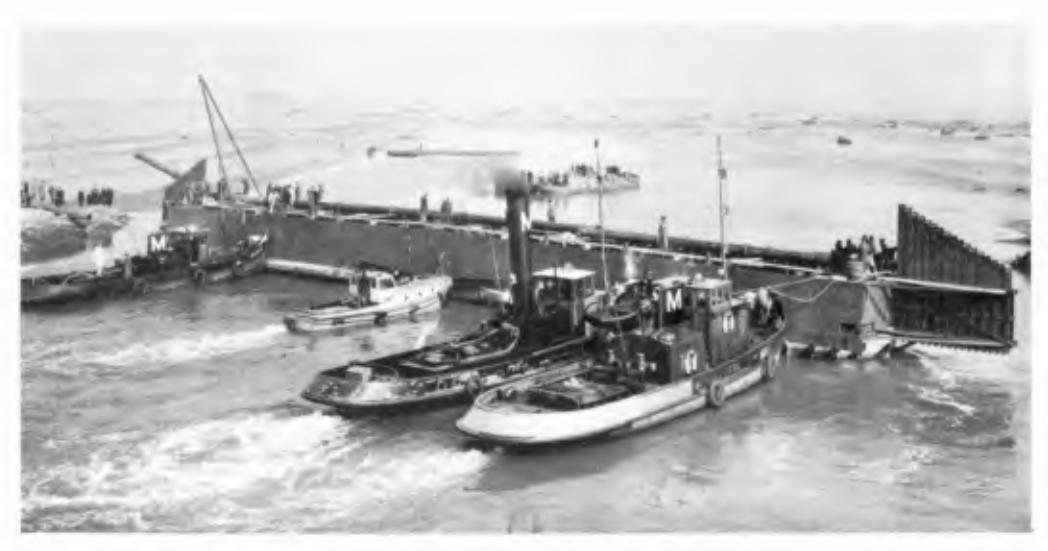
Fig. 7. Pontoon under way.

As soon as the ebb flow had slackened sufficiently, the operation was started. There was a slight delay because the pontoon touched bottom on a protruding edge of a fascine mattress which had not sunk properly. As the tide was rising during the operation, the pontoon floated free just in time. It was maneuvered exactly into position and sunk within a few minutes (Fig. 7).

This however was by no means the end of the operation. The pontoon with its equipment had a weight of about 700 tons. As can be seen from the tidal curve, the water was rising rather rapidly at the moment of closing and very soon at high water the pontoon would have to withstand a head of say 3/4 m, that is to say a horizontal pressure of some 200 tons. Moreover the outward pressure at low water would be nearly twice as much. As from previous experience and from special experiments it was established that the friction coefficient of a concrete pontoon on a bed of dumped stone is about 1 : 3, the total weight had to be brought within a few hours to at least 1200 tons. This was done by pumping sand onto the hulls, for which purpose a pipeline was laid on the pontoon, ready to be connected to a pipeline along the dike immediately after sinking. At the same time stones were dumped between the ends of the pontoon and the dike ends, and both in front of and behind the pontoon, to be followed later by clay in order to seal off the leaks left by the imperfect fitting of the concrete pontoon on the rough bed.

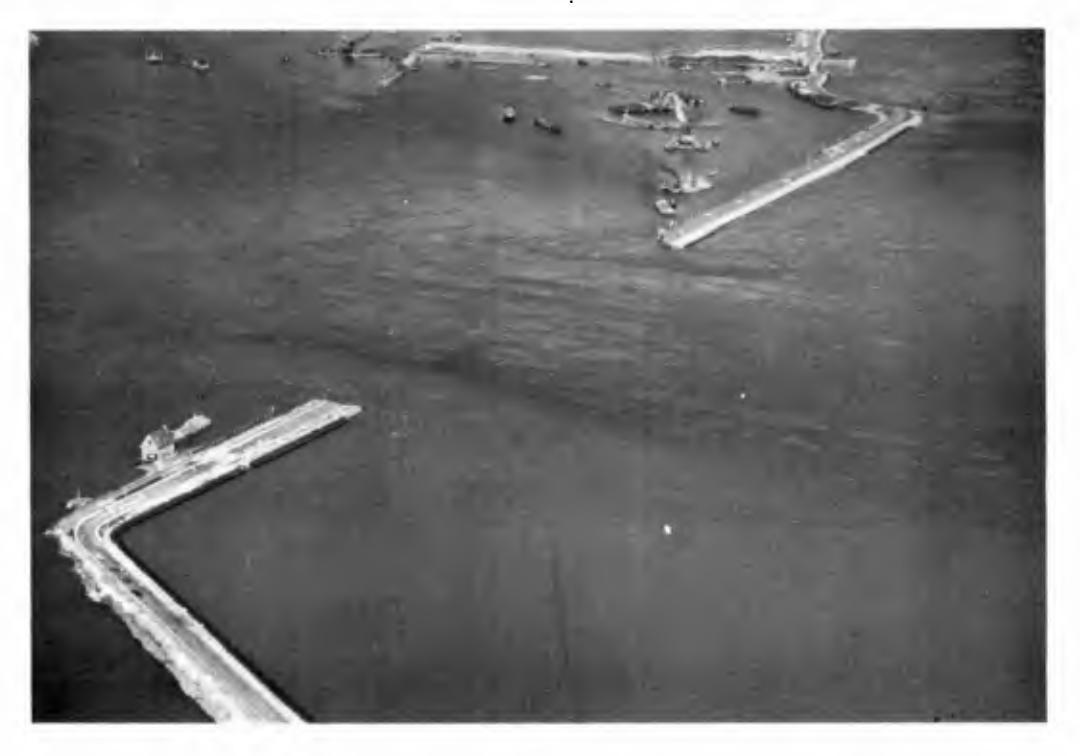
### Fig. 9. Breach Sohelphoek at high water.

The largest and most difficult breach was that of Schelphoek on the island of Schouwen (Fig. 9). At the time of the first survey it was 300 m wide and the greatest depth was 30 m (Fig. 8). Later it grew to a width of more than 500 m with a maximum depth of 35 m. Gullies, developing into large tidal creeks, were eating their way inland at a rate of 300 to 400 m per week (compare Figs.10 and 11). The tidal volume was, after some time, between 120 and 150 million cubic meters, with a maximum flow of some 14,000 cubic meters per sec, which is more than the maximum discharge of the Rhine. A picture of the tidal motion is shown in Fig. 3.

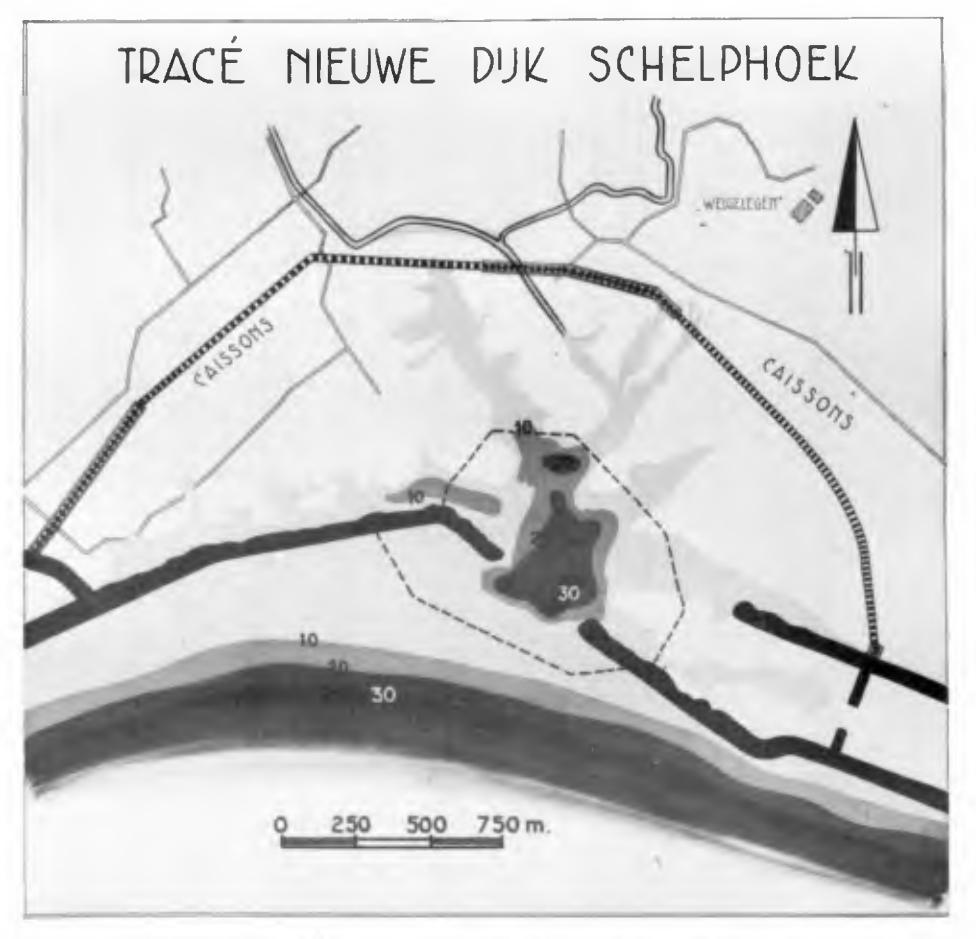
Fig. 12. Alignment of embankment at Schelphoek.

to encircle the breach by a high crest overflow dam. Calculation showed that its length should have to be about 3 km. In the center, just opposite the breach, was the village of Serooskerke, at a distance of nearly  $l \neq km$ . This was situated slightly higher than the general level of the terrain, which varied between 1 and  $l \pm m$  below mean sea level. As the higher ground around the village did not contribute materially to the flow to and from the breach, and in order to keep the village inland of the embankment, this was fixed at a short distance in front of the village at about 1 km from the gap. From there an alignment was projected, ourving gradually to the dike at both sides of the breach (Fig. 12). The embankment was to join the dikes at locations which for practical reasons offered suitable positions for floating pumping stations delivering sand for the embankment by means of pipelines. On the higher ground in front of Serooskerke the embankment was built immediately to above the high-tide level by hydraulic fill, using a subtion dredger with floating pipeline, pumping sand between clay mounds built with olay from the site by clam shell dredges. The same was done for a short distance from the dikes at both sides of the breach in order to create starting

points for the construction of the final embankment. Both east and west of the village in this way there remained some 1500 m, making 3000 m altogether for the overflow crest, and the total length of the embankment was to be 4 km.

progressing, two of the gullies eroded their way inland beyond the projected alignment of the dam. One of them eroded at such a rate in the northwesterly direction that a shifting of the alignment of the dam in order to keep ahead of it was out of the question. Therefore, the project had to be revised in the following way. The embankment was to cross the gullies in a suitable place. The bottom and sides of the gullies were to be covered by fascine mattresses in order to prevent further deepening and widening at the sites of the crossings. Before starting to place pontoons on the brushwood strip the gullies were to be closed by means of concrete pontoons.

As this revision of the project entailed an increase in the amount of fascine work and therefore prolonged the time needed for this part of the project, it was decided meanwhile to extend the embankment at full height at the two extreme ends of the alignment. This was made possible from a hydraulic point of view because the cross-sections of the gullies were added to the total **cross**-section area available for the flow. Accordingly the length of the high crest dam could be safely diminished to 900 m at the west side and 1100 m at the east side of Serooskerke.

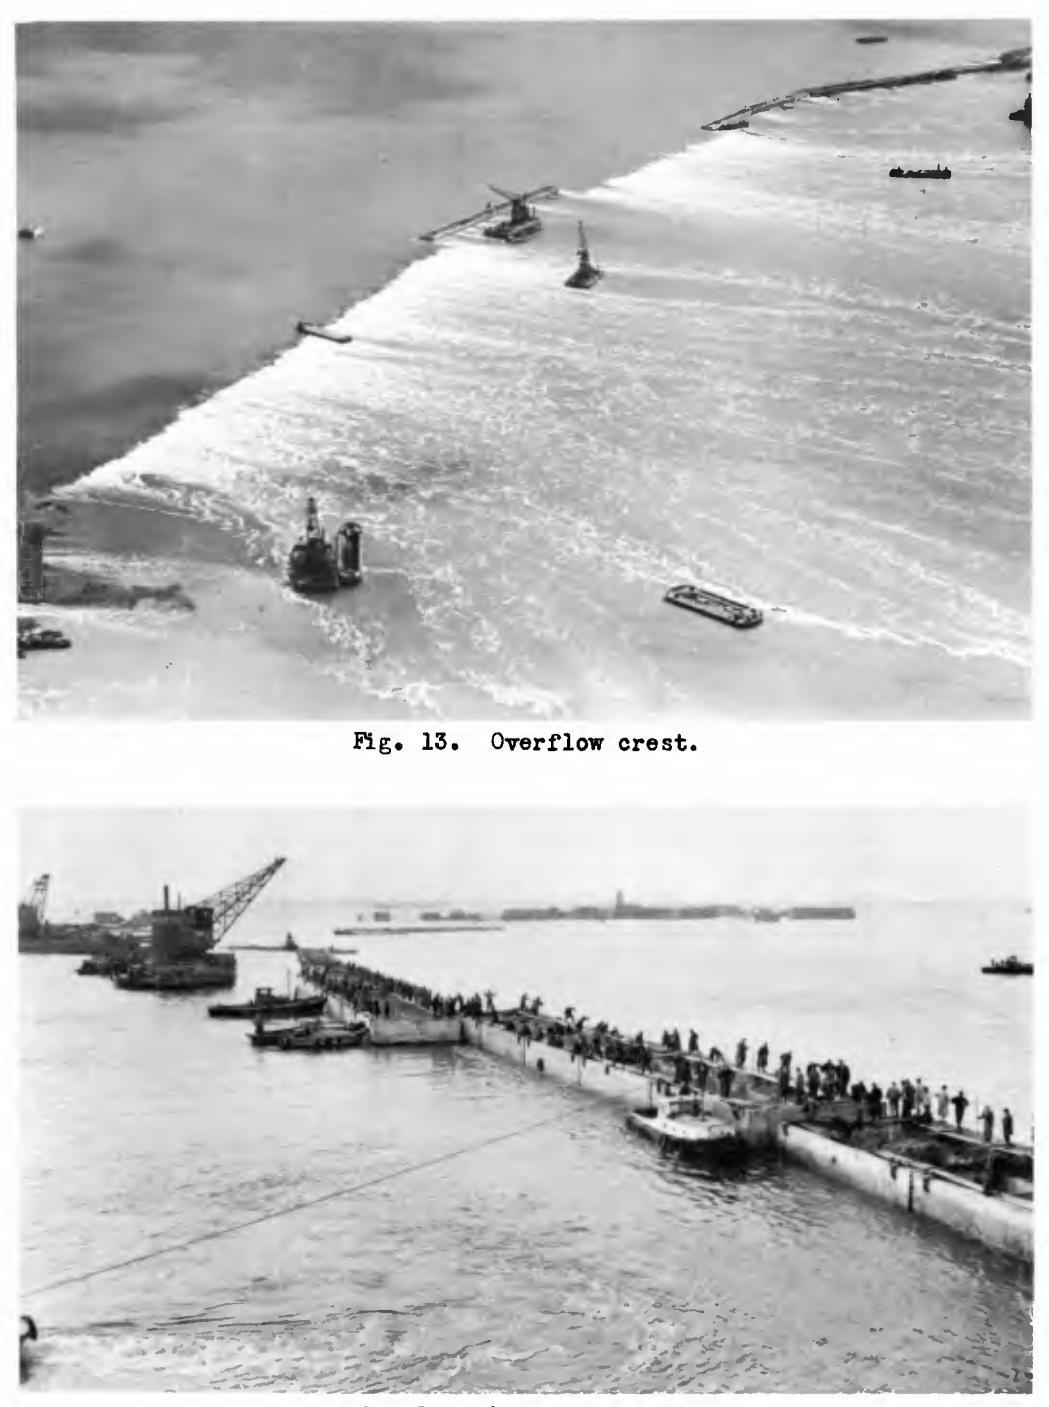
Fig. 14. Closing east gap.

Two days later a pontoon was placed in the east gully. Although this was a smaller pontoon, the operation was difficult because it had to be carried out at the slack tide near high water as the depth at low water was insufficient. The time available was very short, and on this occasion the pontoon had to be held by cables and eased-off with the decreasing flood current instead of pulled against the last ebb flow. However, once again all went well and the most dangerous part of the closing of the Schelphoek breach was past.

Then followed a time of feverish activity in consolidating the position of the two pontoons and sealing the gaps, left below and at the sides, with stone, clay and ultimately sand. At the same time the two stretches of the alignment on the terrain were closed by means of a large number of smaller pontoons (2 to 3 m high) mostly operated in strings of 4 to 6 (Fig. 14). By the end of September the entire ring was closed, although it still took much labor and care to seal all leaks and to convert the slender line of rather flimsy concrete boxes into an embankment capable of withstanding the winter gales. By that time the hope of also closing the breach itself before winter had been given up. It had been planned to use for that purpose 4 or 5 of the big Phoenix pontoons, but as it turned out they were needed at another place. This was the breach at Ouwerkerk, the last one to be closed and the last one we will discuss.

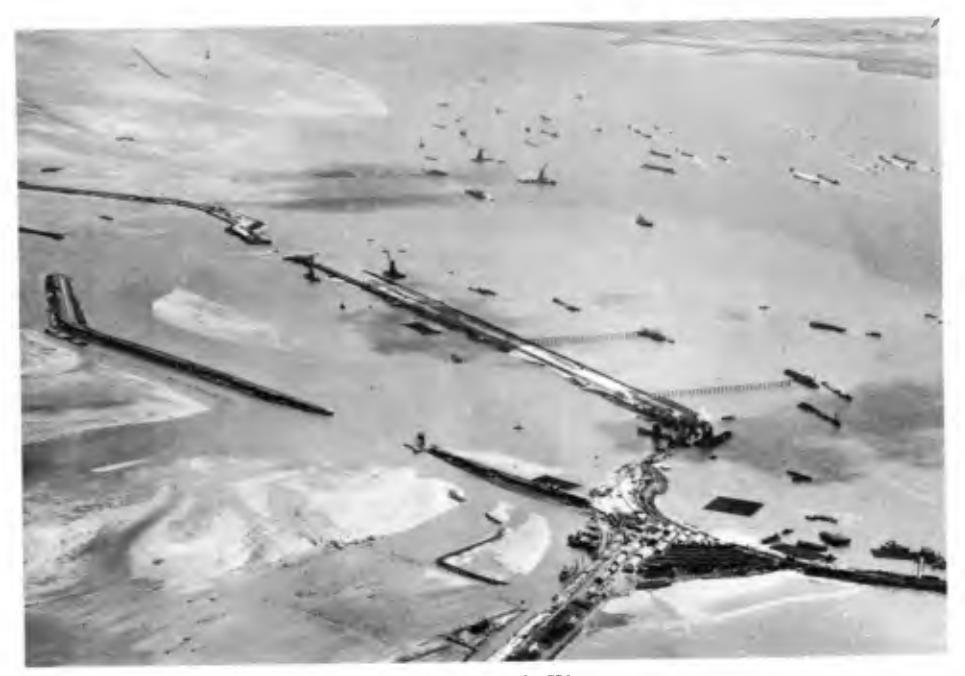
Fig. 16. General View.

In that case there would have been left a 400 m<sup>3</sup> gap with maximum velocities of  $5\frac{1}{2}$  or 6 m/sec. There was no other possibility but to try to consolidate the barrier in the west gap first. This was eventually done by means of additional pontoons, stone, clay and finally sand. But meanwhile the flow through the east gap increased to 5 m/sec and in a few days the bed protection together with the abutment pontoons became a shambles. Every thought of using this gap as a site for a closing operation by pontoons had to be abandoned. Fig. 16 shows a general view of the situation at this stage.

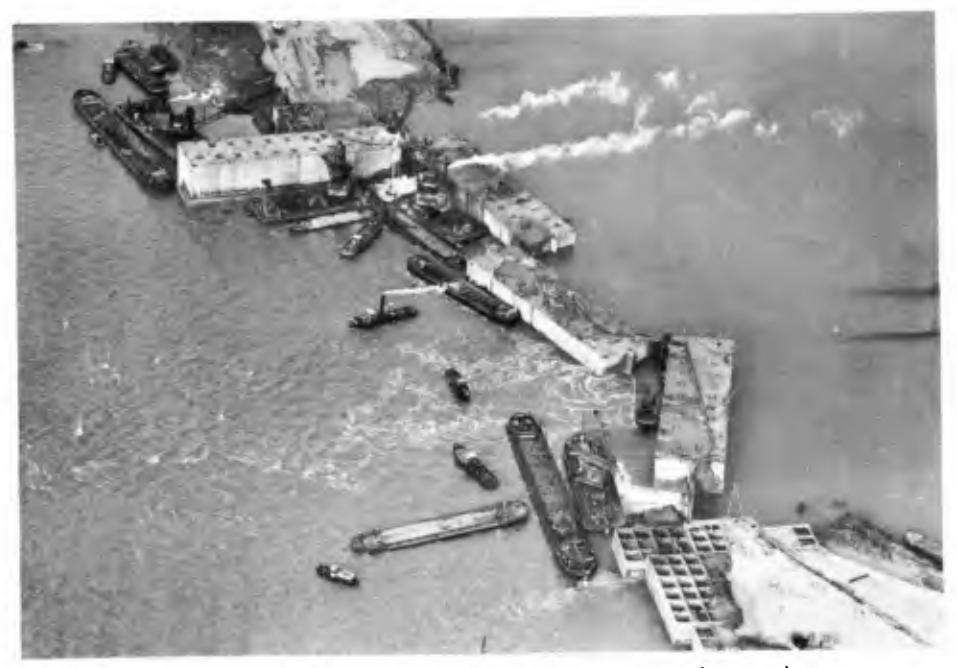
Fig. 17. East gap closed with four Phoenix pontoons.

After careful survey of the new state of affairs by sounding, gauge-reading and flow measuring, an entirely new scheme was eventually developed. This consisted in preparing a new site for placing a pontoon barrier just outside the breach in the old dike. Four Phoenix AX pontoons were to be sunk on a bed of brushwood mattresses and stone at 10 to 15 m depth. As the enclosure dam at Schelphoek by this time was fairly well consolidated, it was possible to concentrate a larger portion of the equipment and manpower on Ouwerkerk. Favored by the exceptionally fair autumn weather, the work proceeded practically without incident so that in the night of 6 to 7 November the last pontoon could be placed according to schedule (Fig. 17).

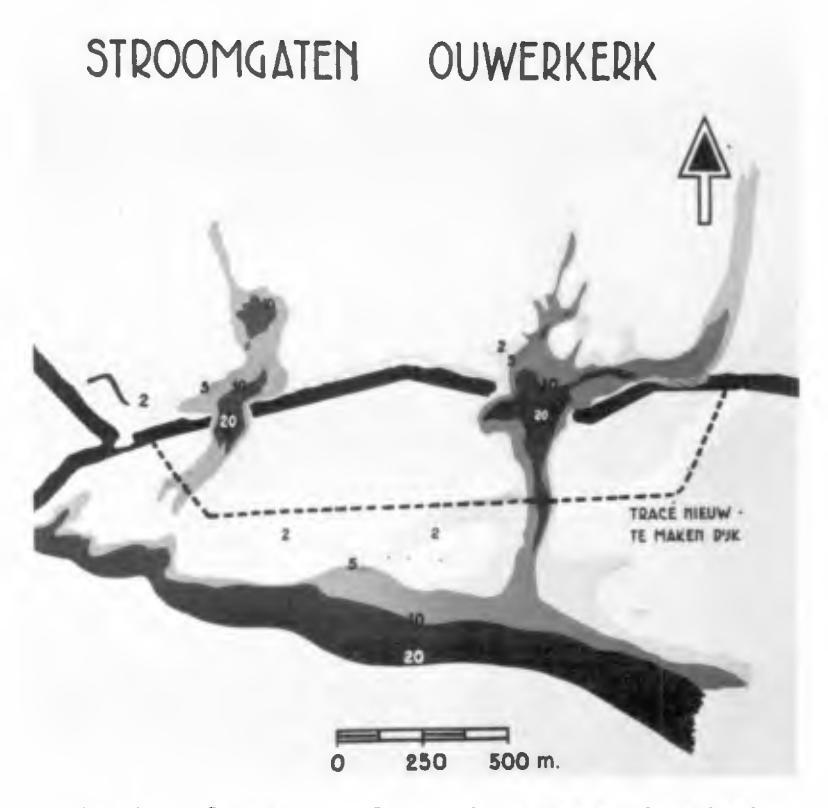
Fig. 15. Scheme for closing breaches at Ouwerkerk.

In front of the dike at Ouwerkerk there was a shallow shelf or foreland several hundred meters wide. As the dike between and adjoining the gaps was badly damaged also, it was decided to construct a new dike in front of the old one over a length of 2.2 km (Fig. 15). Starting from the breaches in the dike, gullies had been scoured out both in the polder and through the foreland. It was decided to build the parts of the dike on the higher stretches of the foreland first and to leave the gullies for the final closing. Of course the bottom and sides of the gullies were protected first with brushwood mattresses.

The area served by the two gaps was  $27 \text{ m}^2$  with a tidal volume of about 40 million m<sup>3</sup>. It was calculated that a total area of the two final gaps of  $1200 \text{ m}^2$ ,  $800 \text{ m}^2$ east and  $400 \text{ m}^2$  west, would be sufficient to keep the maximum velocities below the limit of  $3\frac{1}{2}$  m/sec. Both gaps were to be closed by means of concrete pontoons assembled from standard units on two successive days in a week of neap tides.
