CHAPTER 117

Monitoring hydraulic loads on the Eastern Scheldt Storm Surge Barrier

Leo Klatter¹, Jan Konter² and Tom Jongeling³

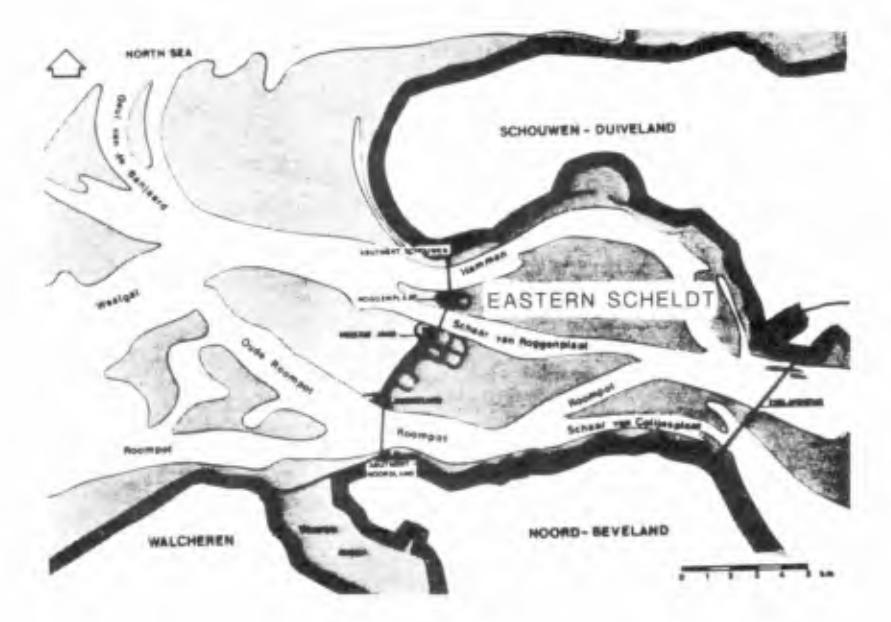
Figure 1: Location of the Eastern Scheldt Barrier

The Eastern Scheldt Barrier is located in the mouth of the Eastern Scheldt and is built across the three main channels; Hammen and Schaar both one kilometer wide and Roompot two kilometers wide (See figure 1). The barrier consists of 62 basic sections. Such a basic section is 45 m wide and is built up as following (See figure 2):

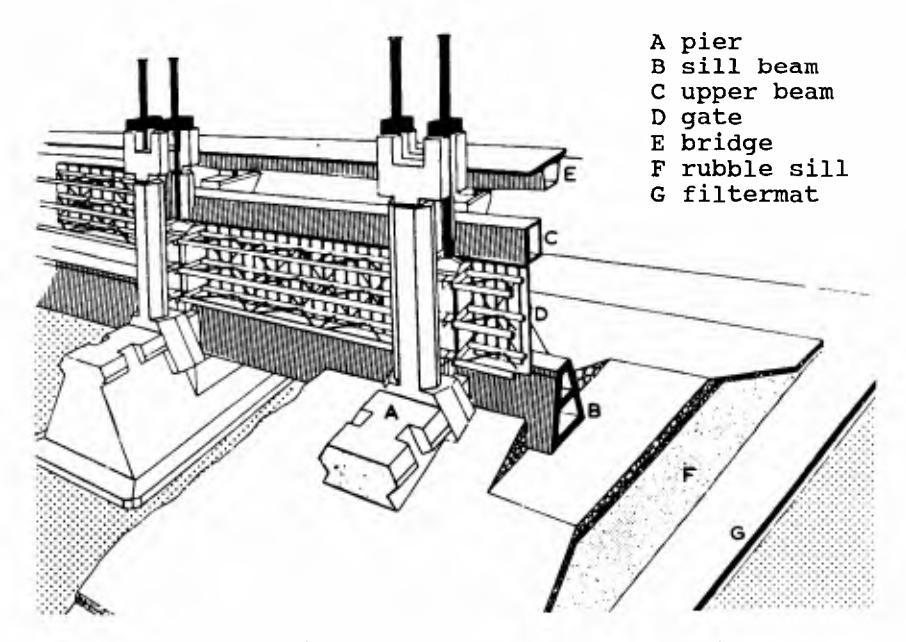
The sandbed is covered by a filtermat. On these mat concrete piers are placed. The final flow opening is framed by a concrete sill beam and an concrete upper beam. A steel gate driven by hydraulic cylinders can close the flow opening. On top of the piers a motorway bridge is located. The piers and sill beams are packed in by a rubble sill structure.

Figure 2: Elements in the Eastern Scheldt Barrier

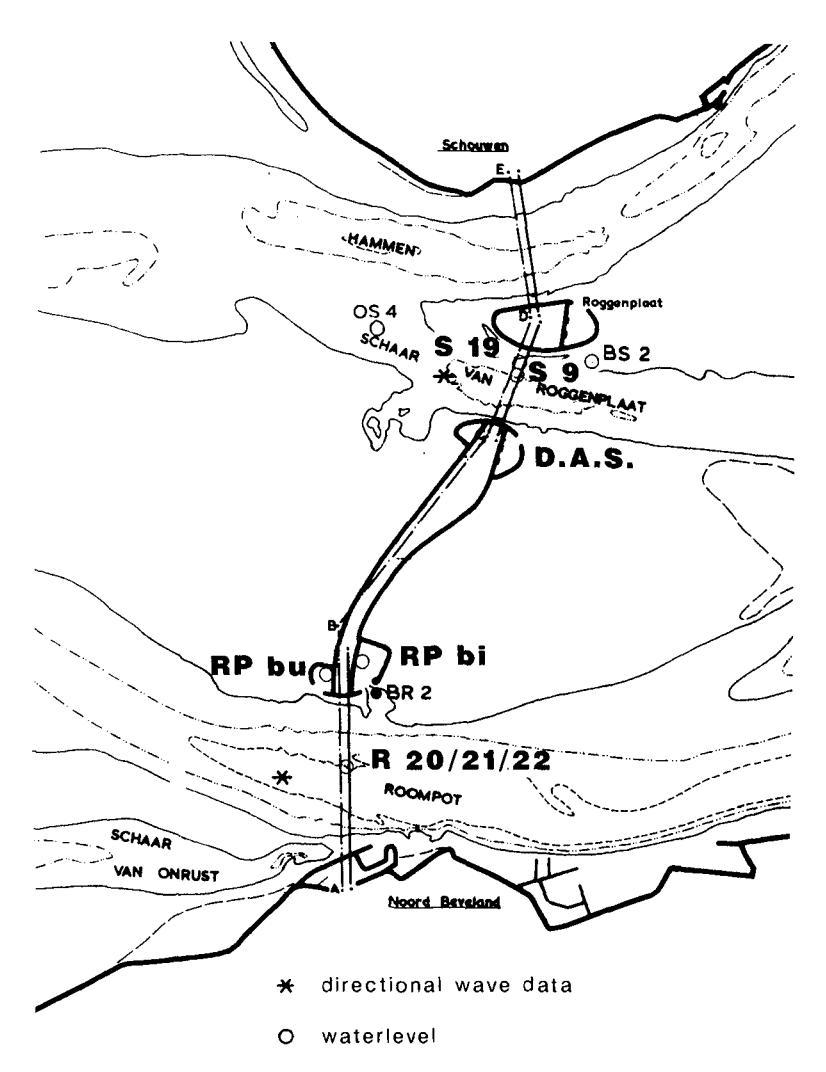
It is obvious that it is impossible to measure every item at every pier location. The following strategy has been chosen: extensive measurements are performed at selected locations. In the Schaar-channel at gate S13 and pier S9, in the Roompot-channel around pier R22, gate R21 and upper beam R20 (See figure 3).

Figure 3: Measurement locations

All measured data are gathered by a data aquisition system (DAS). The large number of sensors, over 250, with frequences ranging from 10 - 1000 Hz made a powerfull computer system necessary. The DAS is located in the operating post (figure 3).

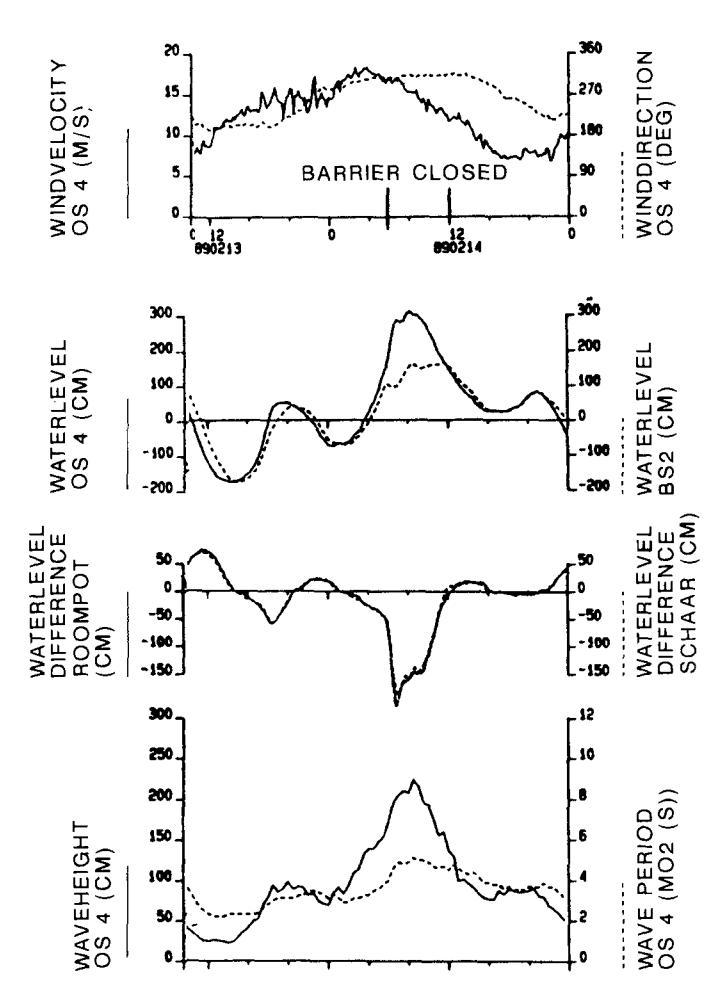
Figure 4: Storm report 13th - 14th February 1989 Westerly winds, with windspeeds between 15 and 20 m/s, caused a maximum waterlevel of 3.08 m above mean sea

level. The maximum waterlevel difference, with the barrier closed was 2 m, with wave heights of over 2 m (significant wave height).

In February 1989 the first storm closure of the barrier was performed, and a complete measurement campaign has been performed then (see figure 4).

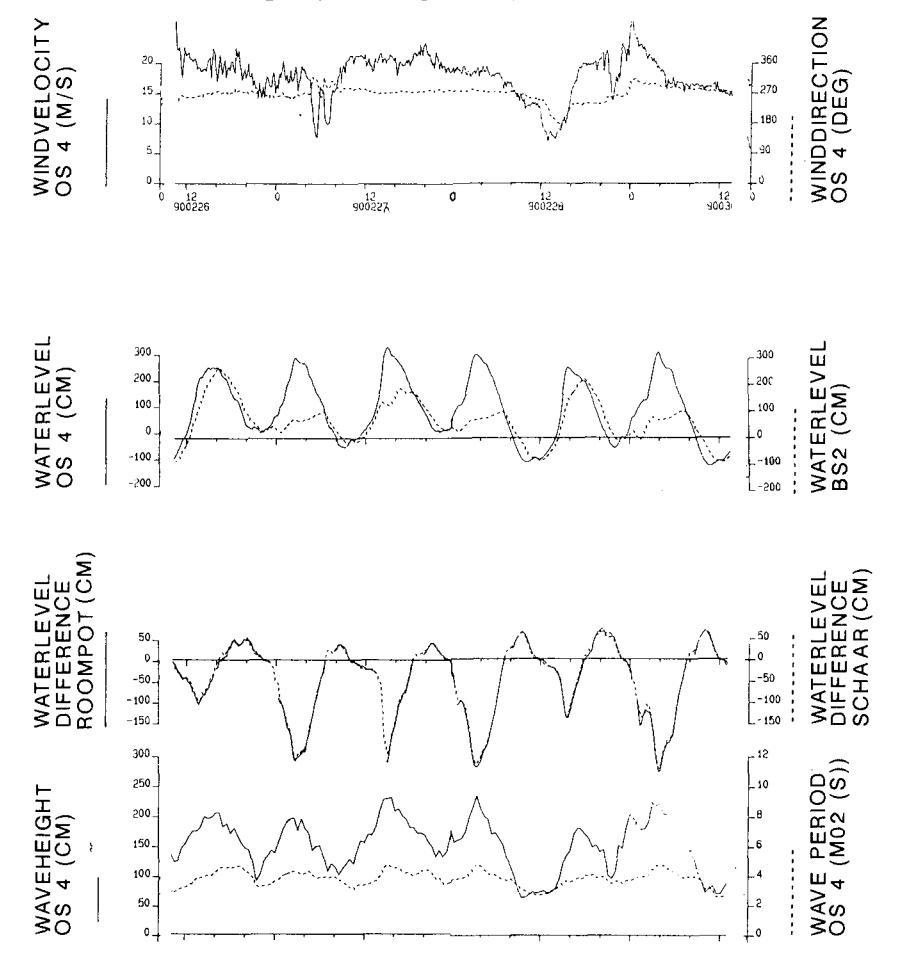
Figure 5: Storm report 26th February - 1st March 1990

The barrier has been closed four times. A maximum water level of 3.61 above MSL was reached. The maximum waterlevel difference was approx 2.4 m with the barrier closed. The significant waveheight reached almost 2.5 m.

February 1990 a heavy storm occurred. This most recent storm was a succesfull one from monitoring point of view; westerly winds, with wind speeds over 20 m/s lasted for more than two days (see figure 5).

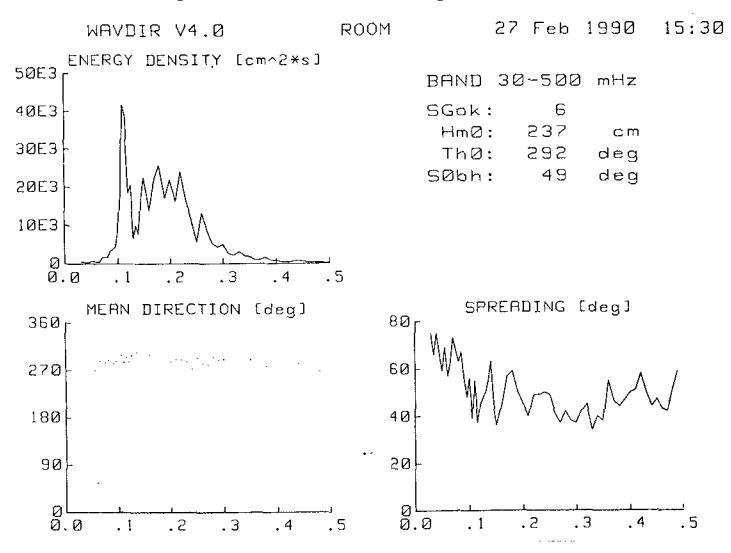
Figure 6: Registration WAVEC buoy

Figure 6 gives the spectral registration of the directional WAVEC buoy. The wave frequences are in the range of 10 to 3 seconds. The average wave period is 5 seconds.

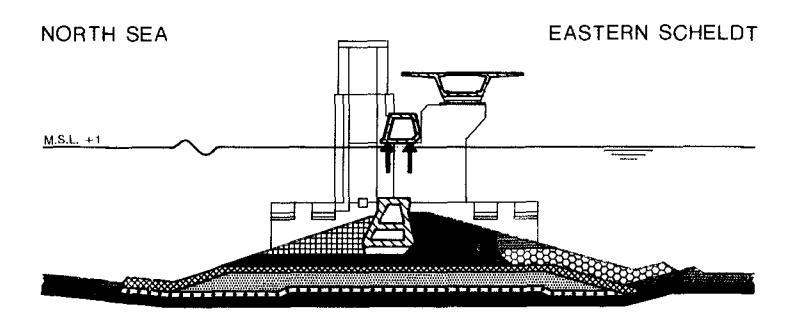
- Pressure gauge.
- Accelerometer.
- Force gauge.
- ▲ Waterlevel gauge.

Figure 7: Instrumentation upper beam

The upper beam is instrumented with pressure gauges, accelerometers, a force gauge in one of the supports and a waterlevel gauge (See figure 7).

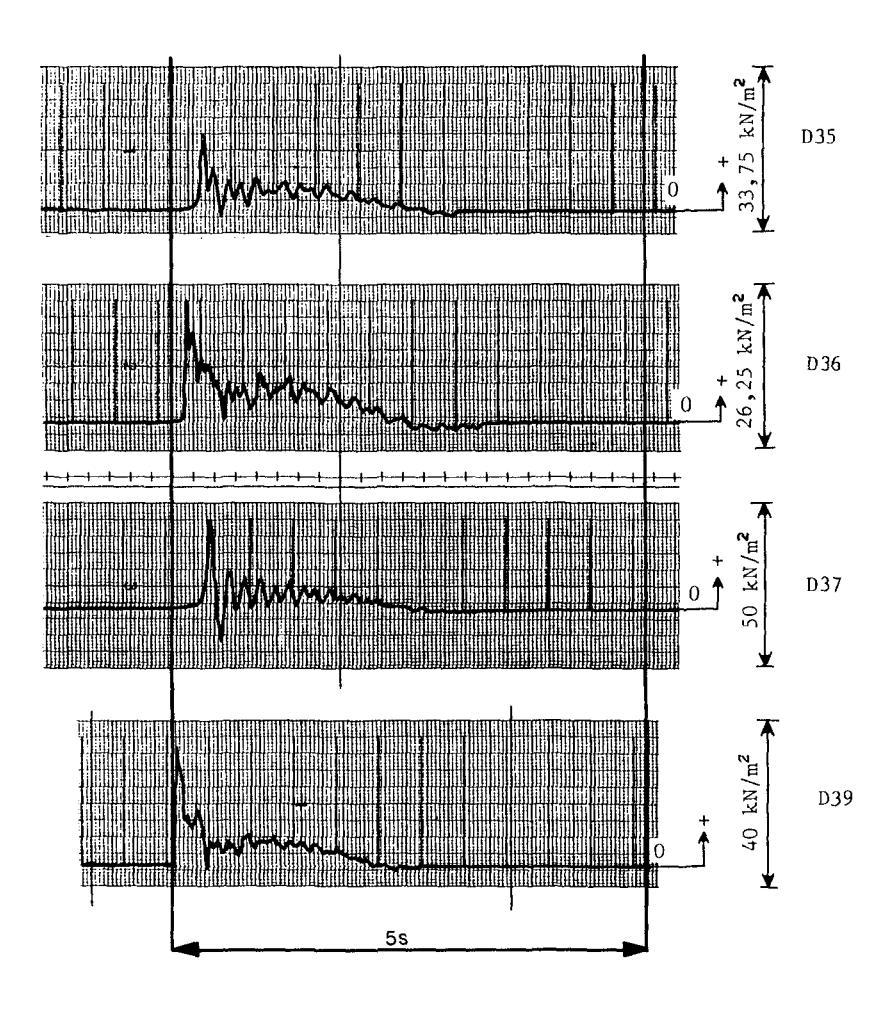
As an example of the results, the registration of four pressure gauges are presented in figure 8.

The maximum pressure in this registrations is approx. 30 kN/m^2 with 1 m significant wave height.

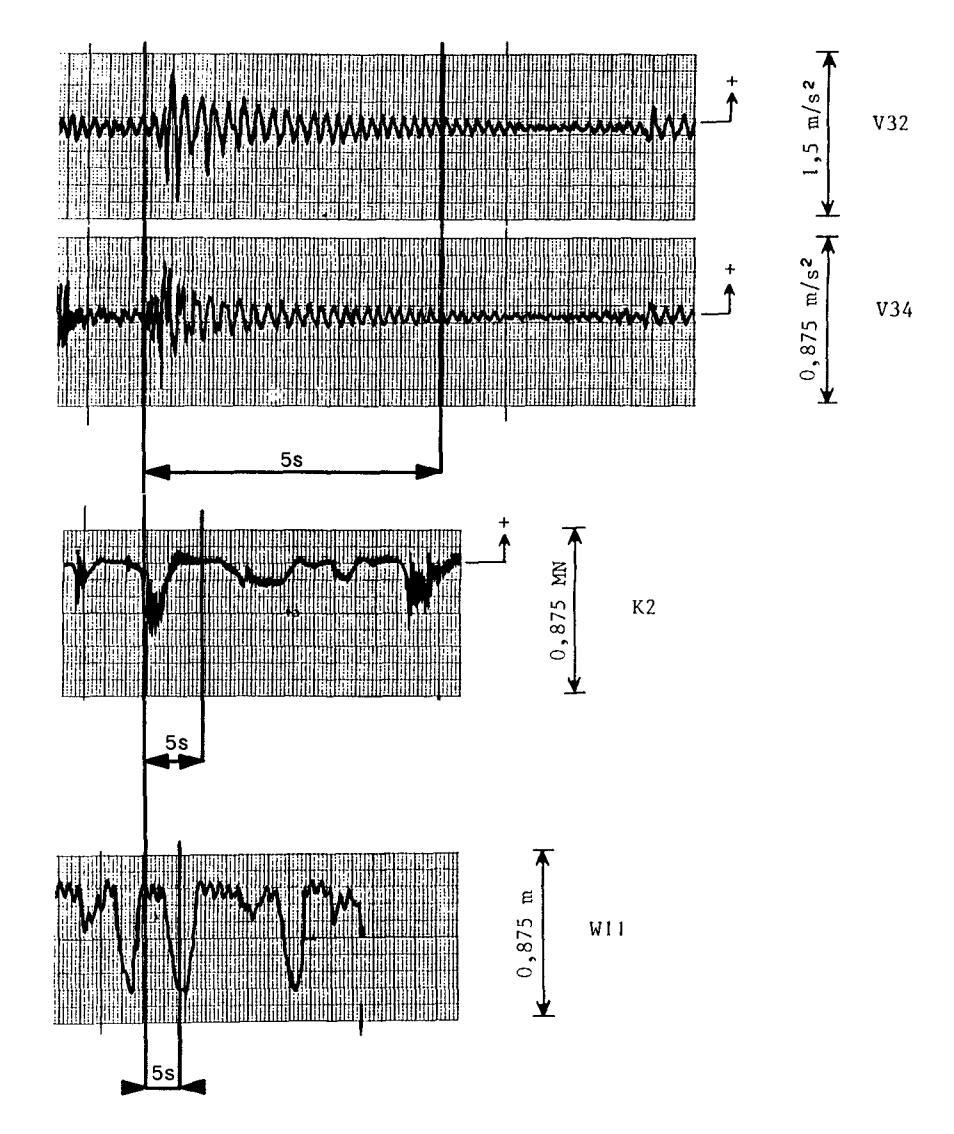
Figure 9 shows the registration the accelerometers in the middle of the beam and at the support, the registration of the force gauge in the support of the beam and the registration of the waterlevel under the beam. The interpretation and the evaluation of the design still have to be completed. Especially the area opposed to an impact is of importance here.

Figure 9: Registrations accelerometers, force gauge and water level gauge upper beam.

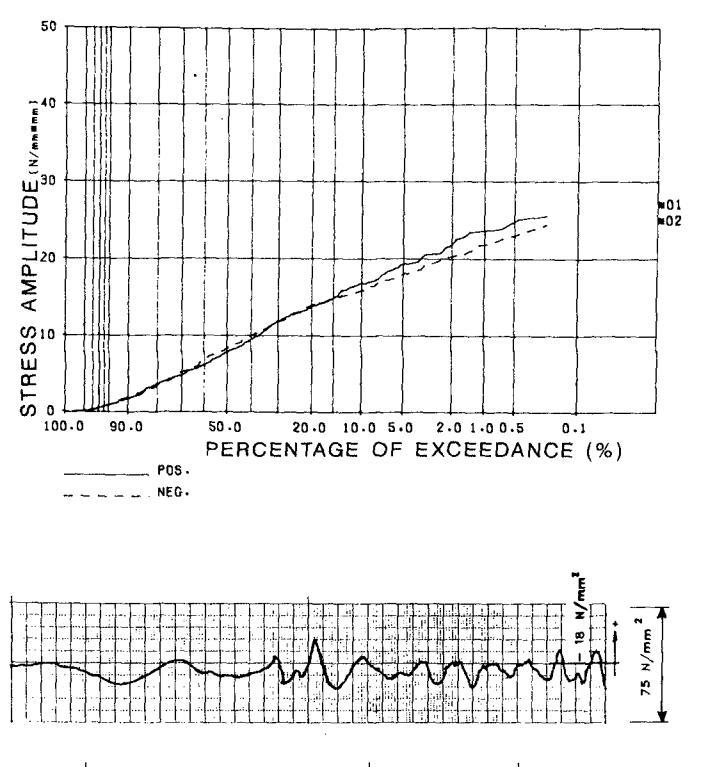
Figure 10 gives an example of one of stress signals related to the lateral force in the gate. The figure gives the stress signal and the exceeding percentage of the stress amplitude.

Figure 10: Registration stress signal (below) and exceeding percentage stress amplitude (top) of "lateral force gauge", gate S13.

Evaluation of these results is important, because the gates are constructed of a high strength type of steel that must be inspected on fatique cracks. The results will be used to evaluate the inspection strategy of the gates.
