CHAPTER 104

CHANGES DUE TO JETTIES AT TILLAMOOK BAY, OREGON

Paul D. Komar¹ and Thomas A. Terich²

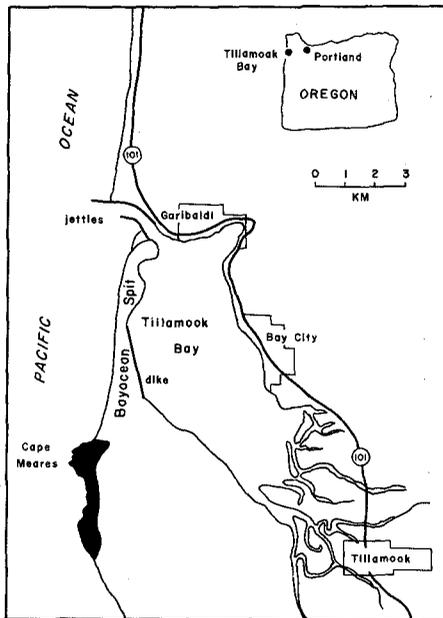
Figure 1: Tillamook Bay and Bayocean Spit.

Bayocean Spit on the northern Oregon coast, about 80 km (50 miles) south of the Columbia River, separates Tillamook Bay from the Pacific Ocean (Figure 1). This spit has had a long history of development and

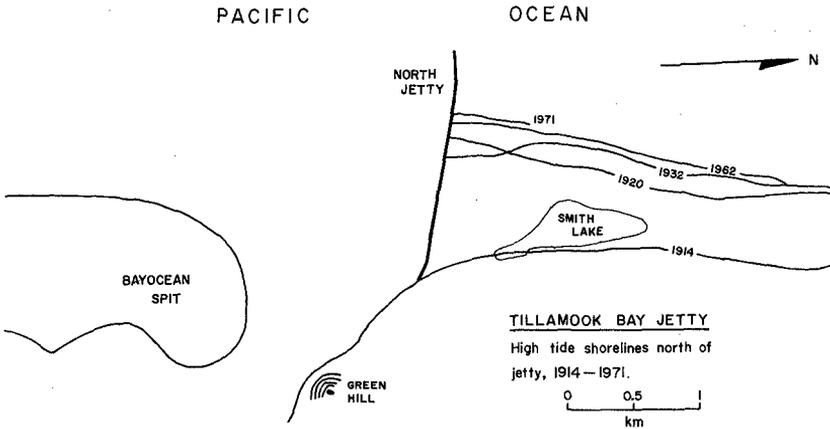
Figure 2: The shoreline advance north of the north jetty at the Tillamook Bay entrance after its completion in 1917. The 1914 shoreline gives a typical pre-jetty location.

A north jetty at the entrance to Tillamook Bay was begun in 1914 and completed in 1917. For economic reasons, an accompanying south jetty was not constructed at that time. The most apparent immediate response to the north jetty construction was a shoreline advance to the north of the jetty, documented in Figure 2. The buildout of the shoreline there nearly kept pace with the jetty extension. As in the cases of jetty construction elsewhere on the Oregon coast, and already discussed in this paper, this deposition adjacent to the north jetty occurred primarily so that the pocket formed between the jetty and the pre-jetty shoreline, which curved inward toward the bay entrance, would be filled. The shoreline built outward only until it became parallel to the prevailing wave crests, at which point long term changes ceased. The overall position of the shoreline has changed very little in the

To the north of the jetty sand accumulated and the shoreline advanced (Figure 2). Deposition there probably derived its sand from beach erosion further to the north, symmetrical with the northward movement of sand on the spit to the inlet. This overall pattern of deposition adjacent to jetties and erosion at greater distances was shown to occur at other Oregon coast jetty systems (Komar, et al., 1976), and was reviewed earlier in this paper. Erosion to Bayocean Spit was much greater than erosion to the north of the jetty at Manhattan Beach and Rockaway Beach (Figure 8) because of the longer stretch of beach that exists to the north. Only a small amount of sand had to be eroded per unit length of shoreline to supply sand to the accretion area immediately north of the jetty. In contrast, Bayocean Spit is only a small segment between the jetty and Cape Meares on the south (Figure 8) so that a larger amount of sand had to be supplied by each unit length of spit shoreline erosion to support the shoal growth next to the inlet.

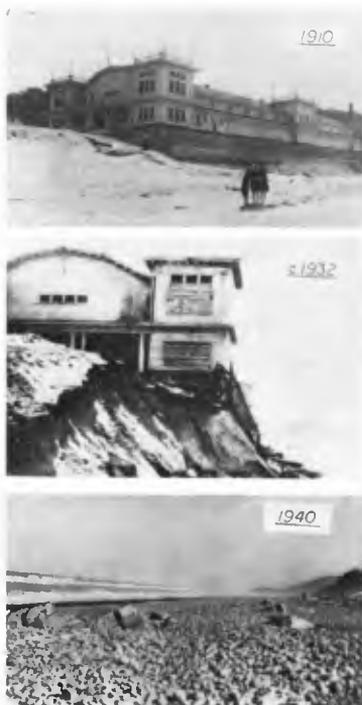
Figure 3: Progressive erosion of the natatorium on Bayocean Spit.

O'Brien (1930) also mentioned that the north jetty had weathered down appreciably. For this reason, the north jetty was reconstructed and lengthened in 1932-33. After this reconstruction erosion on the spit became very apparent. Even while reconstruction was in progress erosion began to undermine the sidewalk fronting the natatorium of Bayocean Park, built close to the beach, and by 1936 the structure's roof had collapsed (Figure 3). Erosion of the spit was progressive, although some winters were more severe than others and caused rapid dune and property retreat. For example, during January 1939 a storm broke a small gap along the narrow southern end of the spit, washing sand and gravel into the bay. The natatorium was finally completely destroyed by this storm (Figure 3). Maximum recession of the top of the dune bluff was 7.5 m (25 ft) with an average recession of 2 m (7 ft). In addition to the loss of the natatorium, four houses were undermined and lost, nine were immediately threatened,

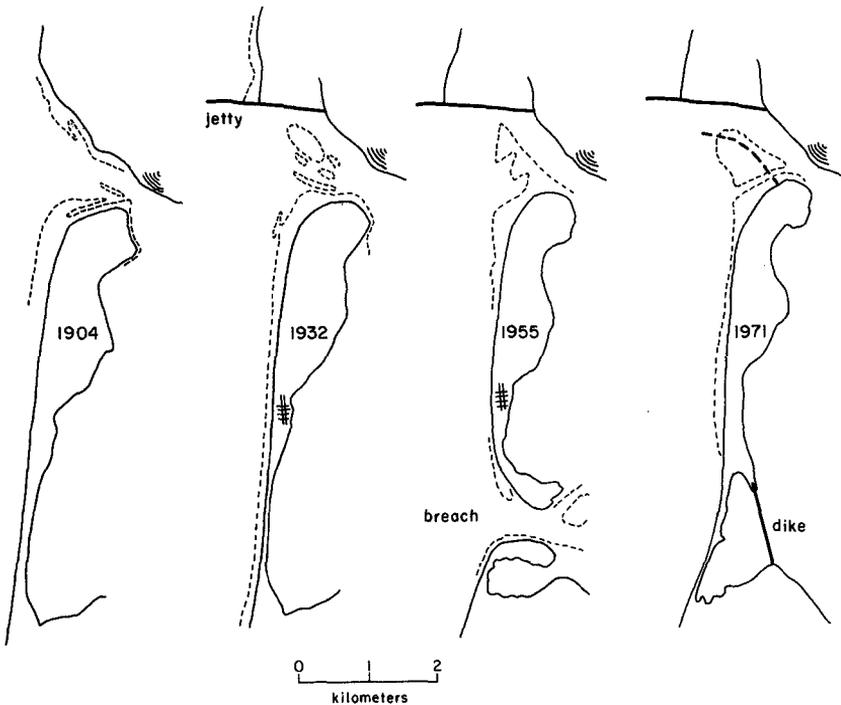
Figure 4: Progressive erosion to Bayocean Spit leading to its breaching in 1952, necessitating the placement of a dike closing the breach.

Washovers of the spit occurred during subsequent winter storms until on 13 November 1952 storm waves together with high tides entirely breached the spit's narrowest southern section, initially removing a 1200 m (4000 ft) long segment of spit. This breach progressively widened, becoming nearly a mile wide at high tide. The breach developed into the natural opening for the bay, the northern entrance with the jetty beginning to shoal and close (Figure 4; 1955 survey). Waves rolled through the breach producing swells within the bay, causing some erosion to farmlands on the bay's edge. For this reason it was decided to close the breach, so in 1956 work was begun on a rubblemound dike, set back within the bay. The construction of this dike and the difficulties in closure are discussed by Brown, et al. (1958). It was anticipated that the

pocket in the shoreline seaward of the dike would fill and re-establish a sand beach fronting the dike, which it did as can be seen in the 1971 survey of Figure 4.

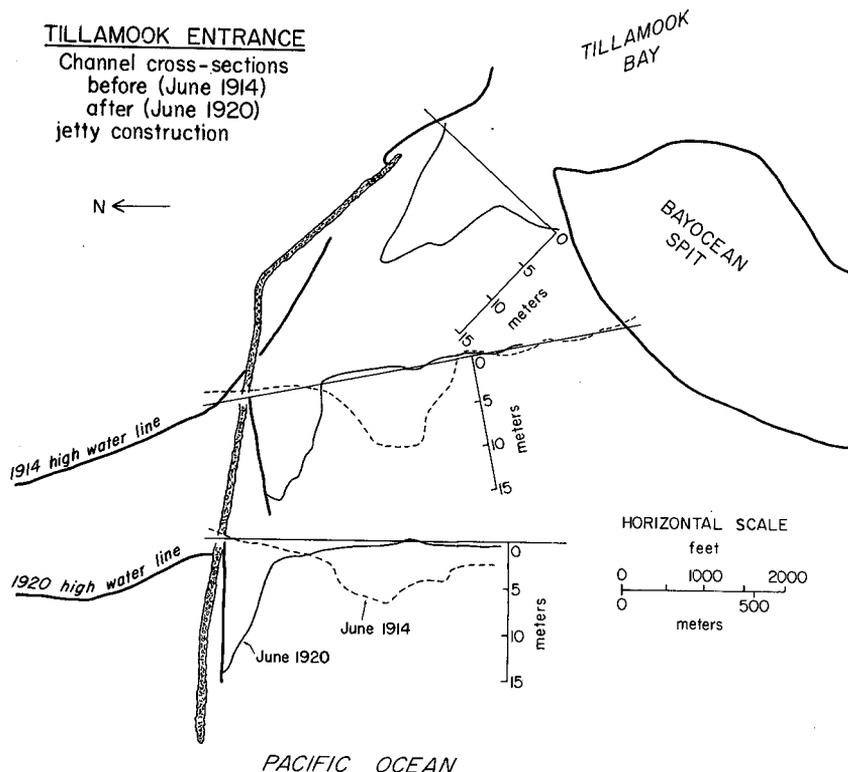
Figure 6: Deepening and narrowing of the channel following construction of a north jetty.

In addition to the growth of the outer bar and migration of the main channel following construction of the north jetty at Tillamook Bay, there were changes in the geometry of the channel outside the entrance. This is shown in Figure 6 which compares channel cross-sections before (June 1914) and after (June 1920) jetty construction. It is seen that after jetty development the channel became much deeper and narrower than existed prior to construction. These changes are presumably the response of the channel to the pressure from the south by the shoal growth. However changed in depths and widths, the channels before and after jetty construction did not differ significantly in cross-sectional areas. In addition, the changes in geometry did not extend inward along the channel into the entrance itself. Figure 7 shows a number of channel cross-sections immediately north of the spit at the entrance's narrowest point, some before and some after jetty completion. There are no noticeable effects there due to the addition of the north jetty. Despite the changes in channel geometry just outside the entrance and the growth of the shoal, the entrance itself remained relatively unchanged and bore the same relationship to the tidal prism within the bay according to O'Brien's (1931, 1939) relationship.

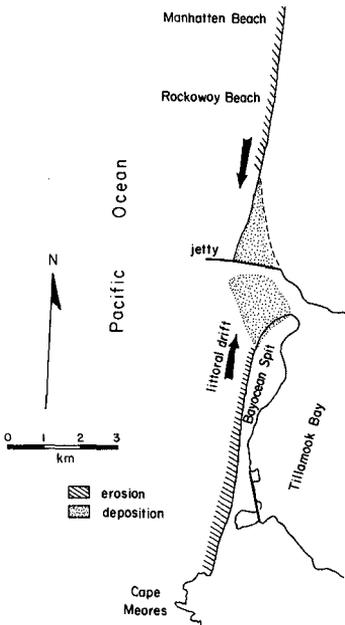
Figure B: Patterns of erosion and deposition following construction of a north jetty but prior to the south jetty development.

As already indicated, a closer inspection of the changes following construction of the north jetty does not agree with the interpretation of a large net littoral drift identified by earlier studies (Corps of Engineers, 1970). The overall pattern of erosion and deposition is illustrated schematically in Figure B, and it is seen that the pattern is symmetrical north and south of the jetty, complicated by the fact that only a single jetty was installed. Although erosion occurred along most

We have attempted to put sediment volumes on the patterns of erosion and deposition illustrated in Figure 8 by the development of a budget of sediments. This budget is for changes following the completion of the north jetty in 1917 but before the construction of the south jetty in 1969. Our estimates are given in Figure 9. Deposition to the north of the jetty amounted to some $6 \times 10^6 \text{ m}^3$, which agrees with previous estimates of the fill (Corps of Engineers, 1970). As already indicated, this sand deposition came from beach erosion further to the north; that erosion value is given in Figure 9 in parentheses because we have no actual measure of the erosion other than the supposition that it will balance the deposition north of the jetty. Of course any transfers of sand around the jetty during or after construction would alter this exact balance; unfortunately we have no way to evaluate such a

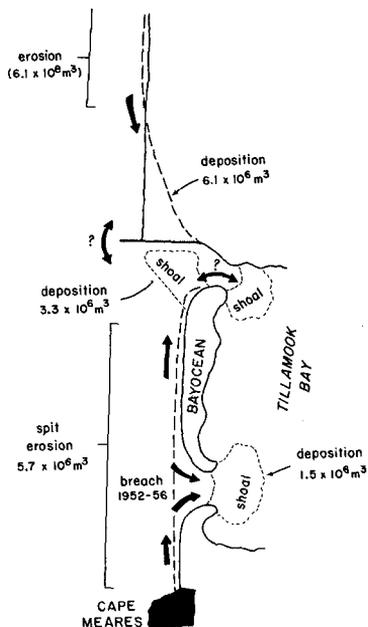
Figure 9: Budget of sediments for areas of erosion and deposition following construction of the north jetty at Tillamook Bay.

Erosion of Bayocean Spit and the area to its immediate south up to Cape Meares amounted to some $5.7 \times 10^6 \text{ m}^3$ (Figure 9). This estimate is based on measured beach and dune bluff retreats and heights of the dune bluffs and sea cliffs.

Altogether there is a reasonable accounting for the transfer of sand from erosion areas to deposition areas in the region of Bayocean Spit and Tillamook Bay following construction of the north jetty. The shoal growth and sand entering the bay through the breach together account for $4.8 \times 10^6 \text{ m}^3$ of deposition. This is close to the $5.7 \times 10^6 \text{ m}^3$ of estimated erosion from the spit. Considering the inaccuracies of these estimates, the results demonstrate that the patterns of erosion and deposition can be accounted for by local rearrangements of nearshore sands following construction of the north jetty, without blockage of an appreciable net littoral drift by the jetty.
