SPENDING BEACH BREAKWATER AT SALDANHA BAY.  
Ir. D. Zwemmer\*, Ir. J. van 't Hoff\*\*

This paper describes the design and construction of a sand breakwater at Saldanha Bay exposed to the severe swell conditions of the south Atlantic.

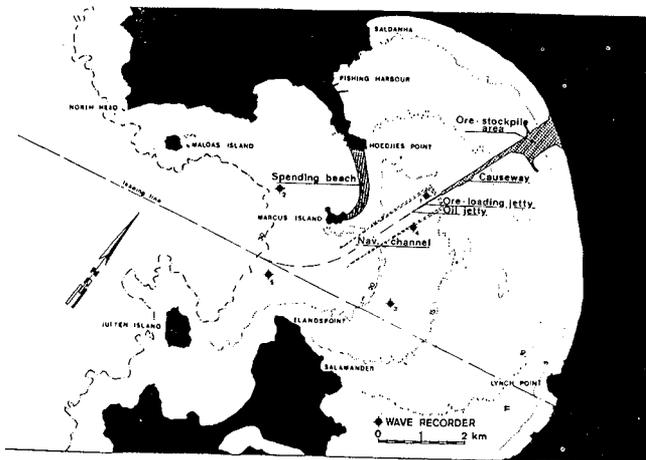
ill. 1. General lay out of harbour configuration at Saldanha Bay.

In order to enlarge the existing sheltered area of the inner bay, the northern peninsula Hoedjies Point was extended by a breakwater to Marcus Island situated in the middle of the entrance to Saldanha Bay (see illustration 1).

During a period of two years, preceeding the design period, wave heights were measured at five different locations in the bay (ill. 1). Simultaneously "deep sea" wave heights, directions and periods were measured. The measurements were executed by the Council of Scientific and Industrial Research (C.S.I.R.).

It shall be clear from the geography of the bay that the location of Marcus Island in relation to Hoedjies Point offered a unique possibility to build an artificial cove as a natural extension of North Bay beach (see illustration 1).

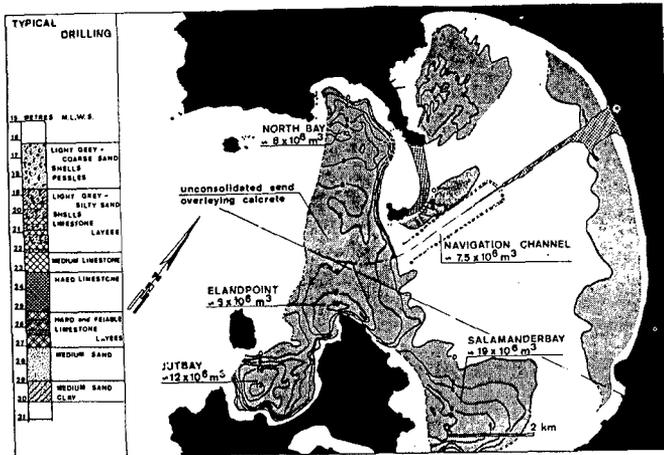
ill. 3. Loose sediments overlaying calcareous material, sandwinning areas.

The areas where loose sediment is overlaying calcareous layers, are indicated on illustration 3, being the outcome of an extensive sonar survey. As main sandwinning areas could now be distinguished:

A typical drilling of the area of the navigation channel is also given in illustration 3. The medium grain size diameter of the numerous samples varied considerably. The Salamander bay area showed some small areas of decomposed granite ( $600 \mu$ ) excellently suitable as building material for the breakwater.

The main volume of sand was obtained from the winning area due east of Salamander Bay (see illustration 3) while an additional amount of approximately 7 million  $m^3$  became available during the dredging of the navigation channel.

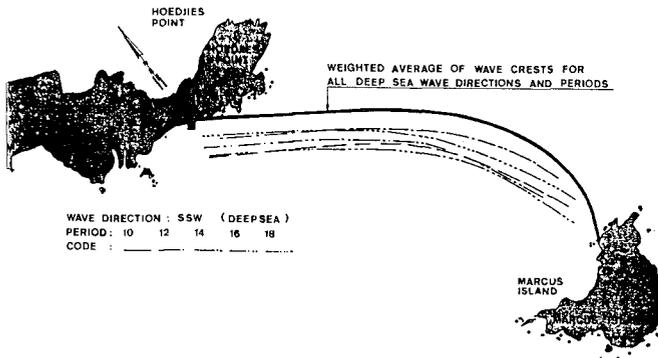
ill. 4. Wave crest patterns according to model studies.

For different deep sea wave directions and wave periods, the wave crest patterns between Hoedjies Point and Marcus Island, as observed in the model test, are shown in illustration 4. The low-water line of the proposed breakwater was determined parallel to a fictive wave crest being the weighted average of the different wave directions and periods. Taking into account the extended low water line of North Bay beach and the location of Marcus Island, the low water line of the proposed breakwater was now fixed, reflecting the kidney-shape like so many beaches in the area.

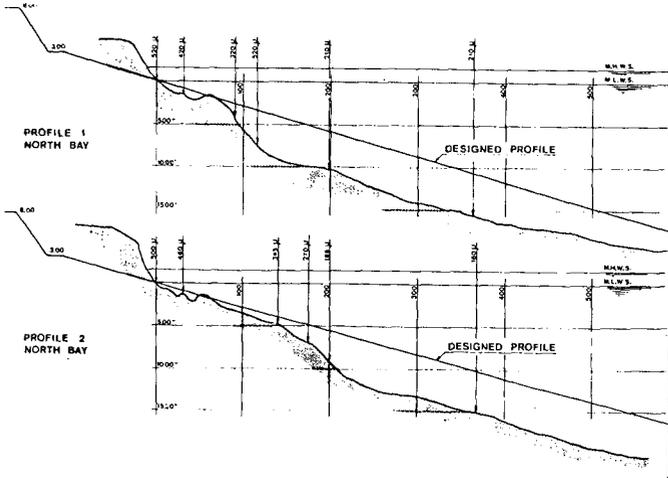
ill. 6. Comparison of designed profile with the actual profiles of North Bay beach.

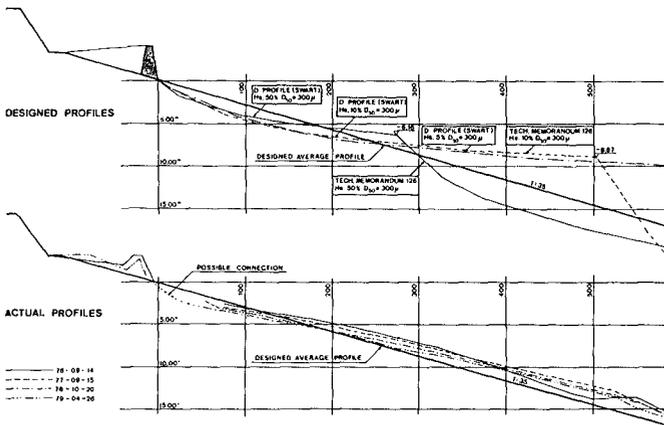
ill. 7. Theoretically calculated D-profiles, spending beach design and actual profiles.

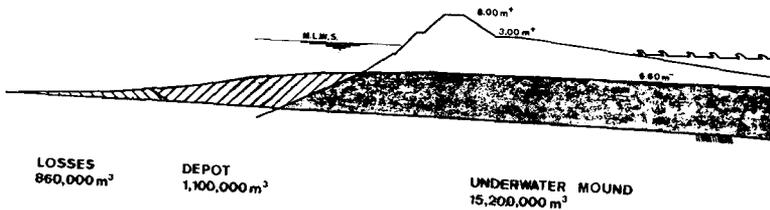
ill. 9. Cross section of spending beach after completion of stage I, including sand stockpile and sandlosses.

In the cross section of illustration 9 the underwater mound, stockpile and sandlosses are indicated. The locations of the stockpile areas which were prepared during the first building stage and used for the closure of the upper part during.

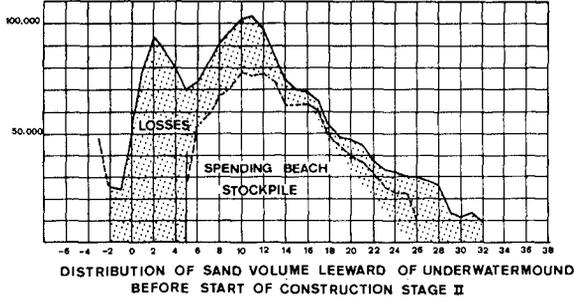
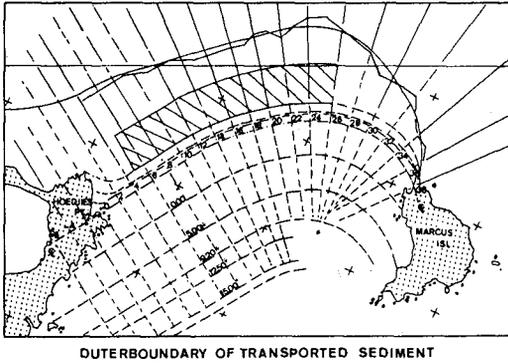
ill. 10. Distribution of transported sediment.

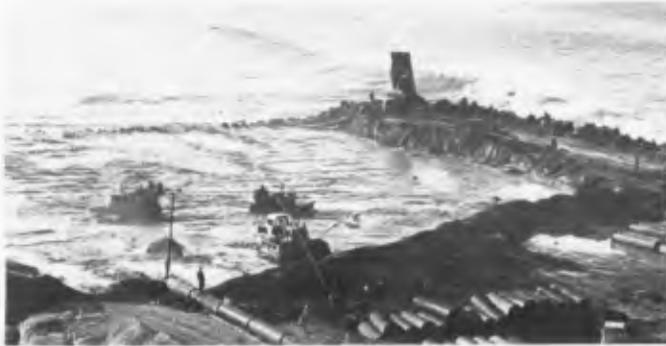
ill. 13. Protruding stone wall shifted forward and acting as knife-edge. Note the size of the breaking waves.

The construction of the temporary breakwater in the lee of Hoedjies Point has learned that a stone wall located at the proposed low water line, with its crest at approximately 4,00 m<sup>+</sup>, protruding seawards like a knife-edge, considerably restricted the amount of sand washed away from the head. It proved that a relatively small stone wall (average 120 ton/m<sup>1</sup>), combined with the pumping of sand at the seaside some 150 m distance behind this head, offered the best progress. The wave forces transported the sand along the seaward profile as well as longitudinally towards the "knife-edge" of the stone head. Directly in the lee of the protruding stone-wall the sand settled and here bulldozers were used to push up the sand towards the backside of the wall. Sand accretion also took place in the deeper areas just in front of the head. As soon as the level here reached 0,00 m, stone was backtipped, shifting the spear head (knife-edge) forward again, as can be seen on illustration 13. This illustration also gives an impression of the enormous size of the breaking waves as compared to the size of the truck. Every 50 m a pipe branched off running through the small stone wall towards the seaside. It very quickly became clear that for the majority of the time, the seaward outlets had to be operated, making use of the waves to carry out the further transport of the spoil. Hydraulic fill directly in the centre part of the spending beach was restricted to a distance of 150 m, backwards from the head in order to minimize sandlosses. The cutter production system was gradually improved during the course of the construction i.e. the lay out of the discharge pipelines and rubble mound dam and also the progress of the rubble mound.

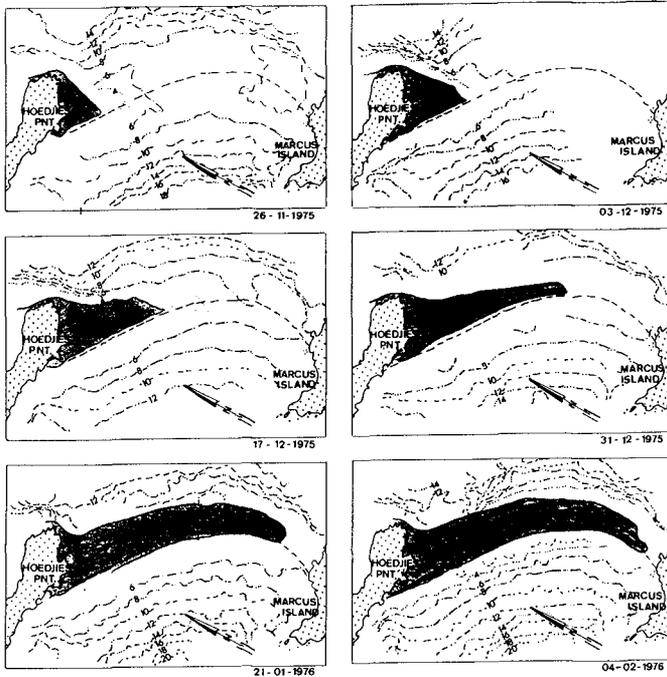
11. 14. Progress of superstructure of spending beach breakwater.

The above described construction method made it possible to realize the closure in 14 weeks with a minimum loss of sand and two months ahead of schedule. The progress is made visible in illustration 14.
