CHAPTER 308

Stabilizing Beaches Downcoast of Harbor Extensions

John R C Hsu¹ and Richard Silvester, M. ASCE²

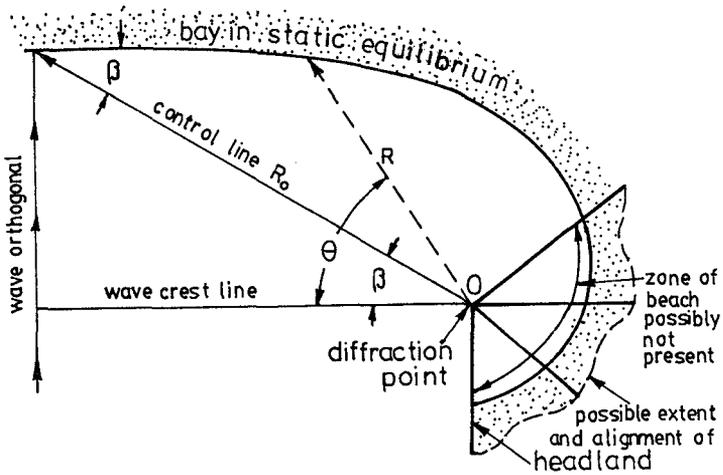
Figure 1. Definition sketch of a new empirical equation for static bay shape.

with the variables R , R_0 , β and θ as given in the definition sketch of Figure 1. The values of constants C_0 , C_1 and C_2 are available in Hsu and Evans (1989) and Silvester and Hsu (1993), in tabular and graphical form. It is noted that the wave obliquity (β) is measured between the control line (R_0) and the downcoast beach tangent. For a stable or near stable beach this is normal to the orthogonal of the persistent swell which sculpts the shape. The straight crests of these incoming waves at the point of diffraction, at the other end of the control line, are also angled β to it, from which arcs (R) are drawn at angle θ to it. Thus, by knowing R_0 and β the value of R is determined for a specific θ , so that the complete periphery of the static equilibrium bay can be drawn. It has been shown that the logarithmic spiral

fits only the curved portion of the actual bay, whereas the parabolic formula fits the complete periphery exceedingly well (Hsu and Evans 1989).

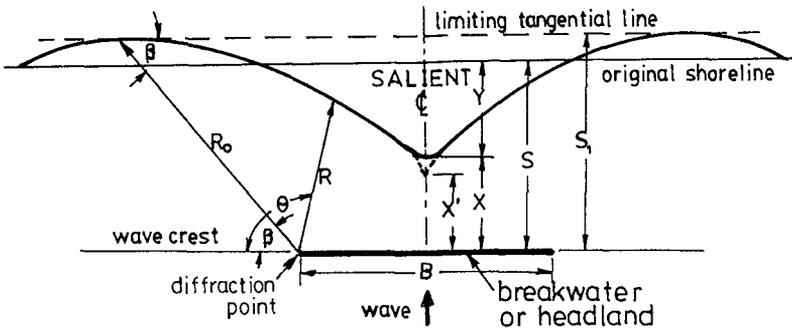
Figure 2. Definition sketch of a salient formed in lee of an offshore breakwater, with normal wave approach, based on the static bay shape equation (1).

Besides the shaping of bays in the lee of headlands, equation (1) can be applied to salients behind offshore breakwaters (Hsu and Silvester 1990), as seen in Figure 2. These accretions are not triangular but assume the parabolic curve either side of the apex, as dictated by the diffracting and refracting waves and the associated longshore current circulation. This added land is at the expense of beaches beyond the extremities of the breakwater, if beach nourishment is not carried out.

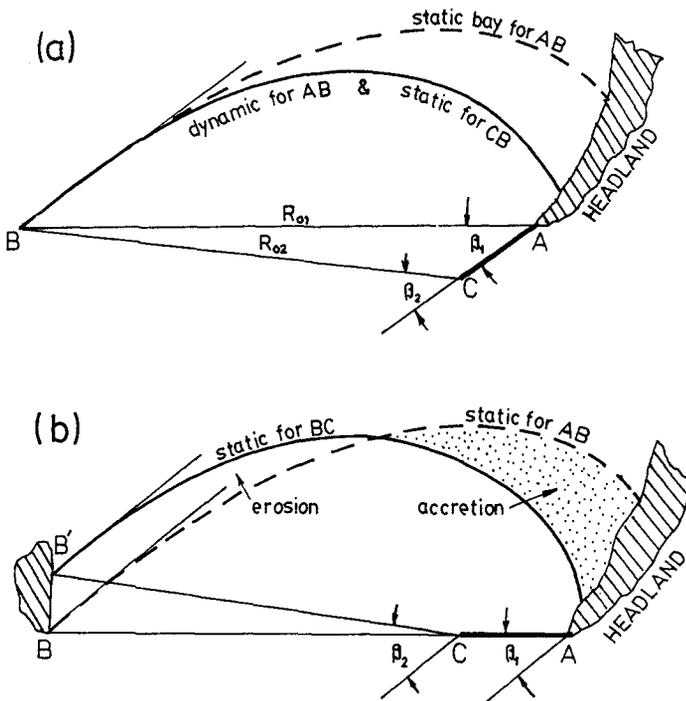
Figure 3. Effect of positioning a breakwater tip (a) in a dynamic bay, and (b) in a static bay, for harbor planning and beach erosion control.

A natural headland is depicted in Figure 3 a & b as A and the downcoast limit as B in which control line AB (= R₀₁) angled to the downcoast tangent by wave obliquity β₁. When breakwater AC is built the new diffraction point C gives a new control line CB and new angle β₂, which results in a changed static equilibrium or

Looking first at Figure 3a, the existing bay may be in dynamic equilibrium, with littoral drift still passing through, as seen by the full line in the figure. The dotted curve denotes the stable shape for control line AB , to which the beach would erode if all sand supply around point A should cease. Now, when the breakwater AC is inserted its length and orientation could be so chosen that diffraction at point C and control line CB , with the static bay for CB being the same as the dynamic for AB . This can be achieved close enough for erosion at all points around the periphery to be negligible. If, however, sand were finally to bypass point C the resulting beach may become dynamic once more with a beachline seawards of this stable shape. But it should be designed for the static condition in case this additional drift ceases in the future.

Now turning to Figure 3b, the dotted curve represents the static equilibrium shape for control line AB which is the existing beach. When breakwater AC is added the new control line CB creates a new static beach which involves massive accretion in the lee of headland A . The material for this has to be supplied from the region of B because the beach was originally stable. This causes a new downcoast tangent to operate that determines a new β_2 for equation (1). The situation would detract from the calm water area serving as an anchorage but could be attractive for tourism purposes.

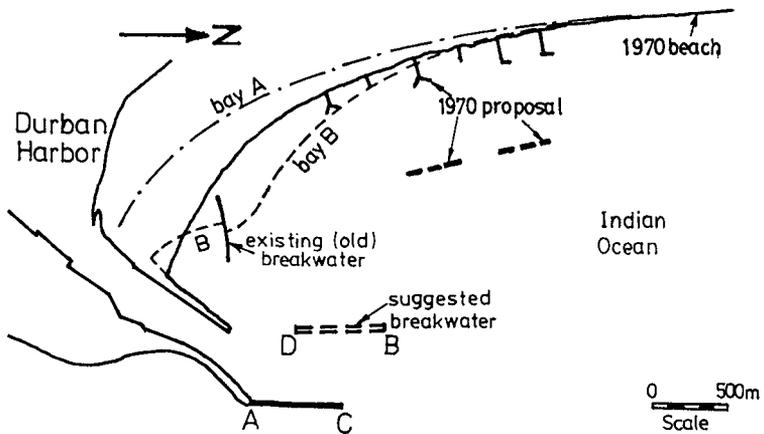
Figure 4. Durban harbor, South Africa

Using the tip of the outer breakwater as the diffraction point (*A*) the resulting stable bay *A* is shown in Figure 4. This indicates substantial erosion even if minor attempts are made to prevent it. The need is for a new diffraction point to the north in order that a beachline seaward of the present can be established. Such a point (*B*) can be provided by an island breakwater *BD* from which bay *B* is formed. The space between structure *BD* and the existing inner breakwater will permit some wave action to round-off this waterline to the existing (old) breakwater as shown. The beach between it and the main port structure will be reoriented as indicated by the dotted line.

The accretion anticipated for bay beach *B* could be supplied from dredging of the entrance channel that appears to be continuous. Otherwise the siltation would come from beaches to the north. It is expected that the groins will be removed and their stone etc used in the new breakwater *BD*. The offshore sand mounds (if built) could also be removed and perhaps utilized as fill for the beach *B*.

To help overcome the necessity for dredging at the port entrance the outer breakwater could be extended as shown (*AC*) which would reflect waves obliquely. The short-crested system so established would transmit material across the slightly diverted navigation channel and create a shoal near the tip *B*. It would finally find its way to the beaches. This new structure would prevent swell entering the gap between breakwater *B* and the existing structure so that beach *B* would extend to the tip of the old breakwater.

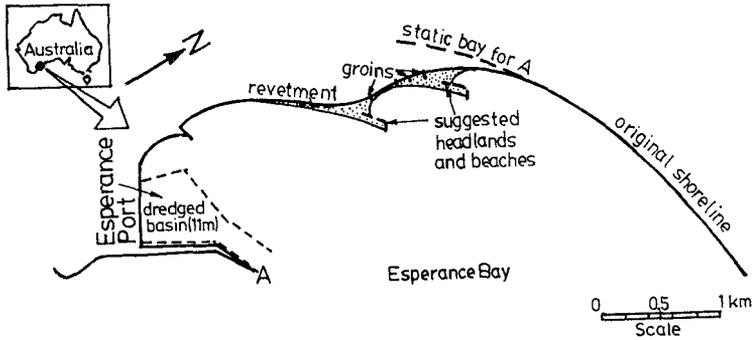
Figure 5. Esperance Bay, Western Australia

Esperance Bay is part of a continuous chain of embayments facing the Southern Ocean in the south of Western Australia. The curved shoreline, in geomorphological terms, was in dynamic equilibrium, implying its stability was maintained by the uninterrupted supply of littoral drift. However, the construction of a breakwater and dredging of an entrance channel for the Port of Esperance between 1962-65, with breakwater extension in 1973-75, has cut off the littoral drift. This has forced the shoreline to recede back to a potential static equilibrium, which is destined by Nature. This limit is landwards of the existing shoreline (see Figure 5). A total of 573,000 m³ of dredged material was placed onto the beach.

The engineering solutions taken to combat with the eroding beach at Esperance has been a low-cost rock groin field with beach renourishment, which has been an ongoing task ever since 1969. Between 1977 and 1995, sand renourishment at an average rate of 23,100 m³/year has been placed on sections of beaches suffering the worst erosion. Two headlands in the shape of a walking sticks with fronting beaches are proposed to achieve the overall stability with one-off beach nourishment to form a bay, rather than a field of short groins or offshore breakwaters with continual renourishment.

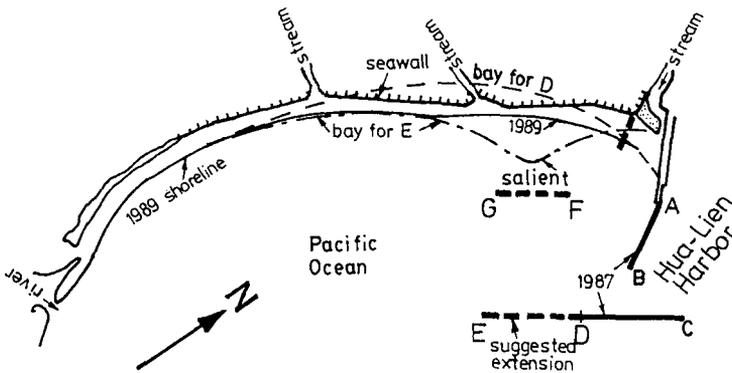
Figure 6. Hua-Lien harbor, Taiwan

Hua-Lien harbor is located on the Pacific Ocean coast of Taiwan at latitude 24°N. Two breakwaters (*AB* and *CD*) were constructed in 1987, as noted in Figure 6 (Hsu et al 1994). Prior to this extension, erosion of the coast south of the harbor entrance had been experienced, resulting in lengthy seawalls protected by concrete armour units which have steepened the offshore area. The stable beach for breakwater *CD* is shown dotted (bay for *D* in the figure) which is landward of the majority of the protected area, except at the northern tip where accretion would inhibit the discharge of the stream in the lee of breakwater *AB*.

One solution to these two problems is to extend the breakwater from *CD* to *DE*. The new diffraction point at *E* will produce the waterline shown as salient for *DE*, which is seaward of the current shoreline protected by the seawall. The remainder of the beaches will be stabilized, so not requiring other protection such as groins or seawalls. An offshore breakwater *FG* may be constructed which will intercept material in the lee of the main breakwater *DE* to form the secondary curve in the form of a salient to ensure that the stream outlet will not silt up.

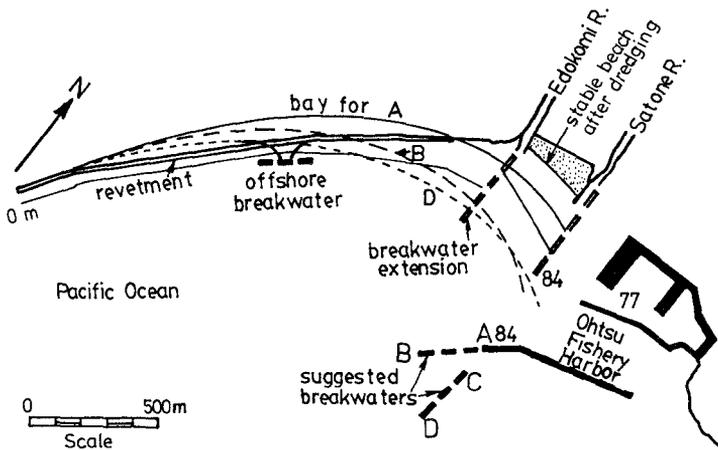
Figure 8. Ohtsu harbor, Japan

The fishing harbor at Ohtsu on the east coast of Honshu, Japan (see Figure 7 for location), as seen in Figure 8, had a small breakwater complex initially in 1977. It was added to point *A* in 1984, as noted in the figure. The island structure created a new diffraction point *A* that caused accretion west of the groin at Edokomi river and between that and the Satone river outlet. The static equilibrium bay shape for point *A* is seen to match this erosion some distance from the port. To overcome this a revetment was built which suffered undermining and collapsed in places during 1983.

Offshore, in the region of the island breakwater, accretion was measured between 1977 and 1984. This was probably due to the oblique reflection of waves from this 600 m long structure that transmitted scoured material to this area. Uda et al (1986) believed these measurements were erroneous soundings. They were aware that the island breakwater had caused the beach accretion but stated: "the current induced the sand movement toward the lee of the breakwater". These authors believe it is the wave direction of approach due to diffraction that generates the new waterline orientation.

Two alternatives are shown in Figure 8 to rectify this problem, namely, either to extend from *A* to *B* or to provide a separate structure *CD*. The new diffraction points *B* and *D* result in stable beaches as shown, which indicate substantial accretion adjacent to the Edokomi river groin but less erosion further west. The additional material required for beach stability could be provided from dredging the outlets of these two rivers, to give the stable beach shown between the two groins. To deal with the slight erosion to the west an offshore breakwater could be constructed from the revetment that should be removed.

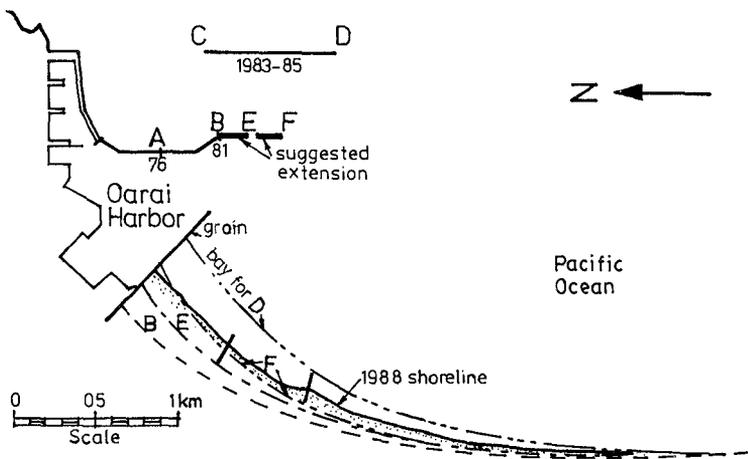
Figure 9. Oarai harbor, Japan

Oarai harbor on the Honshu coast of Japan (see Figure 7) has had many researchers analyze it (Sato and Irie 1970, Mizumura 1982, Kraus et al 1984 and Uda et al 1986). It was a small port comprising two breakwaters at 45° to the coast which was silted up quickly between 1911 and 1916. By 1976 a new breakwater was built to point *A*, in Figure 9, for which the predictable bay shape (not shown) matched the existing beach at the time (Hsu et al 1993; Silvester and Hsu 1993). In

1981 it was extended to point *B*, and to point *D* by 1985, of which the stable bays for *B* and *D* are shown. This involves massive accretion, which had partially been achieved by 1988. The sediment needed was at the expense of erosion downcoast.

In order to achieve a stable shape more in keeping with the 1988 shoreline, or even the current profile, two extensions to *E* or *F* are suggested, together with their resulting beachlines. It is seen that *F* matches the 1988 shoreline at the groin-type structure, even though it is landward of it towards the south. It is envisaged that the two small groins would be removed, which would permit the sand to find its way back to renourish beaches to the south that have been eroded. The extension of *AB* to *F* infers that breakwater *CD* would be removed as it is no longer needed for wave attenuation.

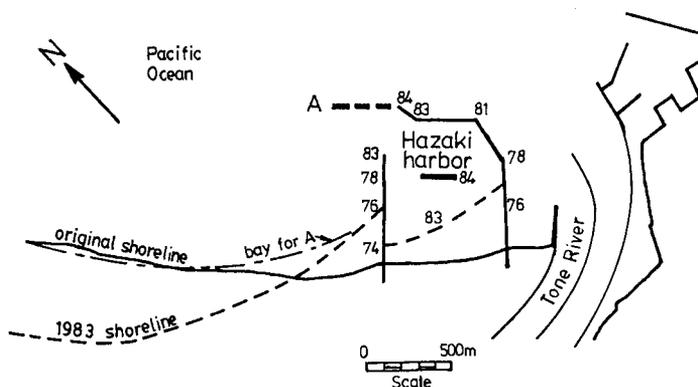
Figure 10. Hazaki harbor, Japan

Hazaki fishing harbor is located at the outlet of the Tone river in Honshu, Japan (see Figure 7 for location). As seen in Figure 10, a breakwater was commenced in 1974 and extended in 1976 with another started nearer the mouth. Additions were made to both in 1978 and to the SE one in 1981. By this time erosion had commenced some 600 m from the NE breakwater with accretion adjacent to it. In 1983 a shore parallel section 350 m in length was inserted to calm waters in the harbor, which became silted very quickly. Uda et al (1986) believed this was due to sediment discharge from the Tone river but the actual mechanism was not discussed. These authors believe it was due to waves being reflected obliquely from this shore parallel arm. These transported sand along it, depositing it at the entrance, which subsequently was moved into the harbor. The leg added in 1984 (see Figure 10) did little to prevent this as the mass-transport current of the short-crested wave system would have still formed a shoal at the entrance.

An extension of this leg to point A in the figure would achieve two important objectives. Firstly, continued oblique reflection will transmit sediment from the Tone river in a NW direction to form a shoal beyond the scoured area in proximity to its tip where an access channel can be maintained. This shoal will continually be fed to the downcoast beach. Secondly, the new diffraction point A will create a stable bay shape, as indicated in the figure, which will require no further structures to keep it in place. The accretion already there will thus remain for all time.

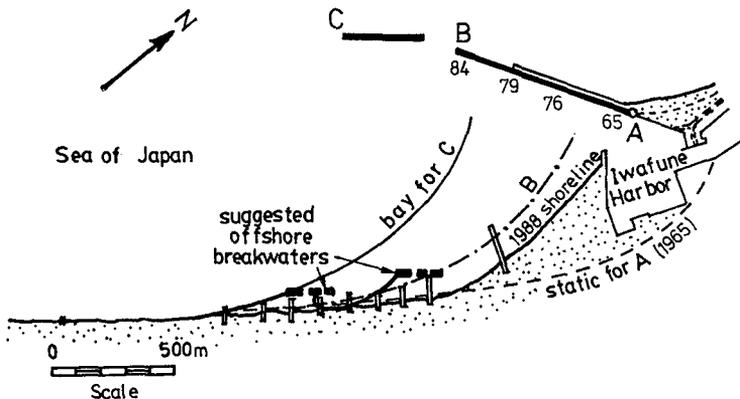
Figure 11. Iwafune harbor, Japan.

The shoreline evolution at Iwafune harbor (see Figure 7 for location) has been discussed by Hsu et al (1993) and Silvester and Hsu (1993). As seen in Figure 11 a large triangular land mass had been accreted up to 1988, from having attained to a stable bay shape for A in 1965. The static bay for diffraction point A matched extremely well the waterline at that time. The extensions of the main breakwater from A to B and then to C (by means of a detached structure) relocated the diffraction points for the incoming swell waves. The resulting bay shapes are shown which predict much more siltation if sand is available from the southern beaches. To overcome the present erosion many groins and an offshore breakwater system have been installed with little effect. The reason for this is that littoral drift still

To prevent the transposition of further material from southern beaches it is recommended that two offshore breakwaters be installed (see Figure 11), with concomitant groin removal. The outer structure would have stable bay C pass through its southern tip, with the tombolo curved bay stretching to the tip of the inner breakwater. its curved tombolo would be tangential to the 1988 or present shoreline. The fill required in the lee of and south of each new breakwater could be transported by truck or pipeline from the large triangular landmass, in order to reduce siltation at the harbor mouth.
