ENVIRONMENTAL ASPECTS OF OIL AND GAS
PIPELINE LANDFALLS IN NORTHEAST SCOTLAND

William Ritchie

Abstract

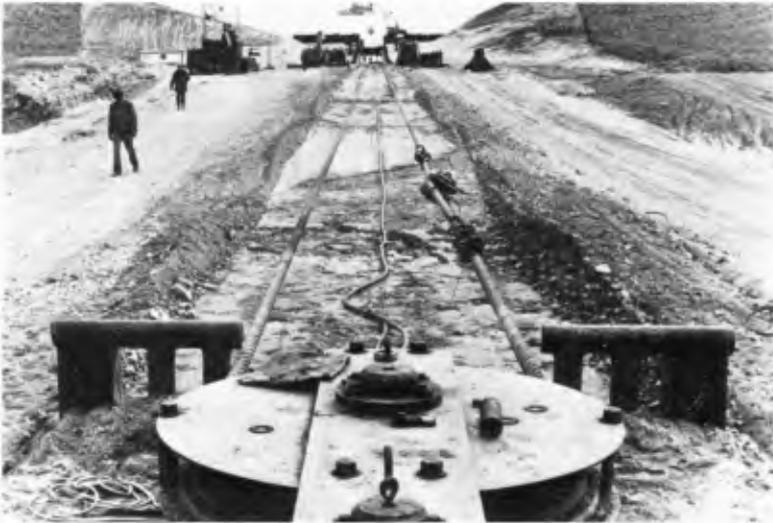
Photo 1. Pipeline Pulling of the Flags Gasline at St. Fergus.

were established beyond which the areas were regarded as inaccessible. Since the storage of sand had proved to damage rather large areas, excavated sand was used to produce a ridge which descended at a low gradient to the dunes and became the bed for the access track and pulling wires (Photograph 1). This greatly reduced the area of surface damage. The sand ridge also had engineering advantages and these have already been described. After pipe pulling the sand ridge was used to fill the gap in the dunes, and the Winter Loch and adjacent surfaces were then carefully lowered to their previous elevation and slope. Exactly the same procedures were used for the dune face, the back-slope and Winter Loch surfaces as had been used previously with the significant difference that good quality top soil was imported to cover the backslope and Winter Loch surfaces. Another minor difference was that the seed mixture was cross-drilled rather than surface spread. This gave better establishment. In all other respects the methods and the progress has been similar to that of the other pipelines.

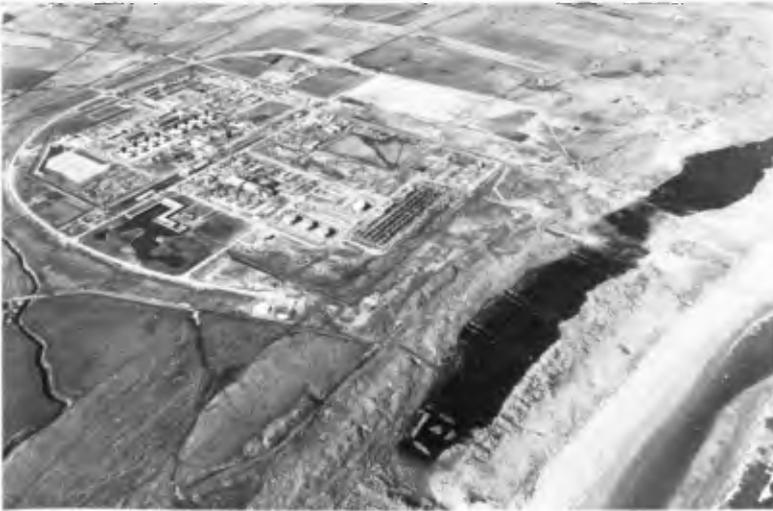
Photo 2. A general view of the St. Fergus terminal and adjacent coastline at an early stage of site work.

half a metre a year. Equally important, there was a long, flat, low, easily flooded strip of land termed the Winter Loch in the lee of the maturely vegetated dune backslope (Photograph 2 and Figure 2). This surface lay beneath the level of high water mark and flooded to a depth of over 30 centimetres from October to April every year. In addition it was recorded as being environmentally sensitive. There is, for example an area of relatively rare vegetation to the north of the landfall and the entire Winter Loch is an important roosting and feeding area for migrant birds. Landwards of this low surface there is a low degraded cliffline cut into glacial deposits. This inner slope leads to a plateau upon which the Gas Terminal was built. For both landfalls at St. Fergus the engineering technique was again that of cutting of a trench down through the dunes and Winter Loch surface to enable wires to run from the lay-barge to the pulling winch on top of the landward plateau some 500m from the beach (Photograph 1). The cutting and sheet piling operations were much more massive than at Cruden Bay. There was also the problem of waterlogging, and the surfaces being crossed were very soft and liable to be damaged easily by the passage of even the lightest vehicle. Moreover, the trench levels at the coast were substantially lower than the beach and the seaward end of the trench required protection from the possibility of flooding and wave damage. As at Cruden Bay there was no question of digging the trench through the inter-tidal beach until a short time before the actual pipe pulling operation.

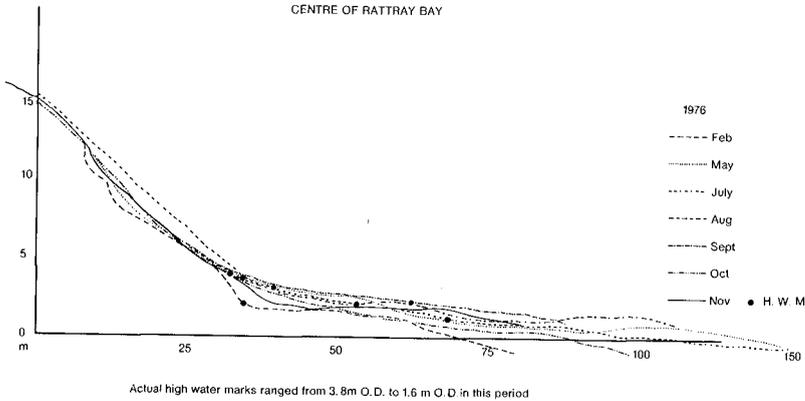
Fig 3

1976 SELECTED BEACH PROFILES

(upper and mid- beach)

CENTRE OF RATTRAY BAY

and just below low water mark, bedrock outcrops normally lie only a few scores of metres to seaward. The sand bars also appear to be rhythmic and rip cells are common. In fact, the approach of the St. Fergus pipelines to the coast uses an exceptional area of unconsolidated sediments that runs across the rock platform and provides a tract for pipeline burial. In so far as the prediction of sand movements is concerned it is probably correct to state that little is known about nearshore dynamics in both Cruden Bay and St. Fergus. Sediment movements have to be deduced from morphological evidence. Beach profiling revealed that the beach at St. Fergus varied considerably in thickness (Figure 3.). On the basis of these profiles the lowest profile was defined and used as the level below which the pipeline had to be buried under 2m of sand.

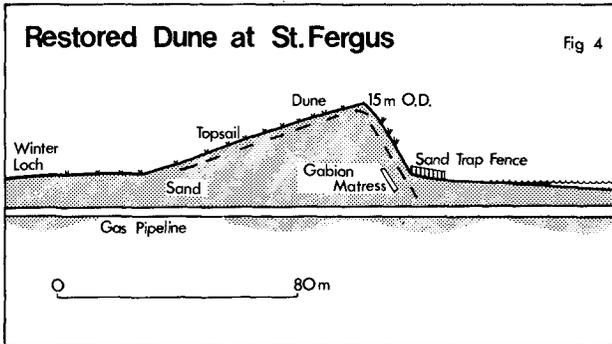
vided by inserting a toe protection of gabions, buried at the base of the dune on the seaward face (Figure 4). The arguments of such emplacement concerned the need to protect the dune face in the interim period between restoration and the achievement of natural stability. The fear was that in this critical period the dune might be attacked by an exceptionally high water level with destructive waves. In the event, this did not happen and the gabion wall remains as a fail-safe device beneath about 1.5 metres of surface sand. The same device, for the same reasons, was used on the Shell pipeline landfall a hundred metres to the north. Once the profile was restored it was held in place by stretching old fishing nets from the toe of the dune over the crest and down the back-slope. A further 30 centimetres of sand was added, and the crest and back-slope were covered by a layer of topsoil. (Unfortunately in this particular area the topsoil proved to be of very low quality, with a high clay content, and this has led to some minor problems which had to be rectified at a later date.) The seaward face, crest and
