STABILITY OF INTERLOCKING ARMOUR UNITS ON A BREAKWATER CREST

Ilse van den Bosch¹, Erik ten Oever¹, Pieter Bakker¹, Markus Muttray¹

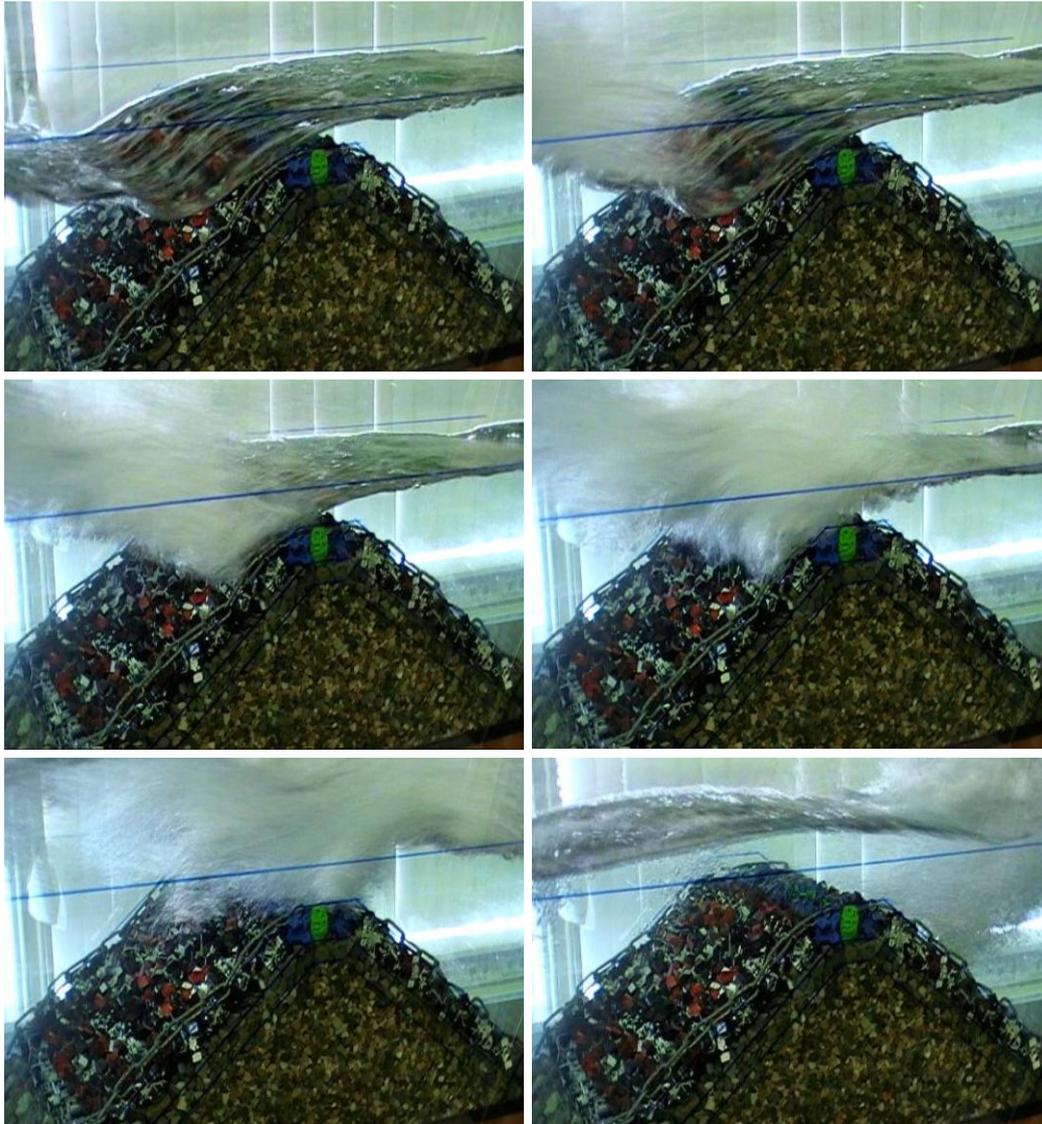
Figure 1: Wave passing over low crested breakwater with a narrow crest (van der Linde, 2010)

Stability tests on low crested and submerged breakwaters were performed by van der Linde in the DMC wave flume in Utrecht, The Netherlands. The tests are described in detail by Muttray et al. (2012). Images of a wave impinging on a low crested breakwater are presented in Fig. 1; photos from each test series and tabular test results can be found in van der Linde (2010). A rubble mound breakwater with 3:4 slopes and Xbloc armour layer was tested (see Fig. 2). Although the tests were performed with Xbloc armour units (of 62 g, unit height 4.3 cm, specific density 2339 kg/m³), it is believed that the results would also be applicable for other types of interlocking armour units.

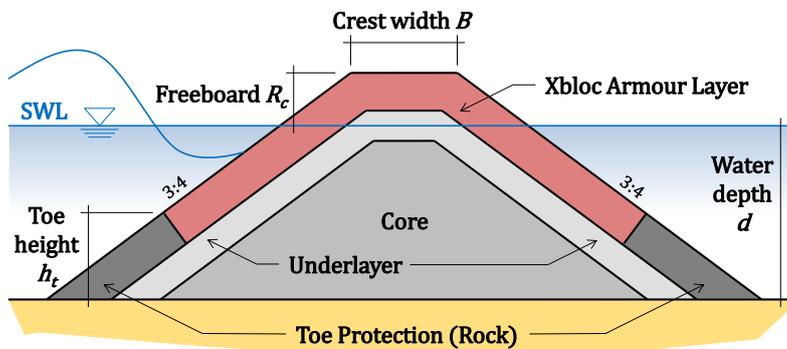
Figure 2: Cross section of breakwater model

The water depth at the breakwater toe was constant (33.9 cm); the seabed slope in front of the structure was 1:30. Five different breakwater crest level and two different crest widths were tested. The relative freeboard $R_c/H_{s,D}$ was 0, ± 0.4 and ± 0.8 (with freeboard, $R_c = 0, \pm 4.4, \pm 8.9$ cm and design wave height, $H_{s,D} = 11.1$ cm). The crest was either 3 or 9 armour units wide (about 10 cm or 25 cm, respectively). The lower part of the slope was protected by a rock layer; the transition from “rock toe” to Xbloc armour varied with the crest height. The number of armour units on the seaward and landward slope was kept constant (14 Xbloc rows, i.e. 147 units were placed on front/rear slope and 32 or 95 units on the crest). The armour layer stability was thus not influenced by the length of Xbloc armoured slope or by the toe geometry.

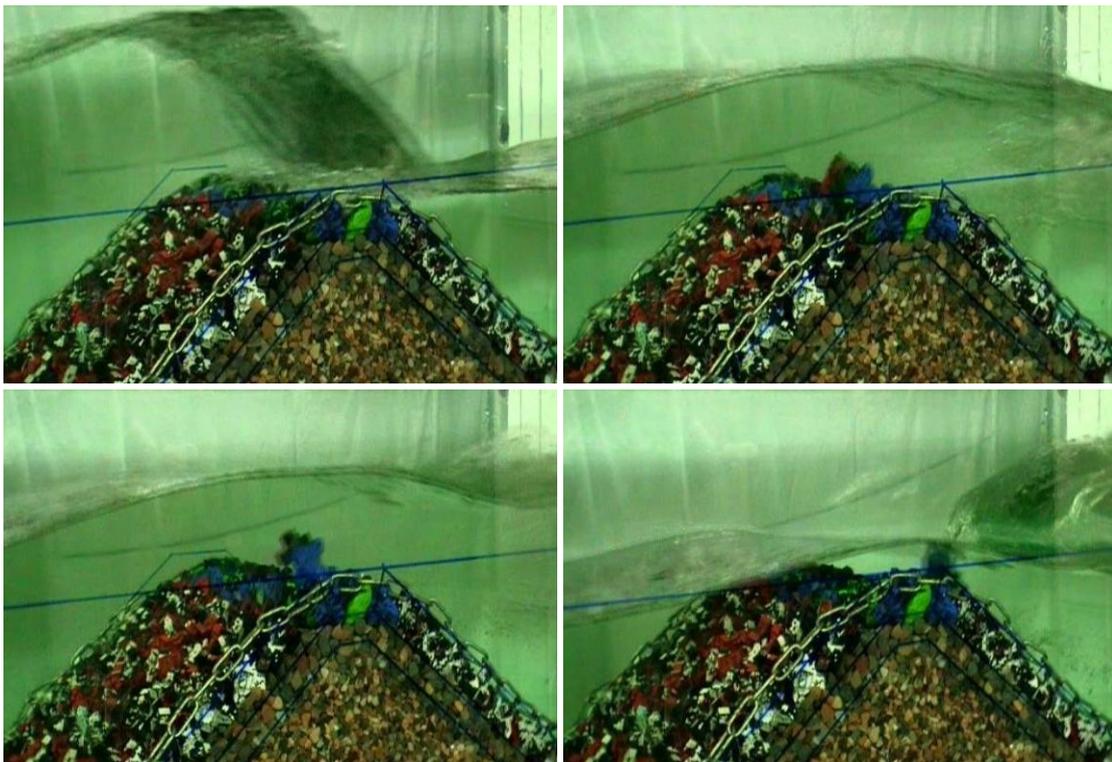
Figure 3: Displacement of an armour unit at the landward side of the breakwater crest (van der Linde, 2010)

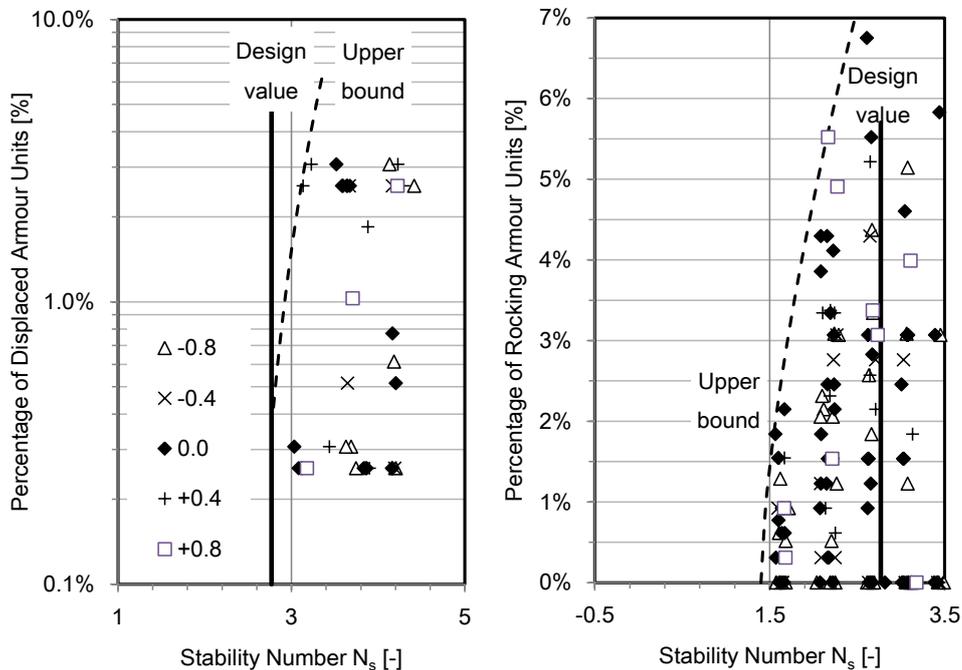
The percentage of rocking armour units and the accumulated damage (percentage of displaced armour units) are presented in Fig. 4. A stability number, $N_{s,D}$ ($=H_s/\Delta \cdot D_n$) of 2.77 is commonly applied for the concept design of Xbloc armoured breakwaters (DMC, 2011). Damage is expected when the stability number, N_s exceeds 3.5. At low crested breakwaters the damage starts if $N_s > 3.0$. The number of rocking armour units on a low crested or submerged breakwater may vary in a design storm from 0% to 7%. Application of common design rules would thus lead to a smaller safety margin for low crested breakwaters as compared to conventional breakwaters.

Figure 4: Overview of displaced armour units (left) and rocking armour units (right)

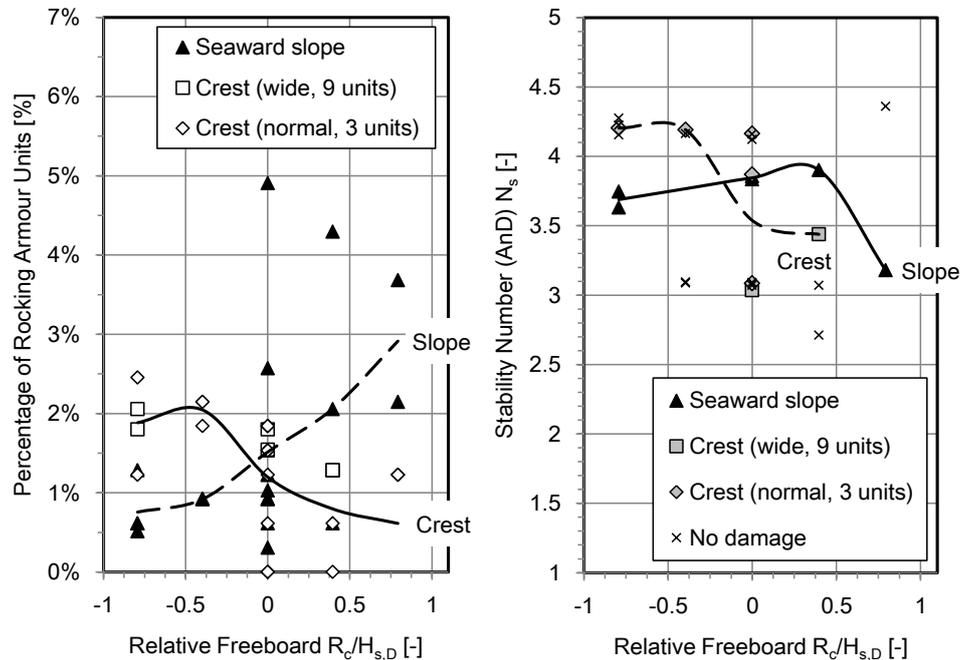
The number of armour units on the seaward slope and on the breakwater crest that were rocking in design conditions (stability numbers of about 2.77) is plotted in Fig. 5 (left). Tests with almost no damage (AnD) are presented in Fig. 5 (right).

Figure 5. Occurrence of rocking armour units under design conditions (left) and stability numbers in tests with almost no damage (AnD, right)

The number of rocking units on the crest is about 2% at submerged structures and is gradually decreasing when the crest is at or above the waterline. The number of rocking units on the seaward slope is significantly larger at submerged structures than at low crested, emerged structures. About 1% of the armour units were rocking on the slope in design conditions at submerged structures. In tests with zero freeboard the number of rocking units on the slope varied from 0% to 5% (1.5% on average). The average number of rocking units on the slope is apparently increasing with increasing freeboard and reaches about 2% to 4% if $R_c = H_s$.

The worst test conditions with no or at most one displaced armour unit (called AnD) are presented in Fig. 5 (right). In case that one armour unit had been displaced it is indicated whether it was extracted from the slope or from the crest. Displacement of armour units on the slope starts around stability number of 3.5 to 4.0. This is similar to a conventional, high crested structures, where the first damage can be expected when the stability number exceeds 3.5. A lower armour unit stability has been observed at emerged structures with a relative freeboard, R_c/H_s of 0.8, where damage starts at a stability numbers of about 3.2. Displacement of armour units on the crest of submerged structures starts at stability numbers of about 4.0. At structures with zero freeboard the stability number of the crest armour is reduced to 3.5 (average value) and goes even down to 3.0 in several tests. No damage was observed on the crest of emerged structures with a relative freeboard, R_c/H_s of 0.8.

The armour unit stability on a breakwater crest reaches apparently a minimum if the crest is close to the water line. The crest stability is increasing at submerged structures and if the freeboard exceeds about 0.5 H_s . The number of rocking armour units on the seaward slope indicates a gradually decreasing armour layer stability with increasing positive freeboard (Fig. 5, left). This trend is in line with the damage development on the slope as depicted in (Fig. 5, right). The percentage of rocking

units on the crest indicates that an emerged crest would be more stable than a submerged crest (Fig. 5, left). The damage development on the crest shows a somewhat different trend (see Fig. 5, right); the crest of low crested emerged structures appears least stable. Thus, the percentage of rocking armour units may not necessarily be a suitable indicator for the armour layer stability, especially on the crest.

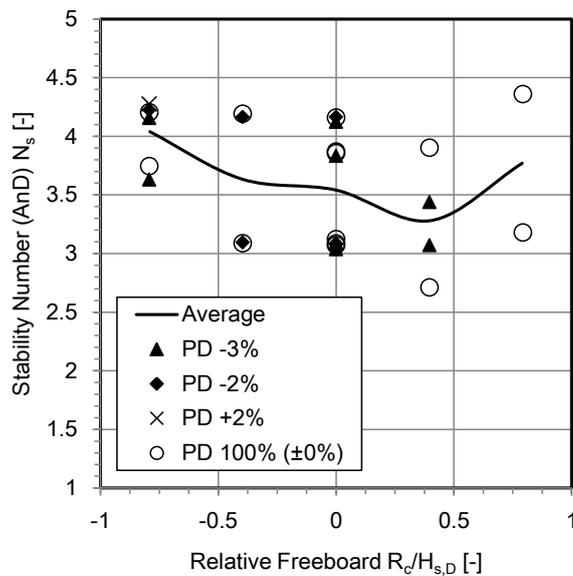
The stability number in tests with almost no damage (AnD) is plotted in Fig. 6 against the relative freeboard; the variation of packing density from the design value (referred to as 100% packing density) is indicated. The stability of the armour layer varies to some extent with the relative freeboard. A distinct relationship between armour layer stability and packing density however cannot be seen. It appears from Fig. 6 that a variation of packing density by $\pm 3\%$ has little influence on the armour layer stability of low crested and submerged breakwaters.

Figure 6: Variation of armour layer stability with freeboard and packing density

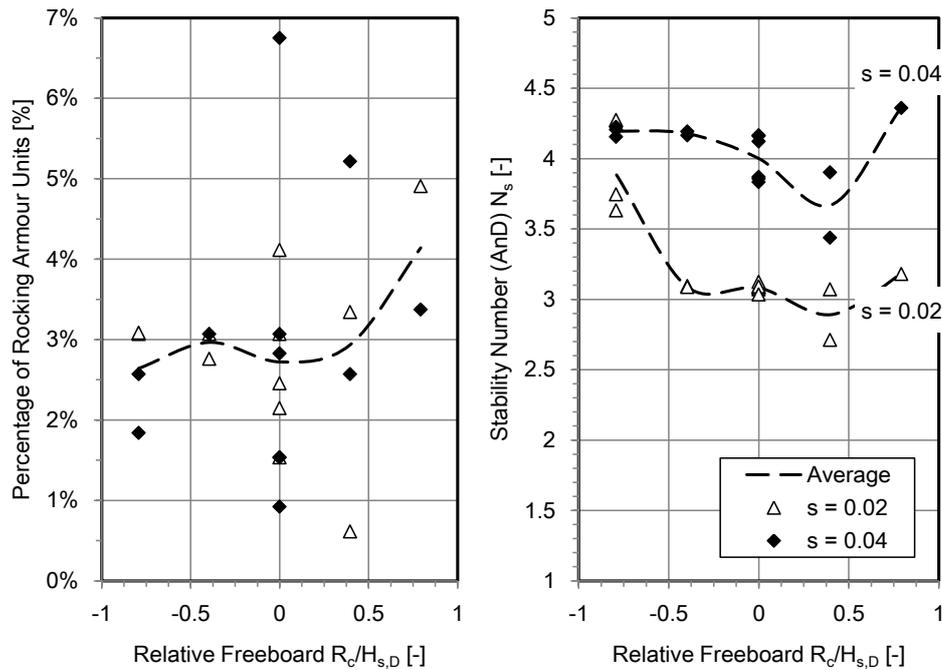
The effect of wave steepness on the armour layer stability is presented in Fig. 7. The stability number in tests with almost no damage (AnD) is plotted in Fig. 7 (right) against the relative freeboard for wave steepness $s = 0.02$ and 0.04 . The stability of the armour layer is significantly lower (on average 21%) for long waves (wave steepness 0.02) as compared to shorter waves of steepness 0.04. The number of rocking armour units in a design storm is presented in Fig. 7 (left). No marked difference can be seen between wave steepness 0.02 and 0.04.

Figure 7: Effect of wave steepness on the number of rocking armour units under design conditions (left) and on the stability number in tests with almost no damage (AnD, right)

The wave steepness has apparently little influence on the number of rocking armour units, but has some influence on the overall stability of the armour layer of low crested and submerged breakwaters. The armour layer stability is reduced by about 20% when the wave steepness goes down from 0.04 to 0.02.

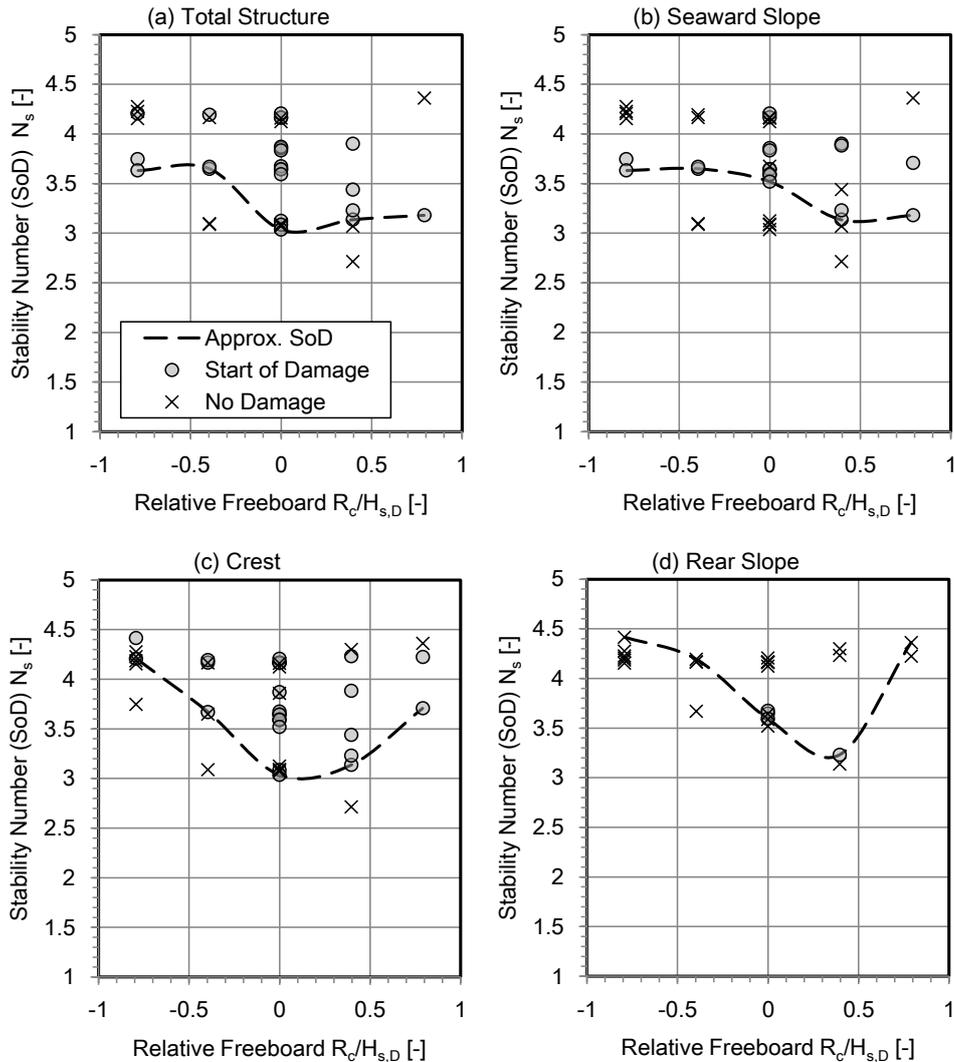
Stability numbers at start of damage (i.e. the test conditions where the first armour unit has been displaced) are plotted in Fig. 8 against the relative freeboard. It should be noted that stability numbers in Fig. 8 may refer to test conditions where more than one armour unit has been displaced (i.e. tests with progressive damage), which are excluded from Fig. 5, Fig. 6 and Fig. 7.

The overall stability (i.e. armour layer stability on crest, front and rear slope) as presented in Fig. 8a reaches a minimum at zero freeboard ($N_s = 3.0$). Somewhat larger stability numbers are determined for submerged structures ($N_s = 3.6$) and for emerged structures ($N_s = 3.2$). The stability of the seaward slope in Fig. 8b is similar to the overall stability. However, the least stability ($N_s = 3.1$) was observed at low crested emerged structures with a relative freeboard of 0.4. The crest stability in Fig. 8c reaches a minimum at zero freeboard ($N_s = 3.0$) and is rapidly increasing with if the crest is submerged or emerged. Damage at the rear slope has only been observed at low crested, emerged structures with a relative freeboard of ± 0.0 and $+0.4$ (Fig. 8d). The stability of the rear slope appears uncritical for structures with higher freeboard or for submerged structures.

Figure 8: Stability number N_s at SoD: Overall damage (a), seaward slope (b), crest (c) and rear slope (d)

The stability numbers at start of damage (i.e. the trend lines in Fig. 8) of front slope, crest and rear slope are shown in Fig. 9 (red and orange lines). The slope stability of low crested structures matches with the stability of conventional, high crested breakwaters according to DMC (2011). Fig. 9 includes further the design value for Xbloc armouring on low crested breakwaters according to DMC (2011). The blue lines refer to the stability of rock armour on low crested breakwaters according to CIRIA (2007). A design wave height $H_{s,D} = 1.5 \Delta D_{n50}$ has been applied for rock armour on conventional breakwaters.

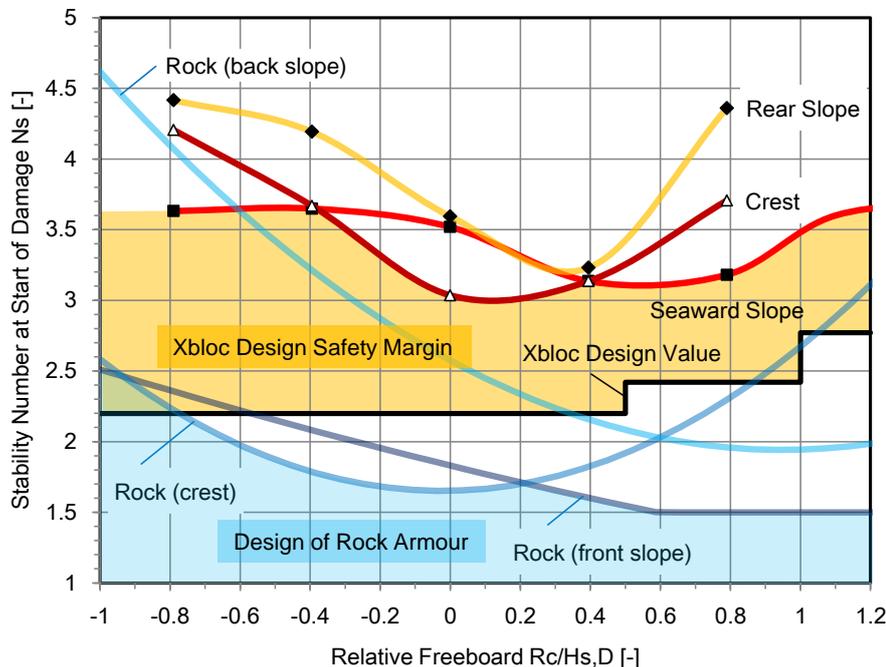
Figure 9. Stability of rock and Xbloc armour on low crested and submerged breakwaters

units the most likely start of damage (i.e. the minimum of crest, front and rear slope stability) corresponds to the upper bound of the orange area in Fig. 9. The stability of single layer armouring on low crested structures is qualitatively different from rock armour. The stability is decreasing at low crested, emerged structures. The least armour layer stability has been observed when the relative freeboard is of order 0 to 0.5. The armour layer stability is increasing again when the structure is submerged.

The design safety margin, i.e. the difference between the recommended design value and start of damage is marked orange in Fig. 9. The design value ($N_s = 2.77$ for conventional breakwater) is reduced to 2.42 (i.e. 50% increased armour unit weight) if the relative freeboard is less than 1 and is further reduced to 2.20 (i.e. 100% increased armour unit weight) if the relative freeboard drops below 0.5. The safety margin is relatively constant (about 25% of the design value, which corresponds to a factor 2 on the armour unit weight) at low crested emerged structures. At submerged structures the safety margin is gradually increasing with increasing submergence. The design value for submerged breakwaters with relative freeboard below -0.5 could and should be similar to the design value for conventional, high crested breakwaters.
